Addendum No. 1
FLEISH PENSTOCK AND HIGHLAND INVERTED SIPHON
STRUCTURAL LINING
PWP Bid No. WA-2016-038
October 23, 2015

6.0 Visual Inspection of Interior

Condition Assessment of Truckee River Siphon

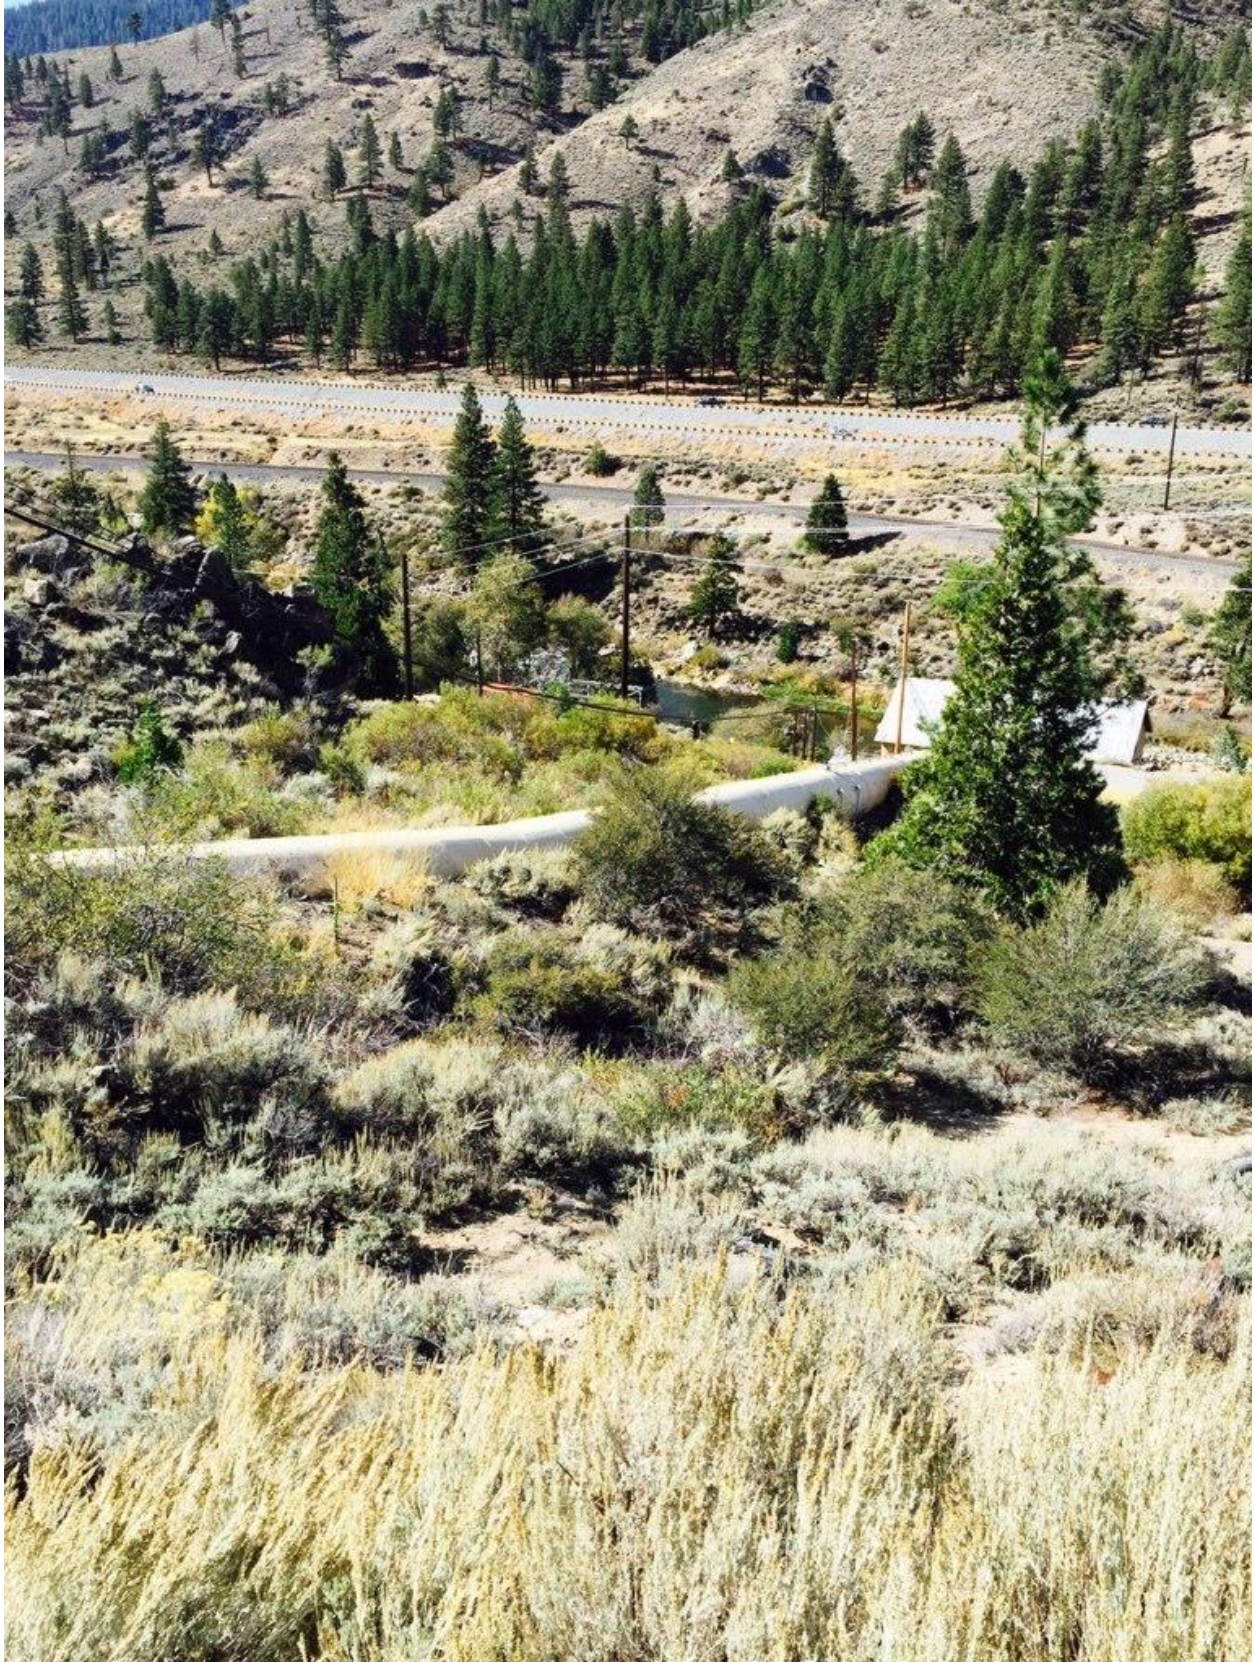
Fleish Penstock down to Powerhouse

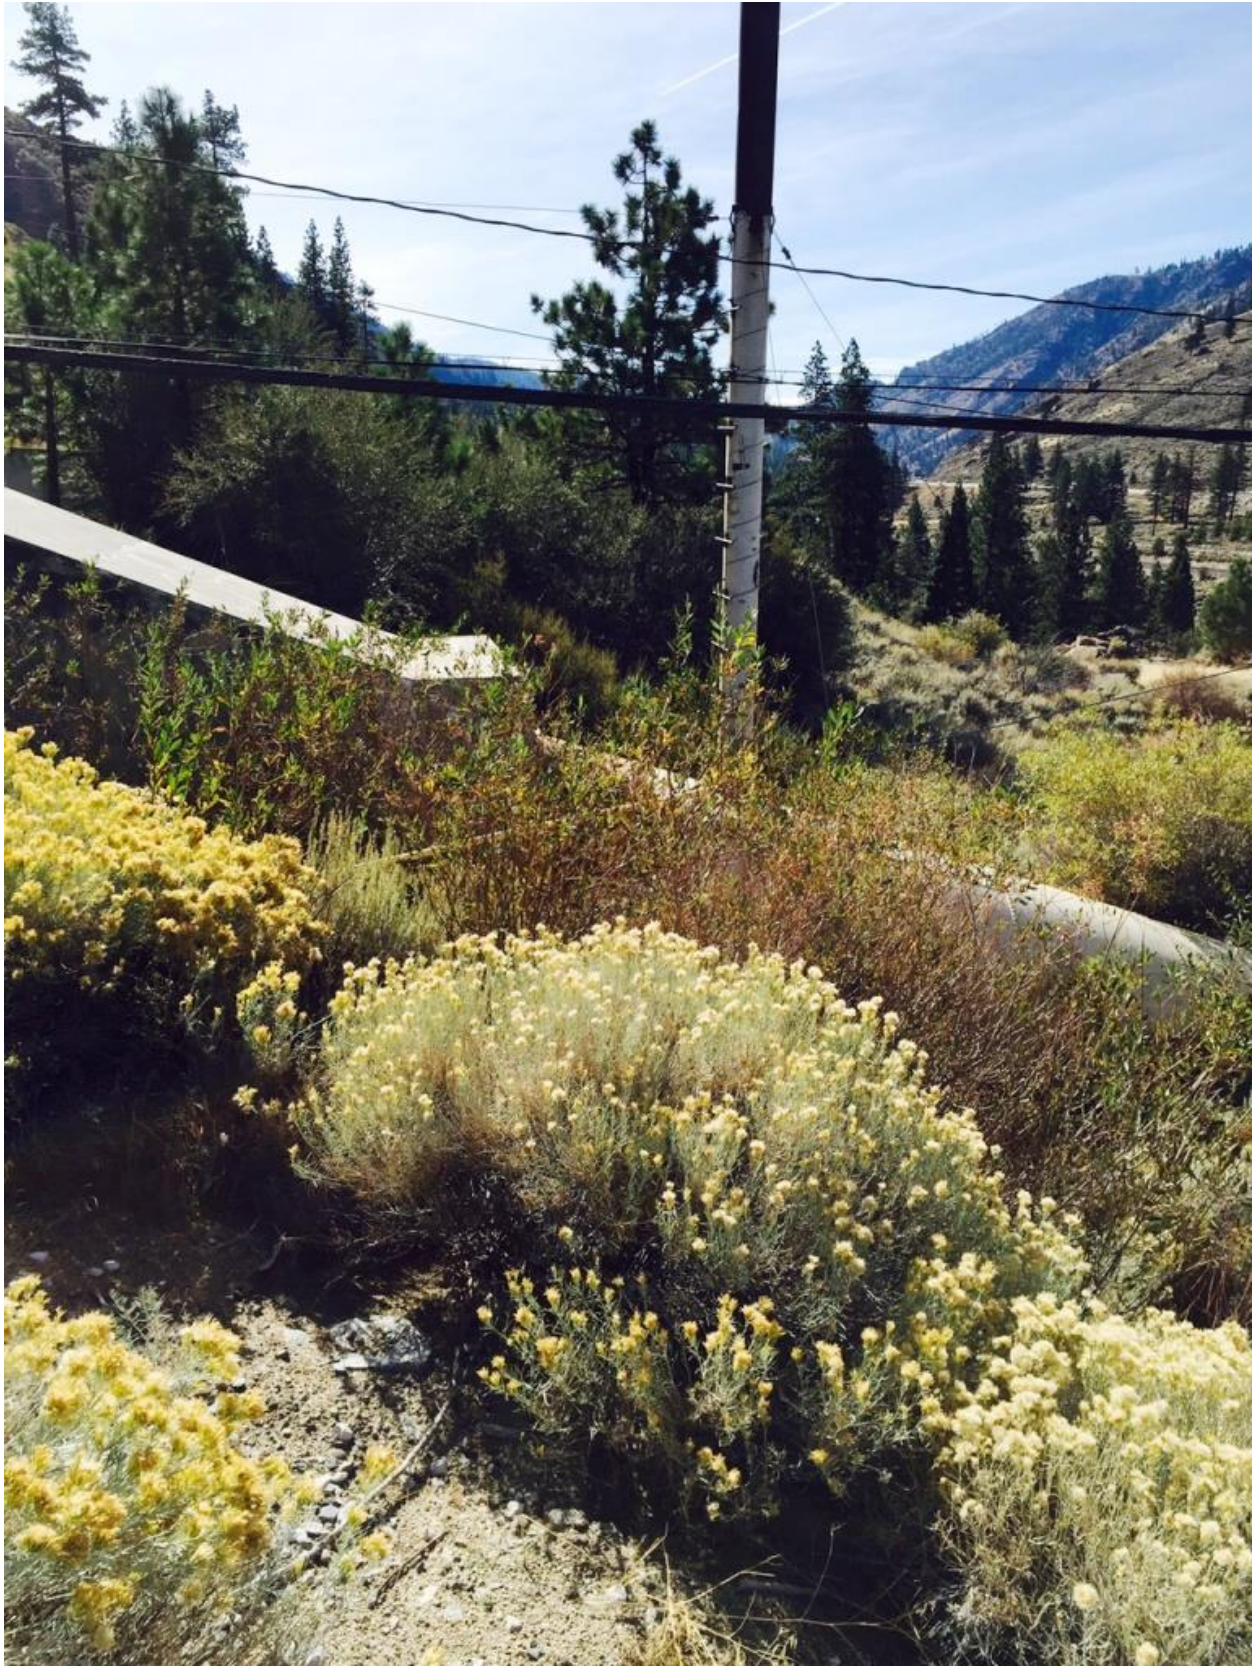
Forebay on Left Transitioning to Penstock with Vent

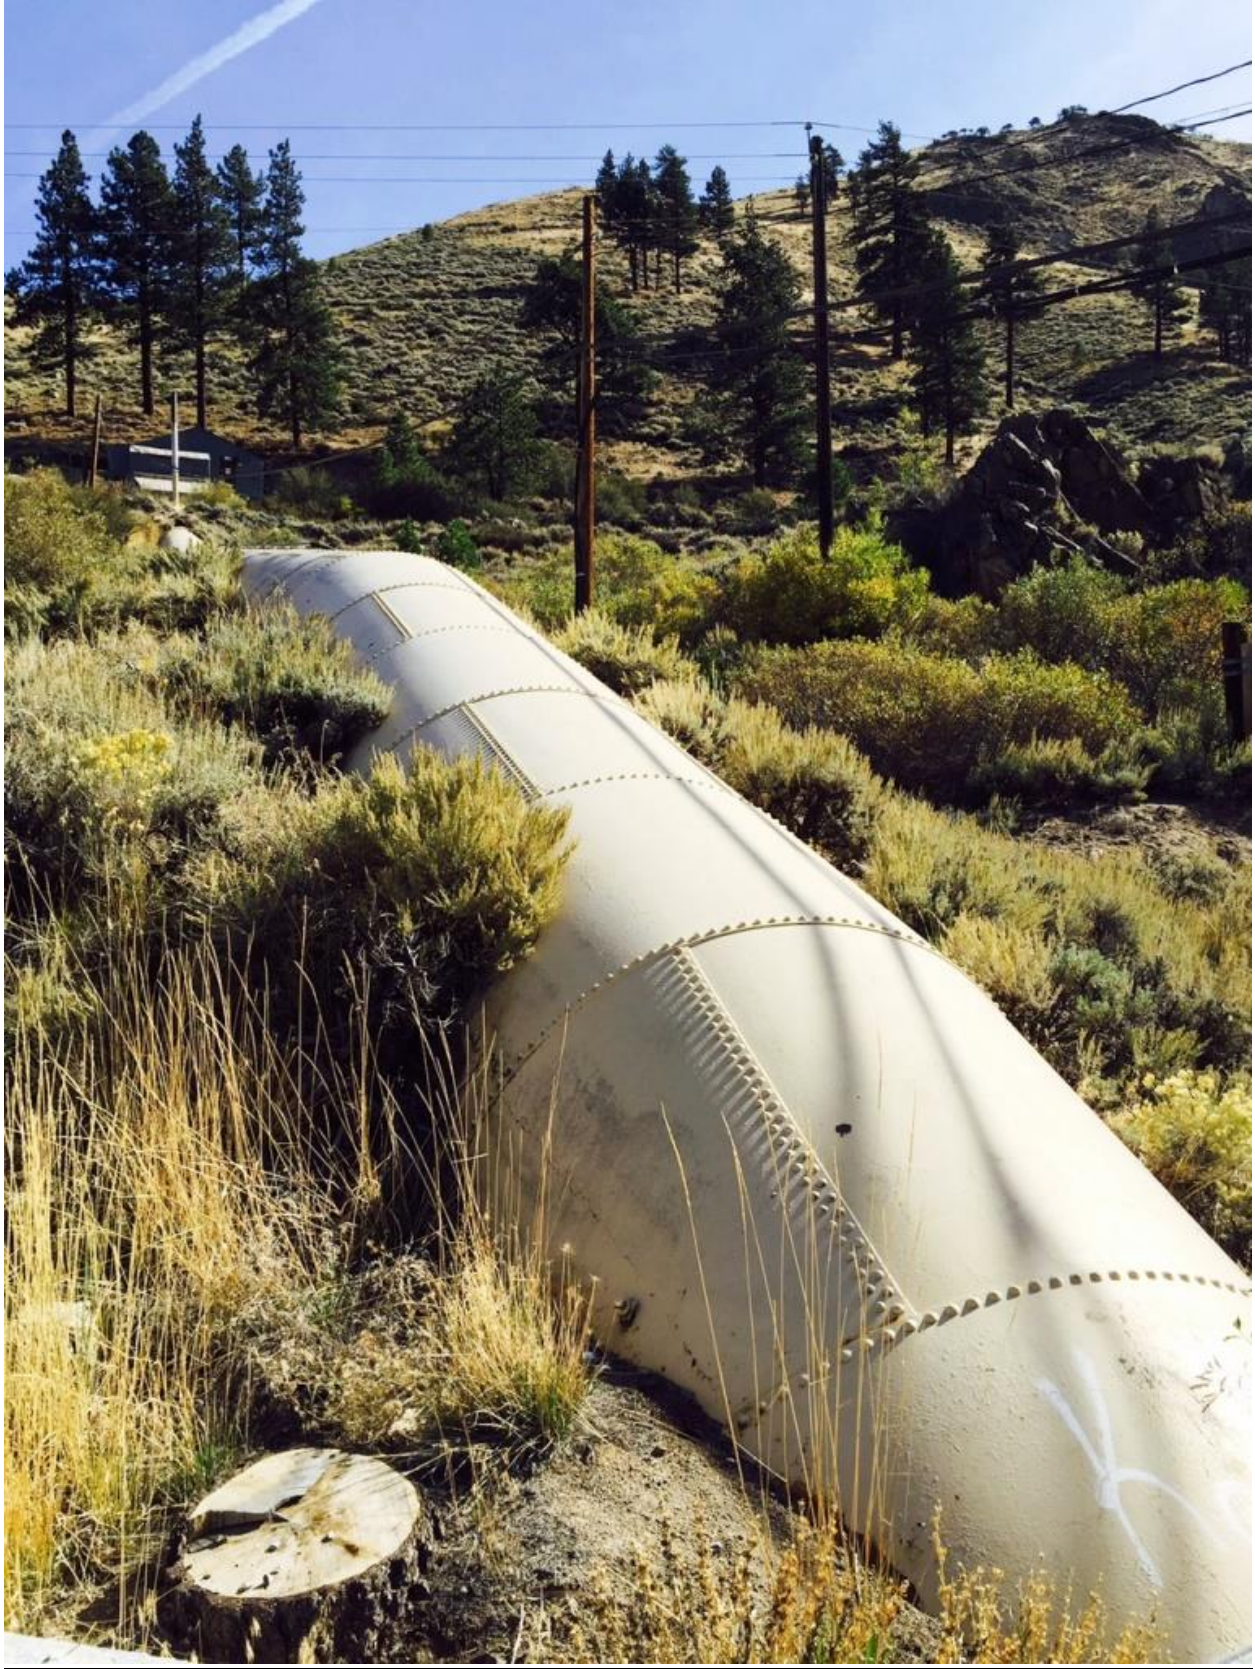
Penstock Showing Vertical Deflection - Forebay in Background

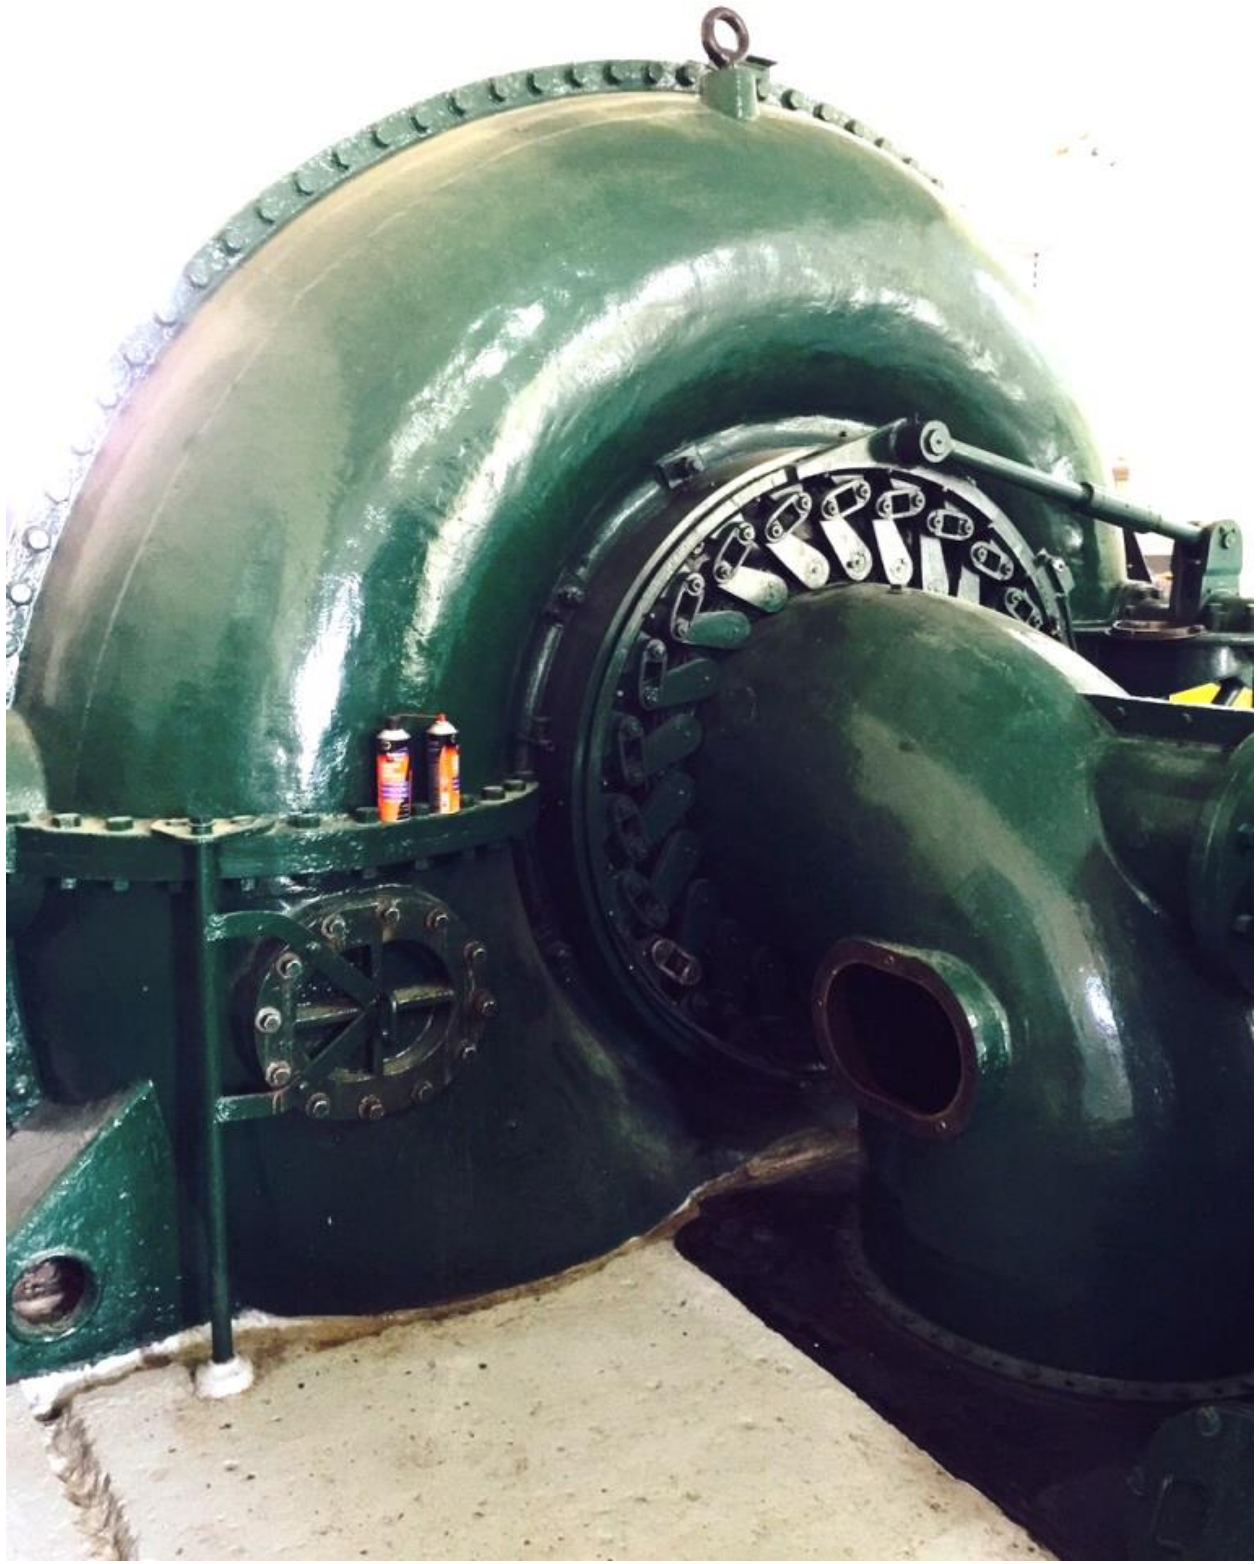
Scroll Case Showing Two Access Hatches

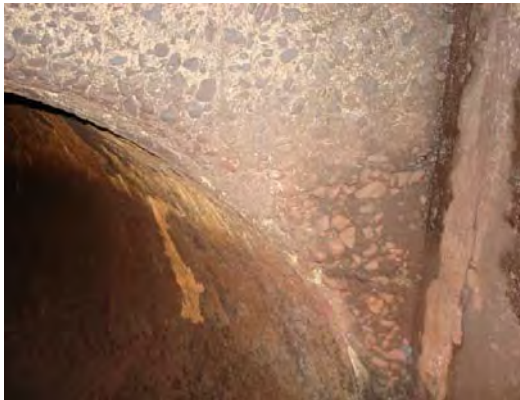
Highland Canal Entrance

Entrance to the siphon at Highland Canal structure. Note exposed aggregate in concrete face. Pipe appeared to be completely encased in concrete with no gaps.

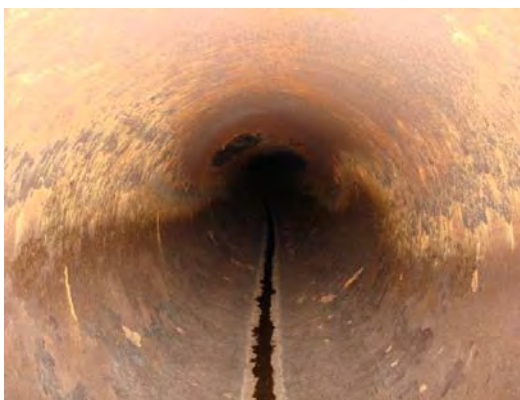
Pipe Section S1 (26'5")

Viewing looking east in section S1. Note absence of asphaltic lining except patch at 11 o'clock, 10 feet into pipe.

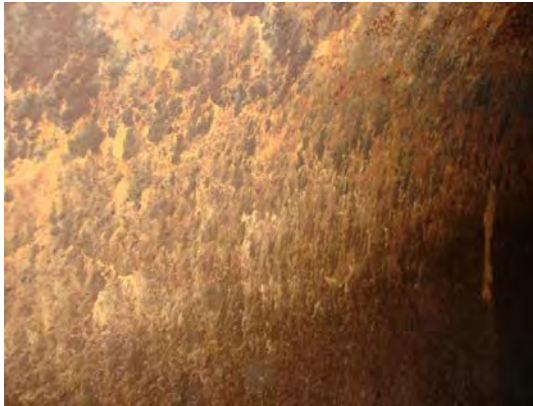
Heavy general corrosion at 9 to 10 o'clock in S1.

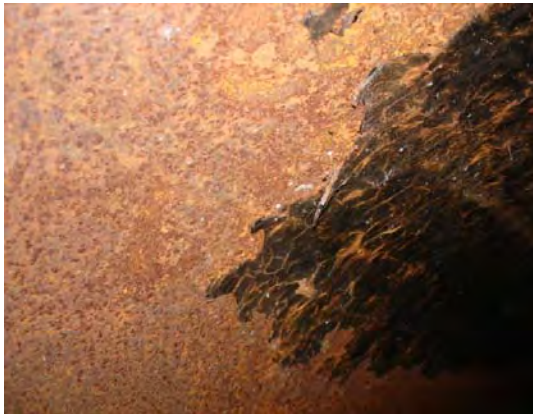
Patch of asphaltic lining in S1. Not adhering to wall and flaking off.

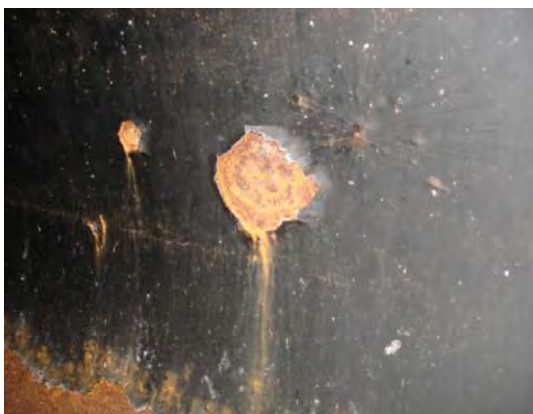
Pipe Section S2 (30'0")

Very little asphaltic lining in first 10 feet of S2.

Several holes (popped blisters) in the asphaltic lining. Blisters held water behind the lining and eventually popped releasing water and exposing inner surface.

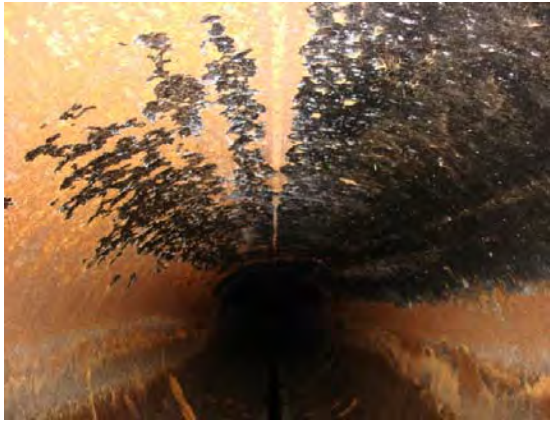
View of crown of section S2. Note poor condition of asphaltic lining. Lining completely missing below the springline.

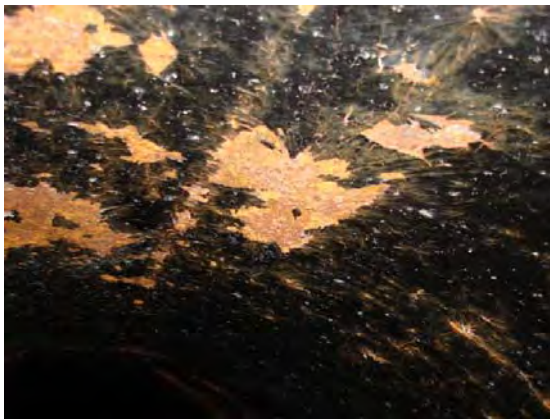
Approximately 21 feet into S2, three dimples found in the crown of the pipe. Dimples were between 11:30 and 1:00 o'clock and are probably caused by large rocks or boulders resting on the outside of the pipe. Ultrasonic thickness measurements were later made adjacent to some of these dimples. The thickness was found to be 0.217 to 0.238 inches, or about 13% reduced from the original nominal of 0.25". Section S2 has also experienced up to 7.1% vertical pipe deflection. The crown appeared flat.

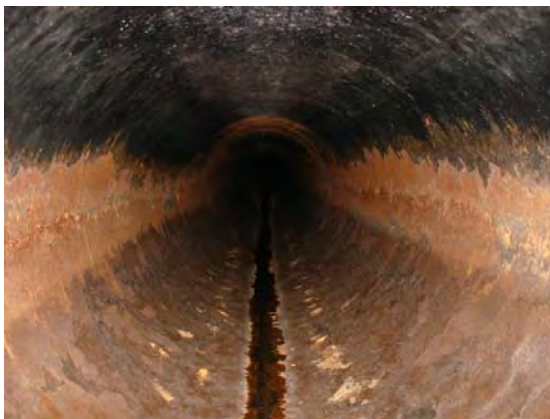
Pipe Section S3 (29'11")

View looking down section S3. Asphaltic lining missing from 3 to 9 o'clock, and also on crown near end of the section.

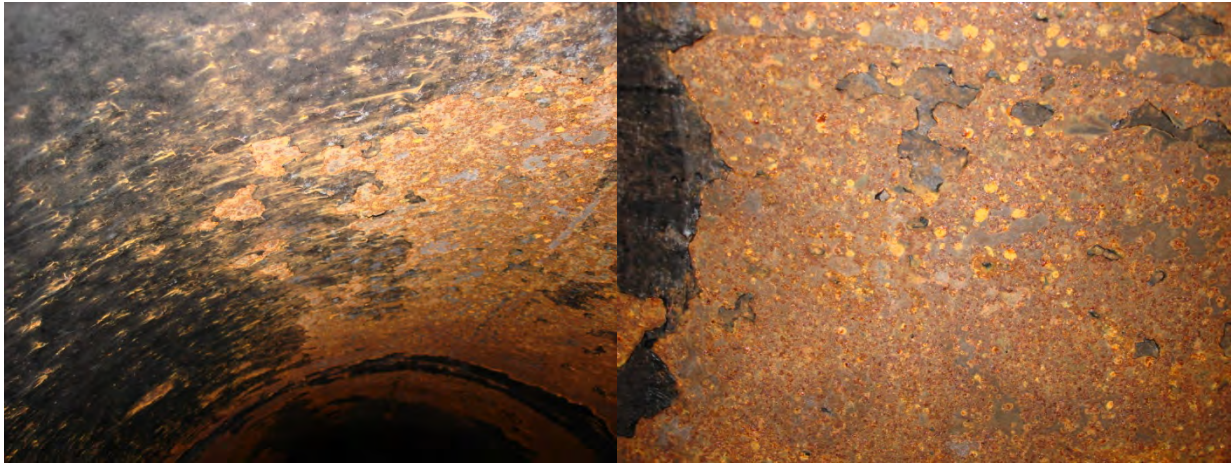
Last 4 feet of S3, asphaltic lining is patchy and pit corrosion on crown noted.

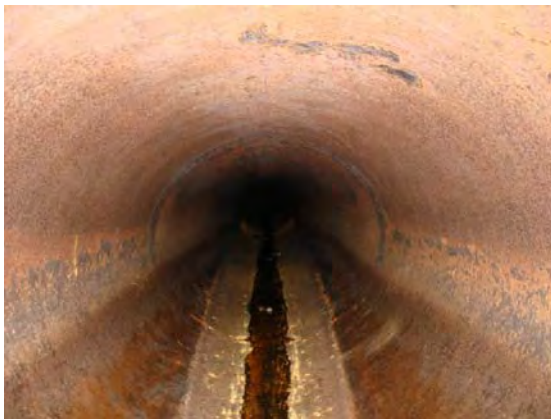
Pipe Section S4 (29'6")

Section S4 is similar to S3, namely missing most of its asphaltic lining.

View down section S4. Note that most of the asphaltic lining is gone. Vertical deflections are approximately 6.5%.

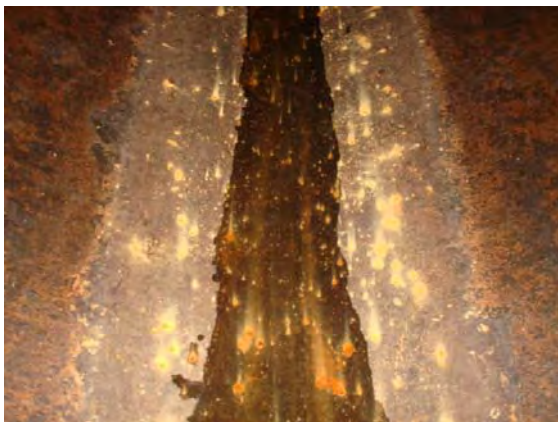
Pit corrosion found on the crown and invert (shown) of S4.

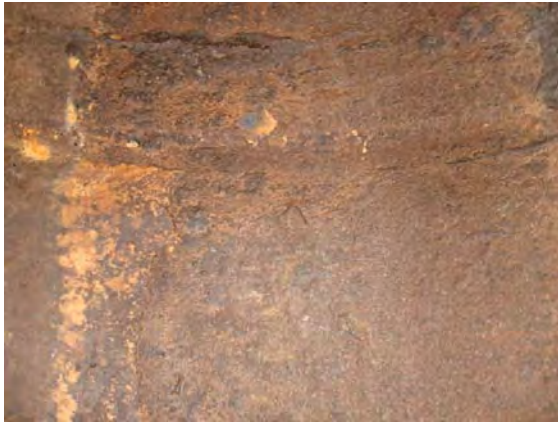
Lap welded joint between S4 and S5. Joint still has some asphaltic coating protecting it but missing at 7 o'clock.

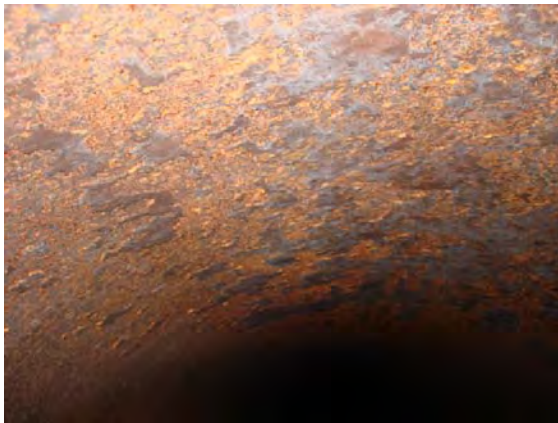
Pipe Section S5 (28'10")

The asphaltic lining is pretty much completely gone in S5.

The crown of S5 (picture is approximately 3 feet into S5) had considerable general corrosion.

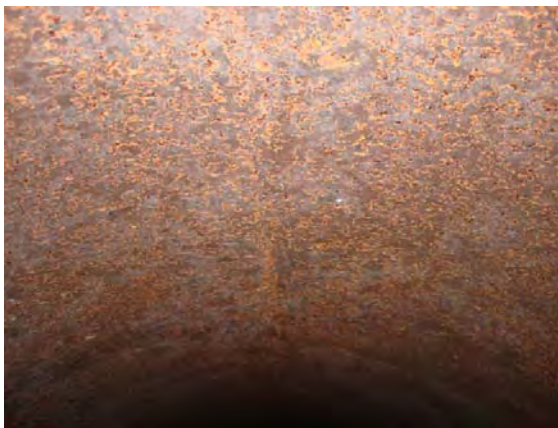
A longitudinal weld on the crown is visible.

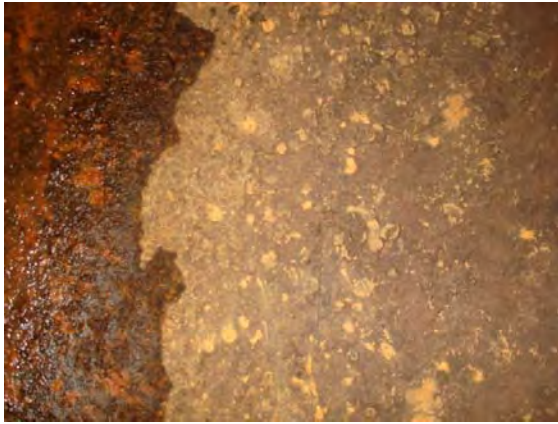
Pipe Section S6 (29'8")

Asphaltic lining is very patchy in S6.

Corrosion, including pit corrosion, found along the invert. Pipe surface very rough from 4 to 7 o'clock.

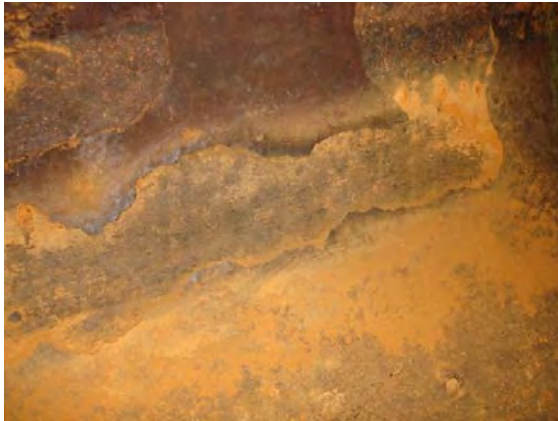
Seven (7) ft from the joint with S5, the surface had some light corrosion and was wire brushed. Underlying steel looked okay.

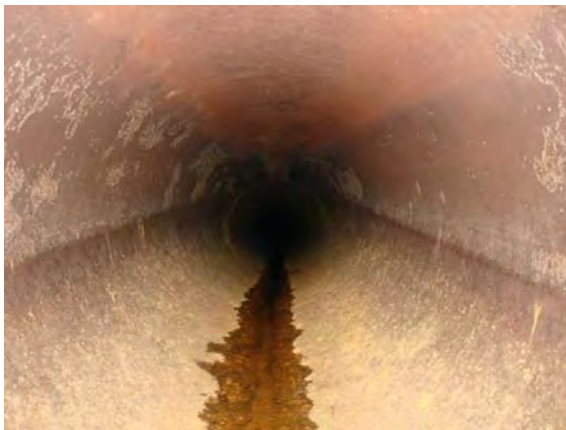
Pipe Section S7 (14'4' to miter elbow, 16'1" to end of pipe)

View down S7.

Corrosion evident in S7, especially in the invert.

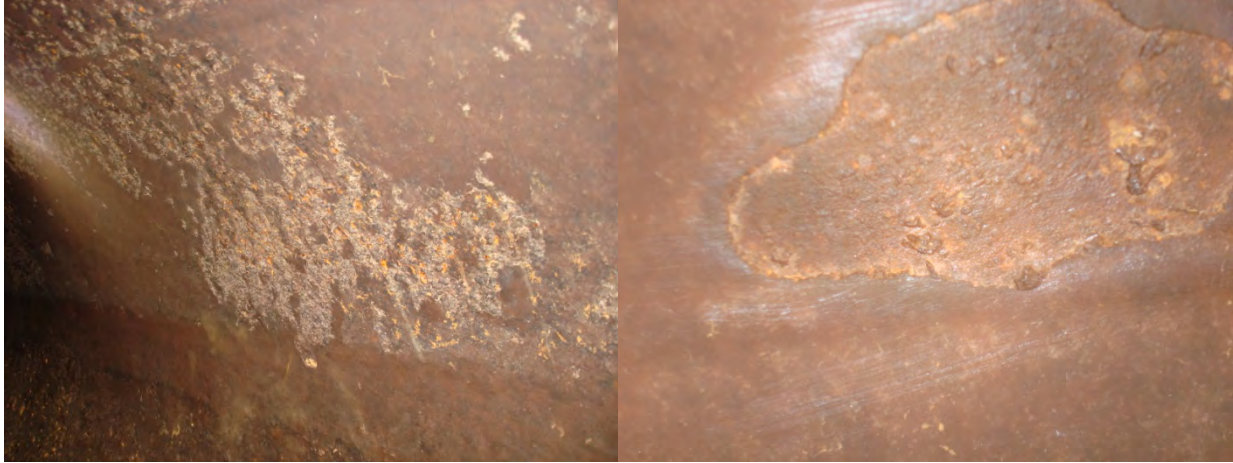
Approximately 6 feet east of the miter, at 10 o'clock, there was a fuzzy material with a bluish tint attached to the surface of the lining. A photo was taken of the lining with the fuzz and after wire brush removal.

The thickness of the lining in this area was measured using the Thorpe pit depth gage. The lining thickness was 0.075”.

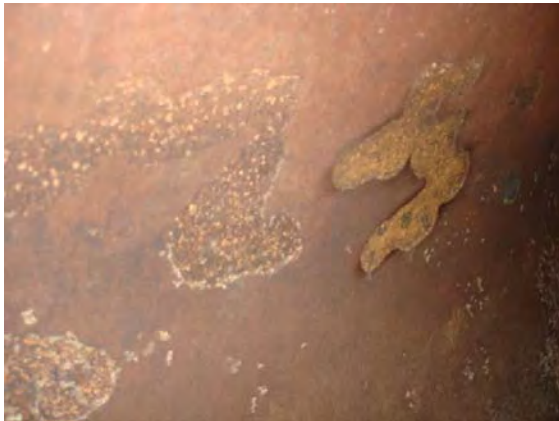
Lots of pits were found adjacent to the miter in S7. The Thorpe pit depth gage was used to measure the depth of the pits. Pit depths were 0.04” and 0.05”.

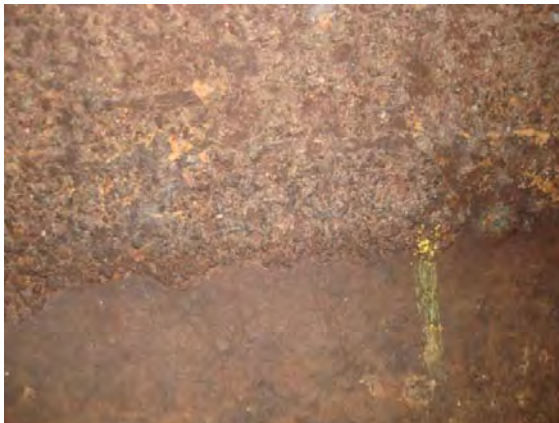
An 8 ft long section in S7 had some very rough general corrosion above the springline, from 9 to 3 o'clock.

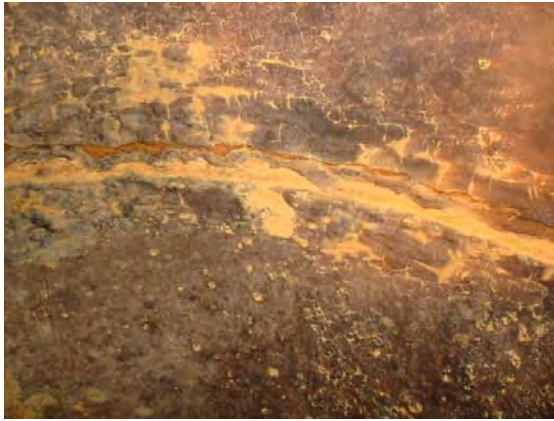
Dresser coupling used to join S7 and S8. Asphaltic lining missing from the coupling area. The joint is leaking as wetness was found running up the coupling joint.

Enough of an end of a pipe was exposed that it was possible to measure the thickness with a caliper. The thickness was 0.25". No ultrasonic thickness measurements made here.

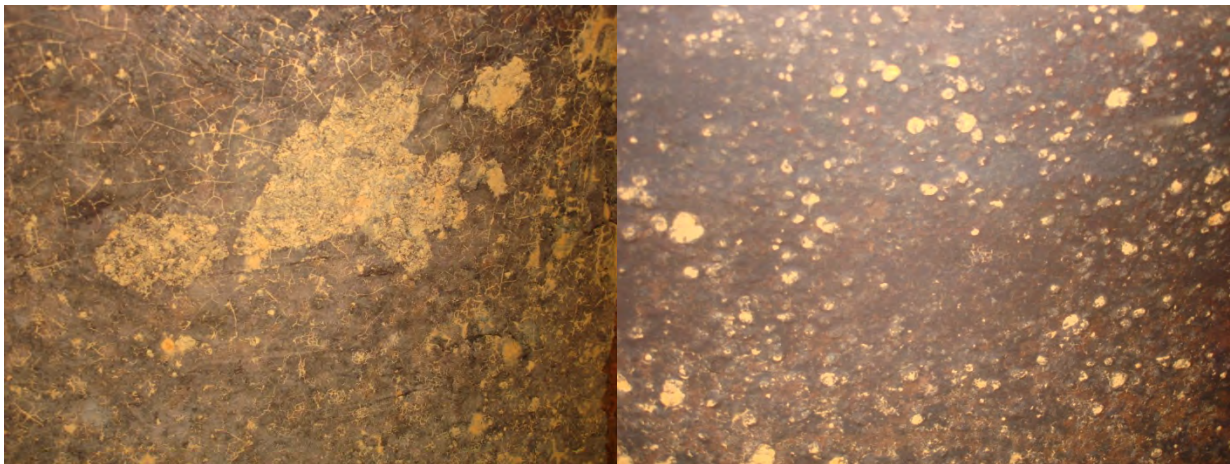
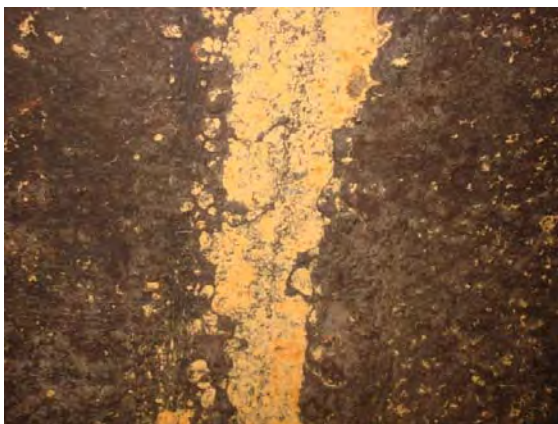
Pipe Section S8 (29'6")

The inside surface of S8 showed considerable corrosion around the entire pipe circumference. Pit corrosion was prevalent on the crown, from 9 to 3 o'clock.

The longitudinal welds, 180 degrees apart, were clearly visible in this pipe section as all of the asphaltic lining was gone.

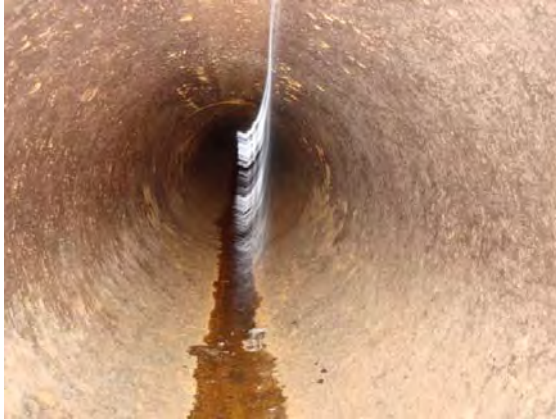
Pipe Section S9 (30'3")

S9 had little remaining asphaltic lining as evidenced in this view.

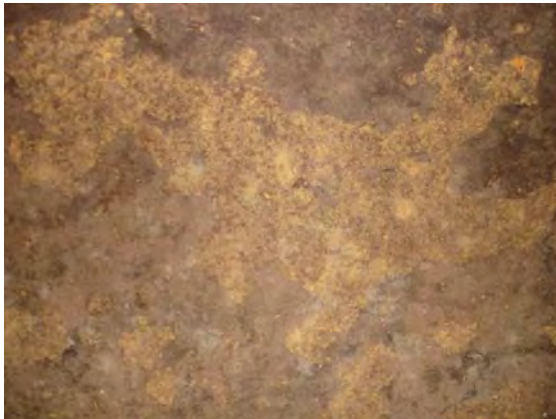
Approximately 6 feet from the end of section S9 there was very heavy corrosion found.

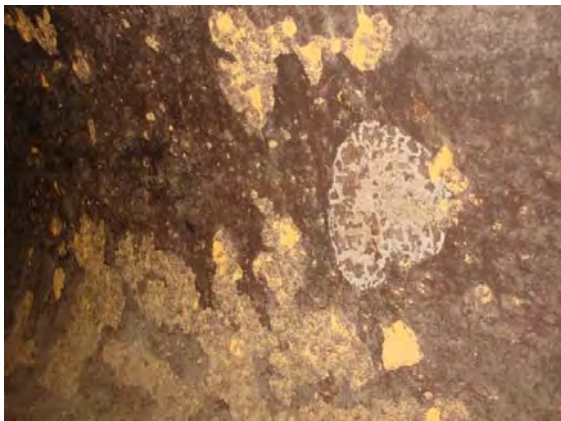
There was also an area on section S9 where the corrosion had a blue tint. We believe this might be indicative of some microbiological attack of the lining.

Unfortunately, the blue tint does not show up in the photos.

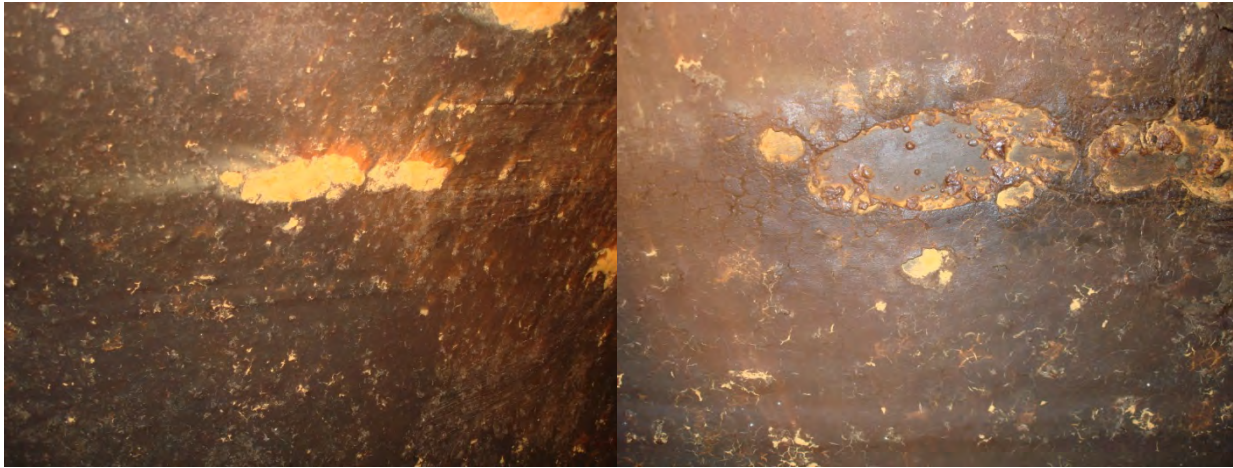
One area where considerable tuberculation or corrosion build up was present was wire brushed to see the condition of the underlying steel.

Before brushing.

After brushing – no pits found.

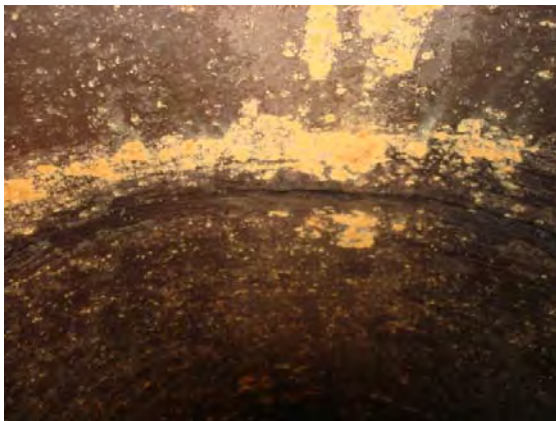
The lap weld joint between S9 and S10 appeared okay, with some corrosion noted on the crown immediately adjacent to the joint.

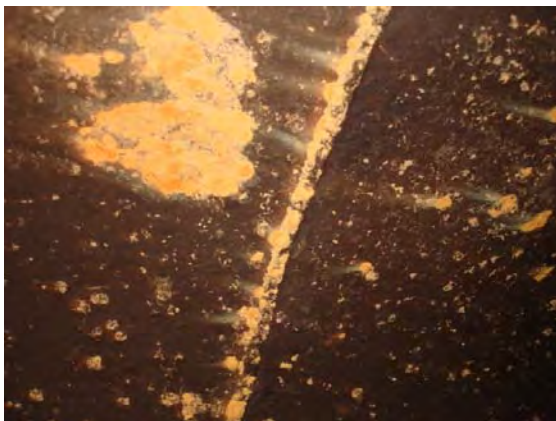
Pipe Section S10 (25'0" to miter elbow, 6'6" to pipe end)

The asphaltic lining appeared intact from 7 to 1 o'clock. Some mud cracks were observed, however.

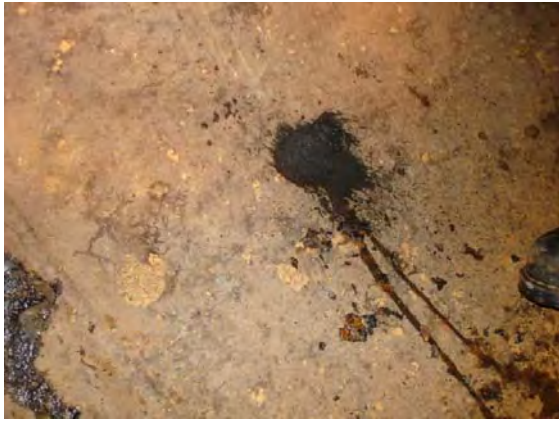
Some corrosion of the mitered joint in S10 was found in the crown, with some pit corrosion adjacent to the miter. Approximately 1 foot west of the miter, at 5 o'clock, some water was trapped behind the liner and escaped when the liner was pressed.

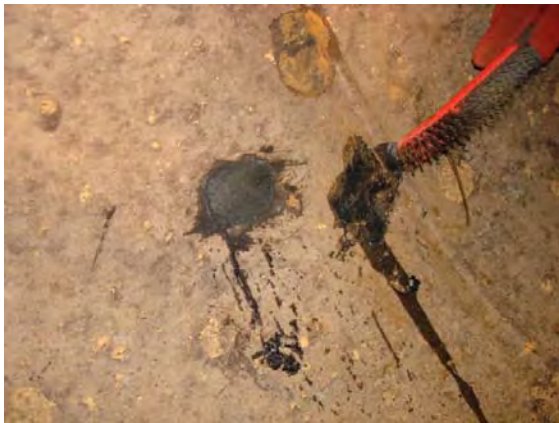
Approximately 5 feet east of the miter, the asphalt was not bonded to the pipe and moisture was found under the liner. After the initial run, it did not continue to leak so this is probably not due to a pin hole leak through the pipe wall.

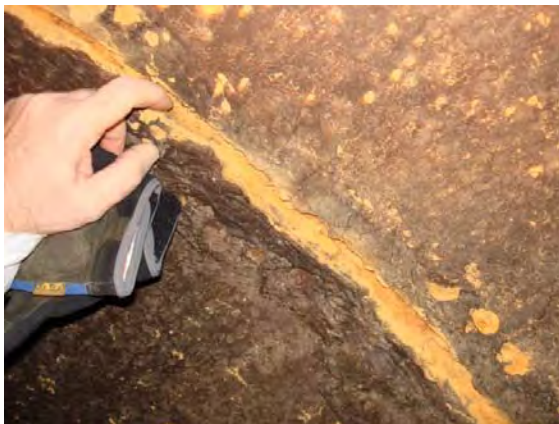
A Dresser mechanical joint was used between S10 and S11. The joint shows signs of leakage. There is a gap of 1" between the asphaltic lining and the coupling at the edge of the steel pipe (S11).

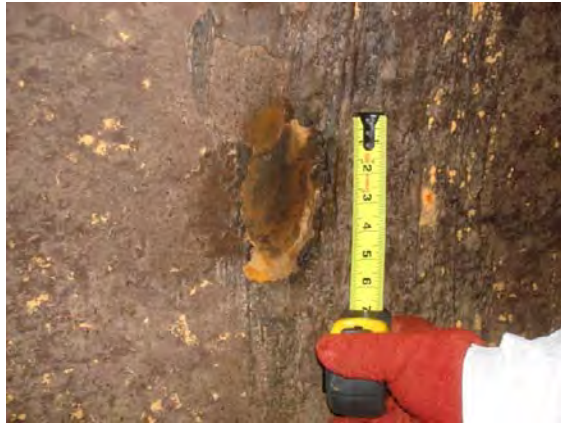
Pipe Section S11 (30'0")

The asphaltic lining was still in place from 7 to 3 o'clock in this section.

Four feet from the joint with S10, an area with corrosion build-up was wire brushed to see the underlying steel surface. After brushing, the steel looked pit free in this area.

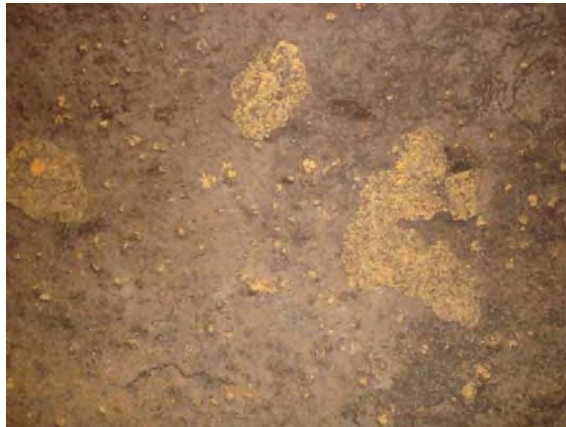
Approximately 23 feet into S11 there was lots of pit and general corrosion in the haunch area between 3 and 4 o'clock.

Pit corrosion was also found on the crown of S11.

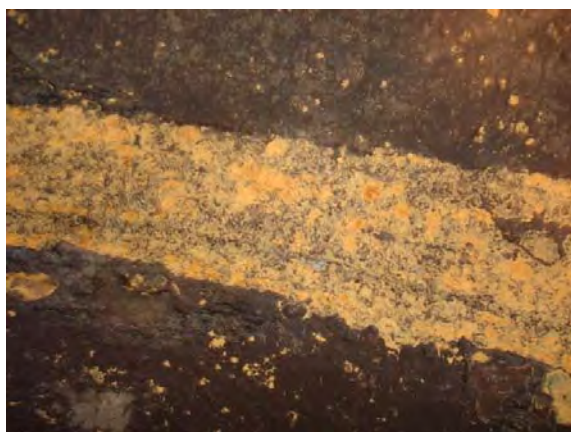
A lap welded joint connects S11 to S12. There was evidence of corrosion of the joint between 9 and 12 o'clock where the asphalt lining was missing.

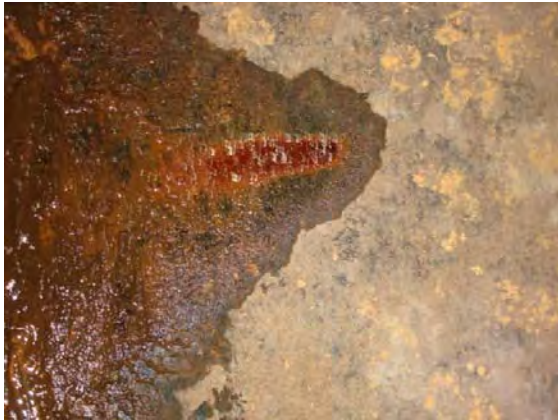
Pipe Section S12 (30'0")

Relatively speaking, section S12 looked pretty good. However, 17'6" in from the S11-S12 joint, at 7 o'clock, there was a through-the-wall pin hole leak (weeper).

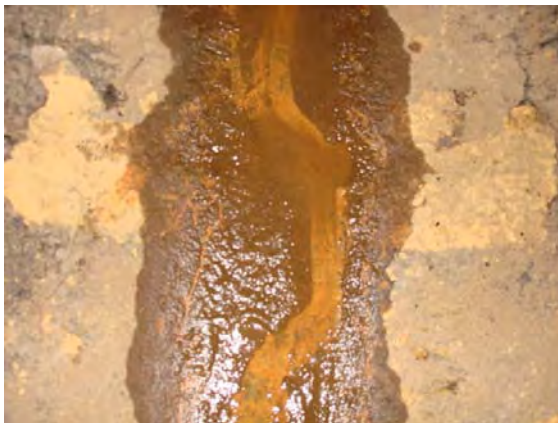
The lap weld joint between S12 and S13 is missing the liner in the invert area. There appeared to be considerable corrosion in this area as well as the crown (11 o'clock).

One foot from joint with S13 the liner in invert is missing with pit corrosion noted.

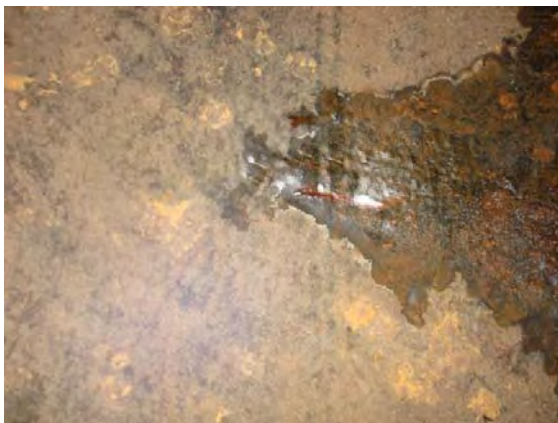
Pipe Section S13 (30'0")

Approximately 10 feet from the joint with S12 there were two pin hole leaks at 5:30 o'clock.

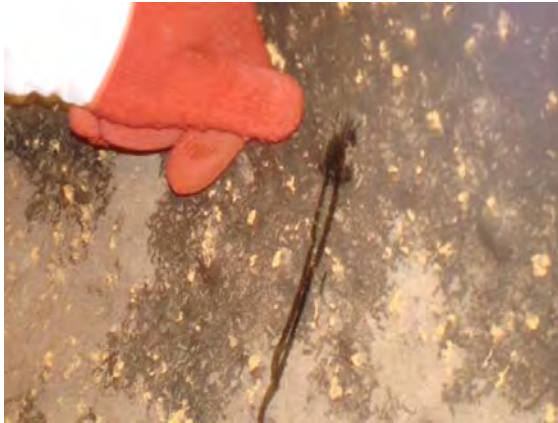
Some of the asphalt lining in S13 has bubbled with water accumulating behind the bubble. The asphalt bubble was popped and water ran out (see following picture).

Since there were two pin hole leak already found in this pipe section more than likely the bubble in the asphalt was due to a build-up of hydrostatic pressure from the outside, through a pin hole, causing the asphalt liner to bubble up.

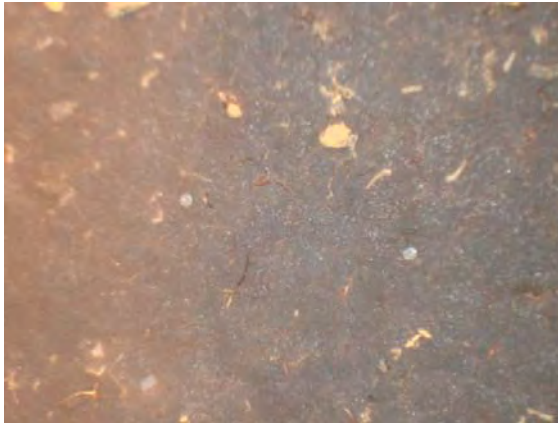
Mud cracks from shrinkage of the asphalt were also found in the asphaltic liner in S12 and several other pipe sections where the liner still existed.

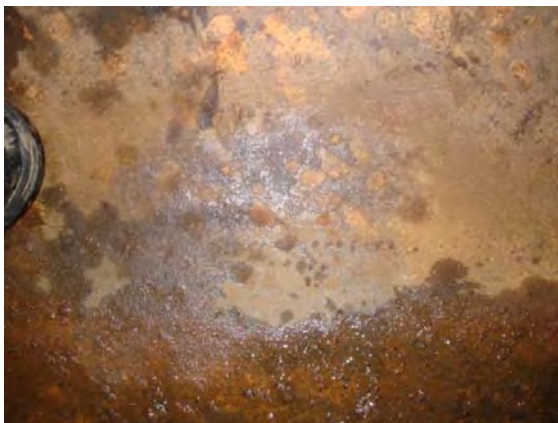
Pipe Section S14 (30'0")

Most of the asphalt lining on the crown of S14 was missing with some pit and general corrosion present.

Picture of the crown of S14 approximately 15 feet from the joint between S14 and S13.
