Blue Locker

Community College Reservoir

05-19-2017

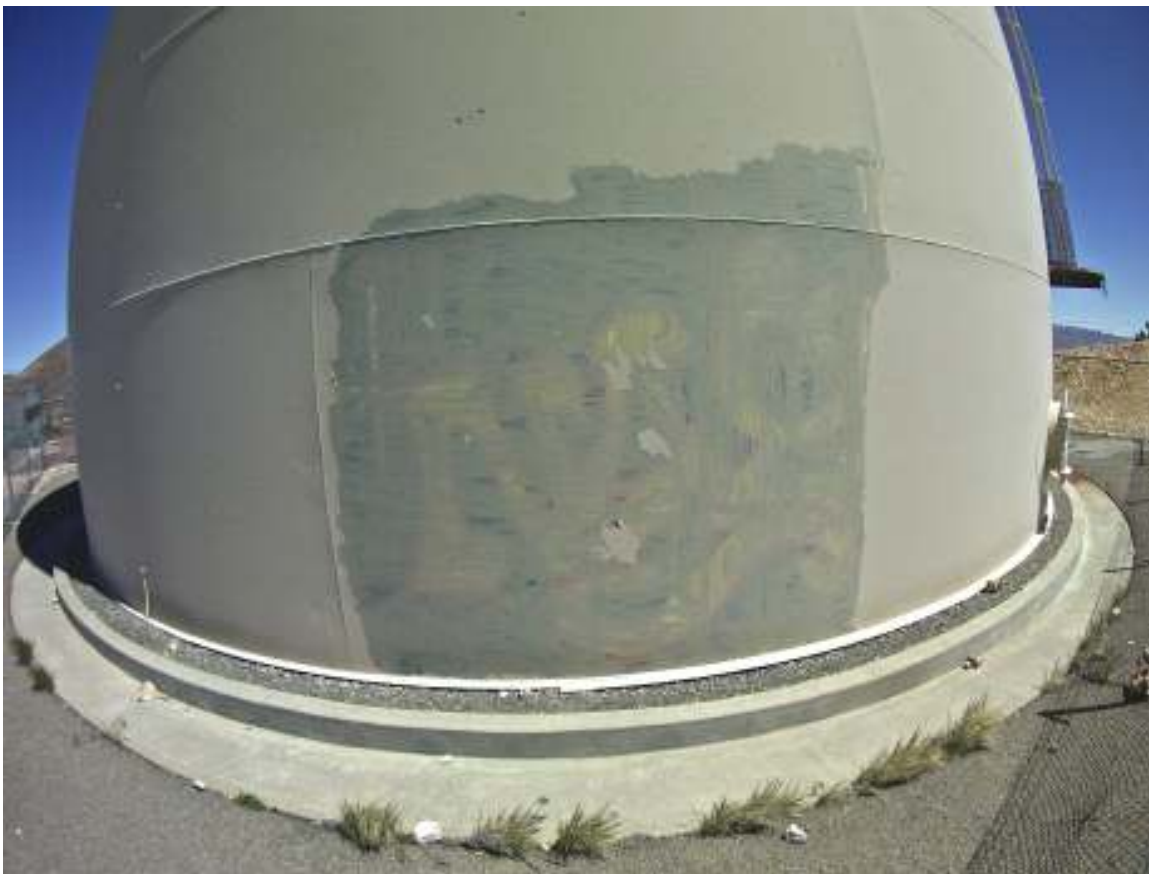
2. Exterior Shell

- **Coating - Poor condition.**
- Alligator cracking in top 2 rings with rust seeping thru all around tank.
- Rust spots in bottom ring due to holidays in the coating.
- No blisters observed.
- Coating is failing in isolated areas in all 4 rings.
- Recommendations:
 - This tank is a good candidate for a blast and recoat in the near future.

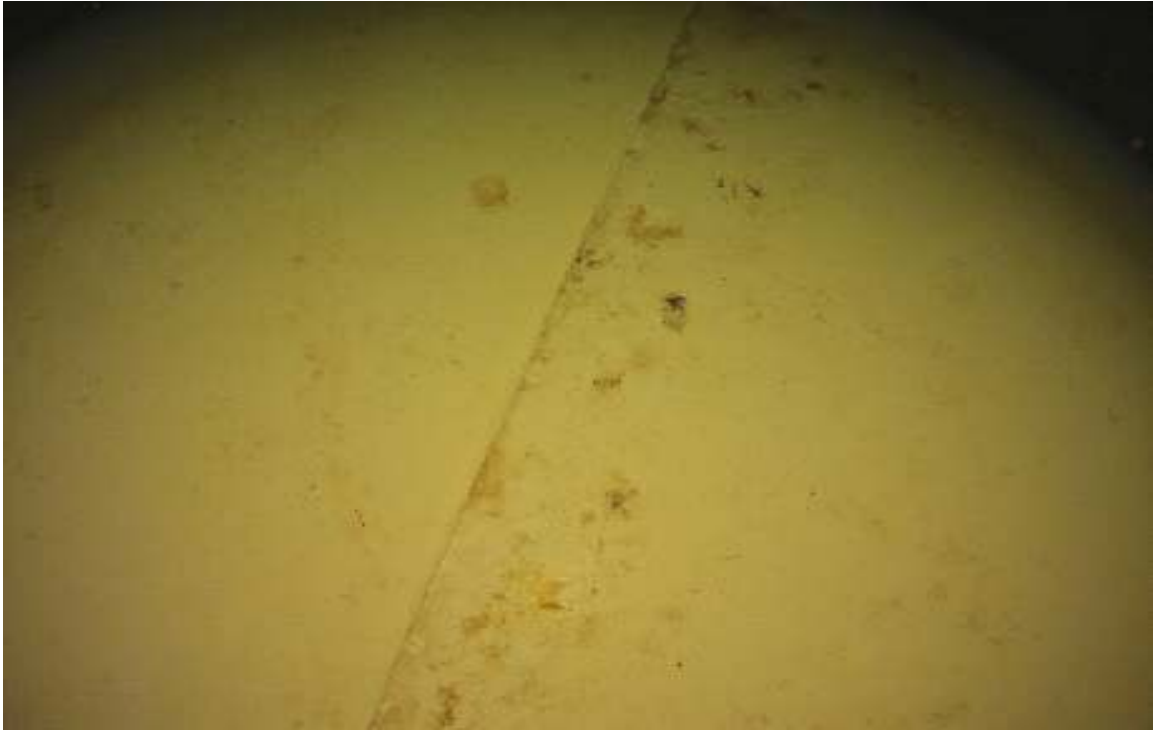
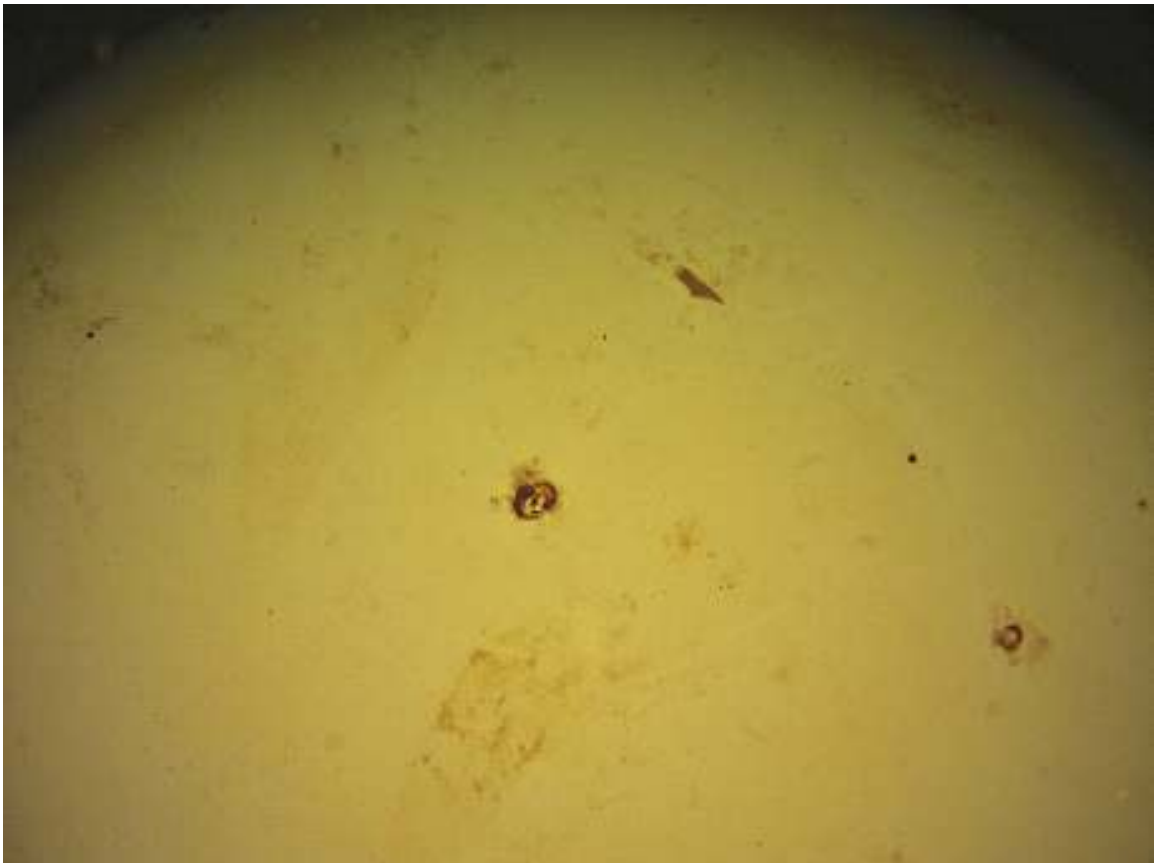
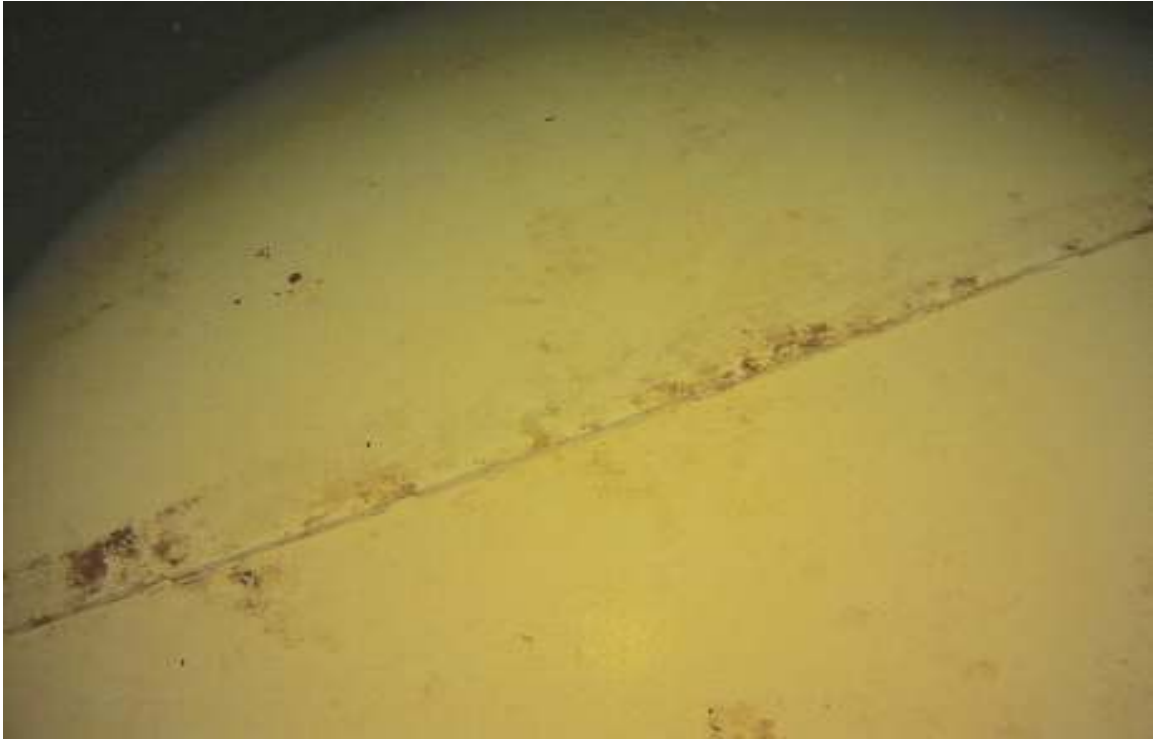
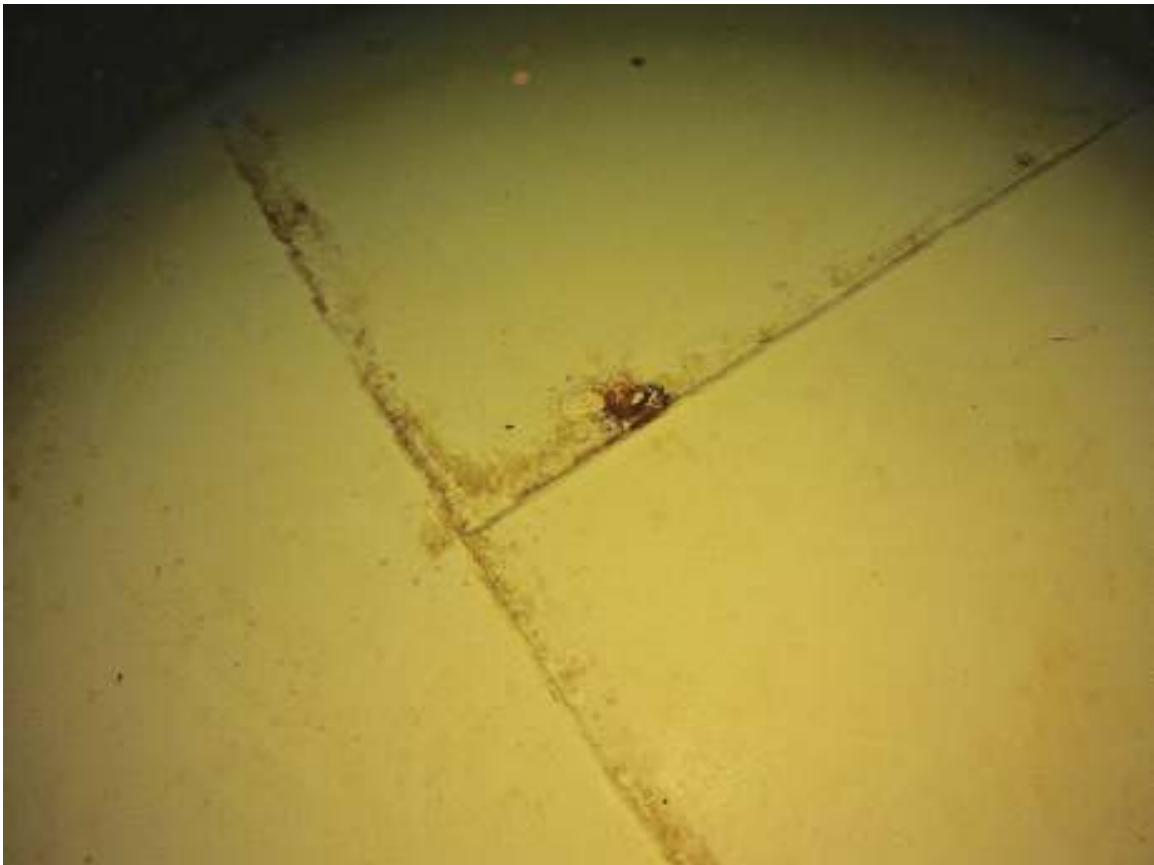
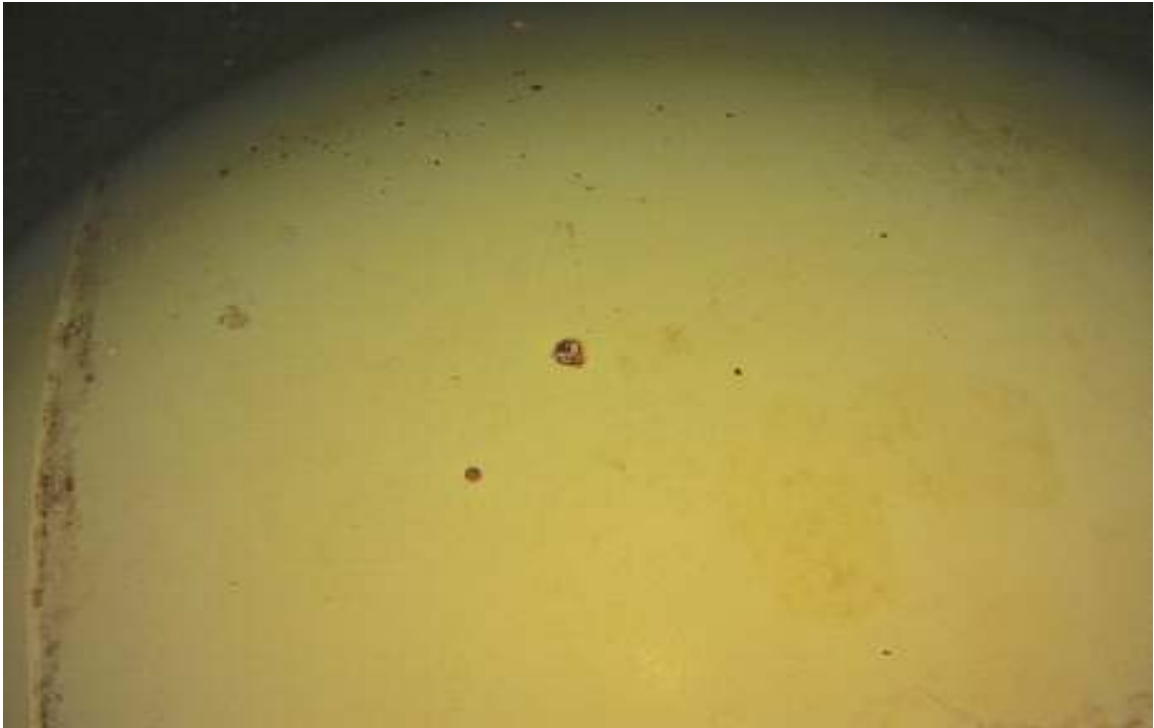
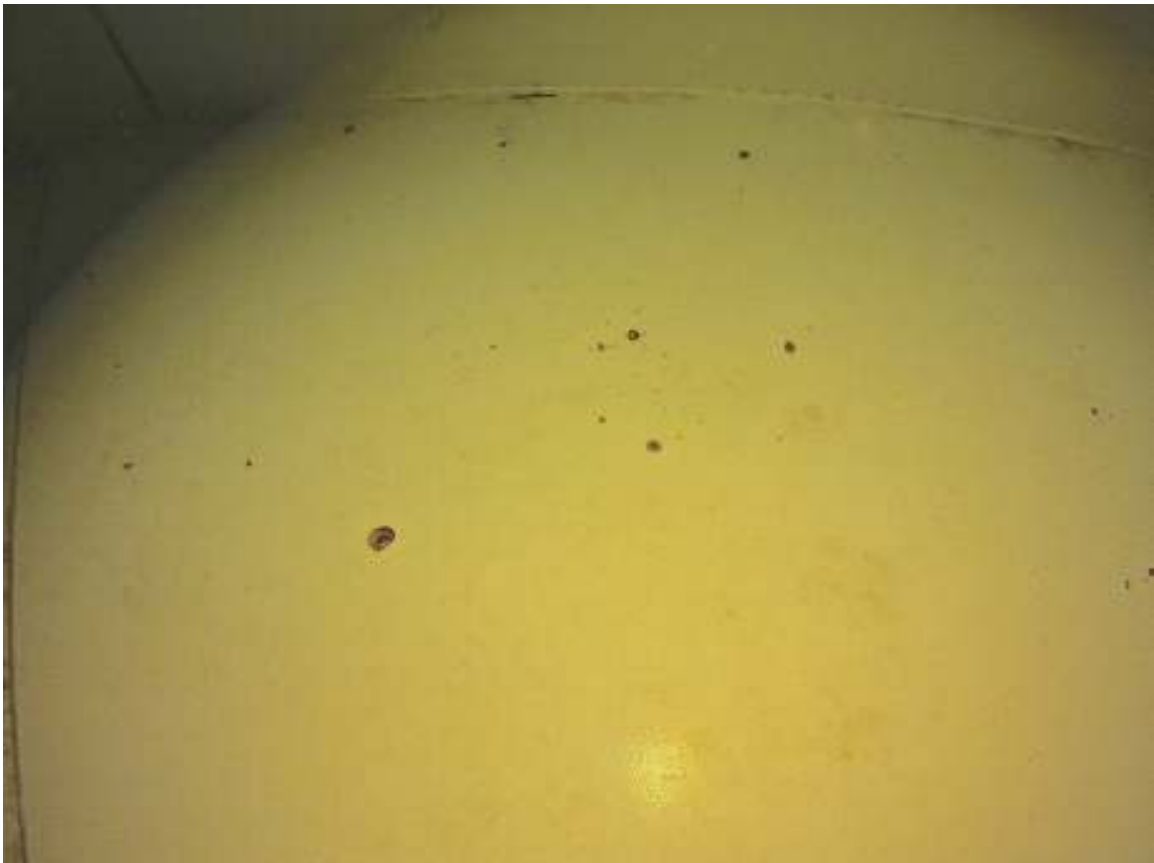
- **Coating - Fair/Poor condition.**
- No cracking, peeling or blisters observed.
- Rust spots on floor due to holidays in the coating.
- Floor has several areas where pitting in the steel can be observed through the rust. (Near transducer & floor penetrations).
- Recommendations:
 - Consider having divers do 3-4 hours of epoxy repair utilizing an NSF approved epoxy to help remedy some of the rust issues on the floor. (Until blast and recoat can be performed).
 - Blast and recoat recommended in the near future.

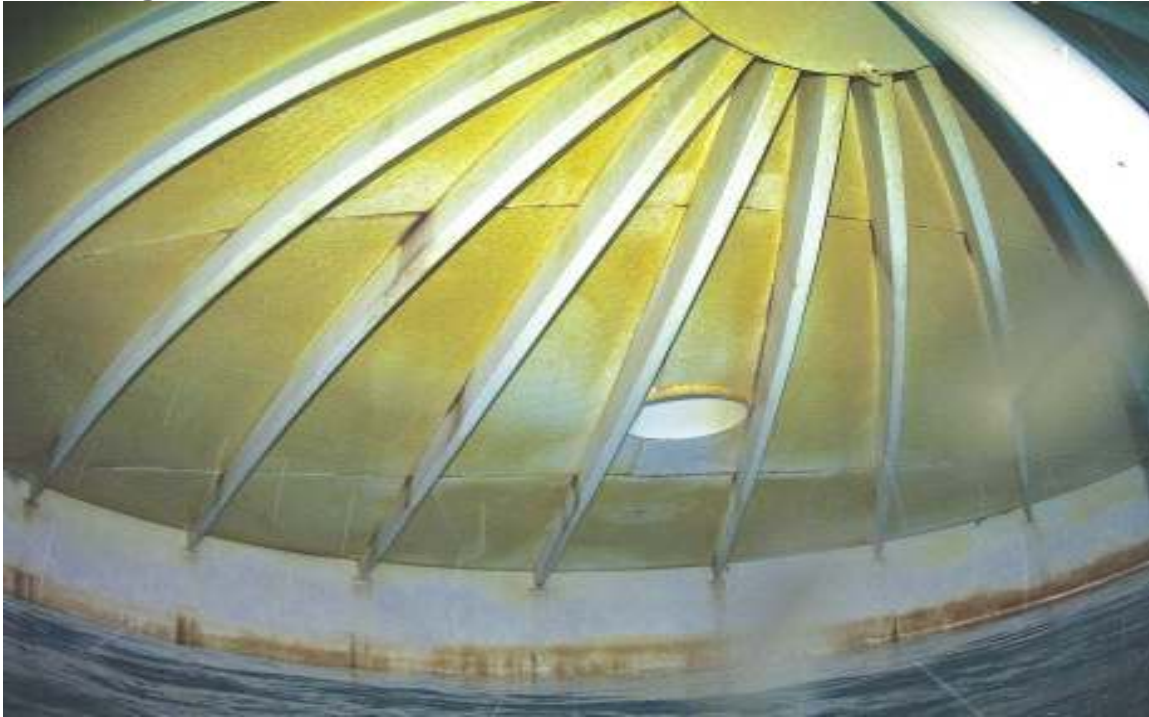
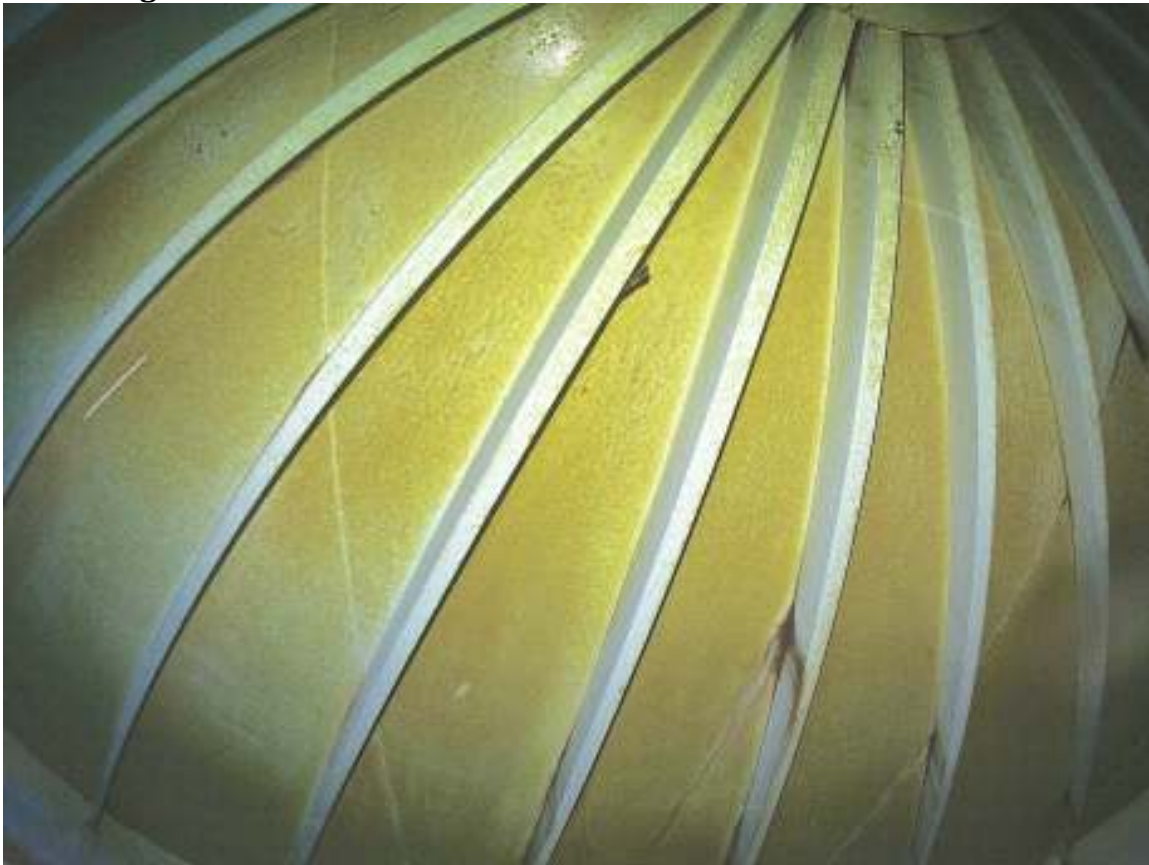
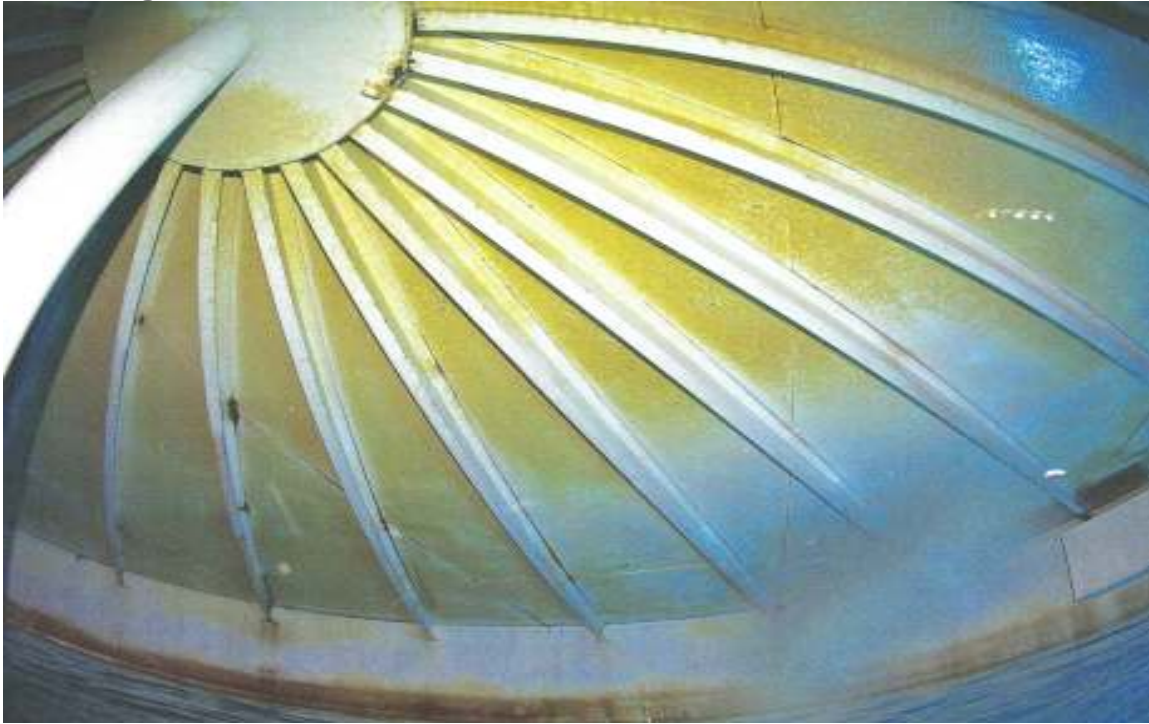
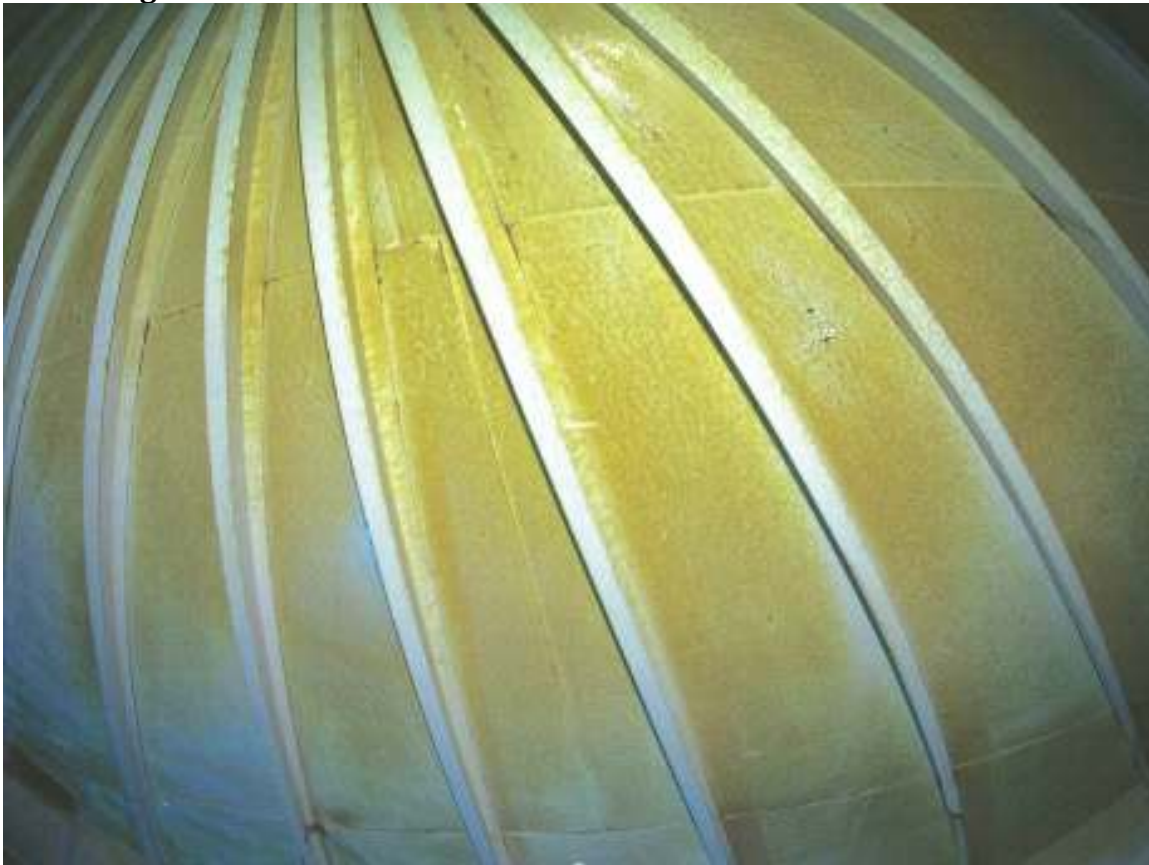
- **Coating - Good condition.**
- No peeling or blisters observed.
- Surface rust on ceiling panels may indicate alligator cracking similar to upper half of shell.
- Rust and rust staining in crevices at beams.
- Recommendations:
 - See shell.

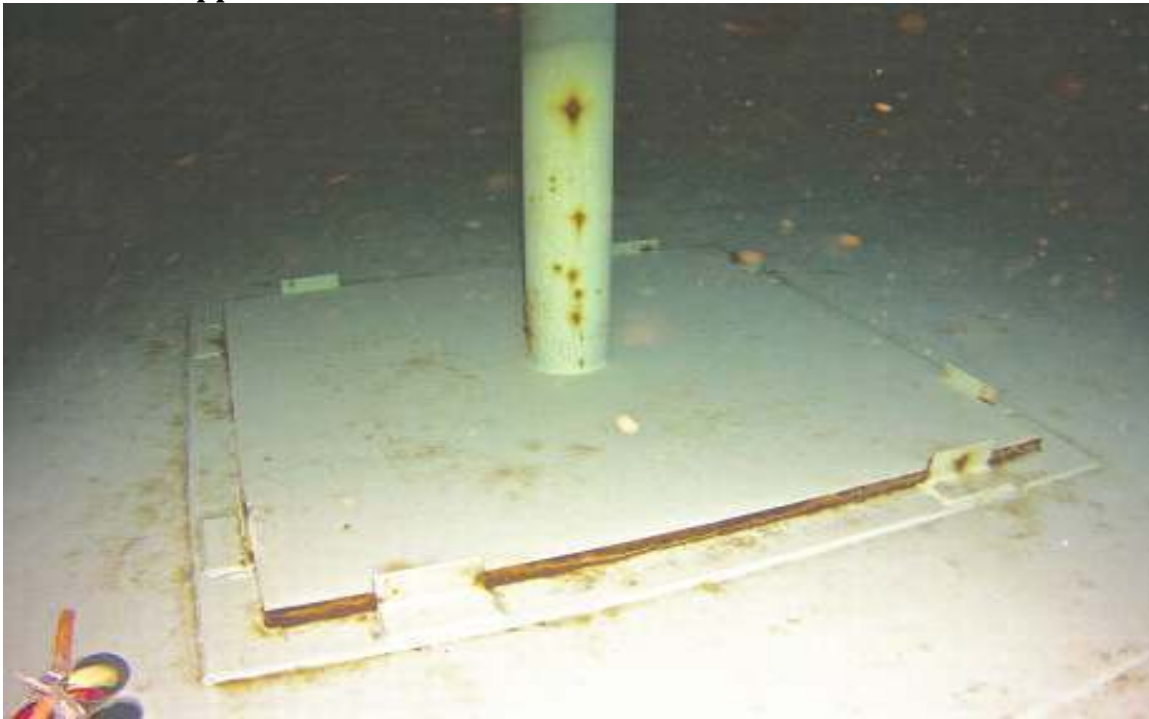
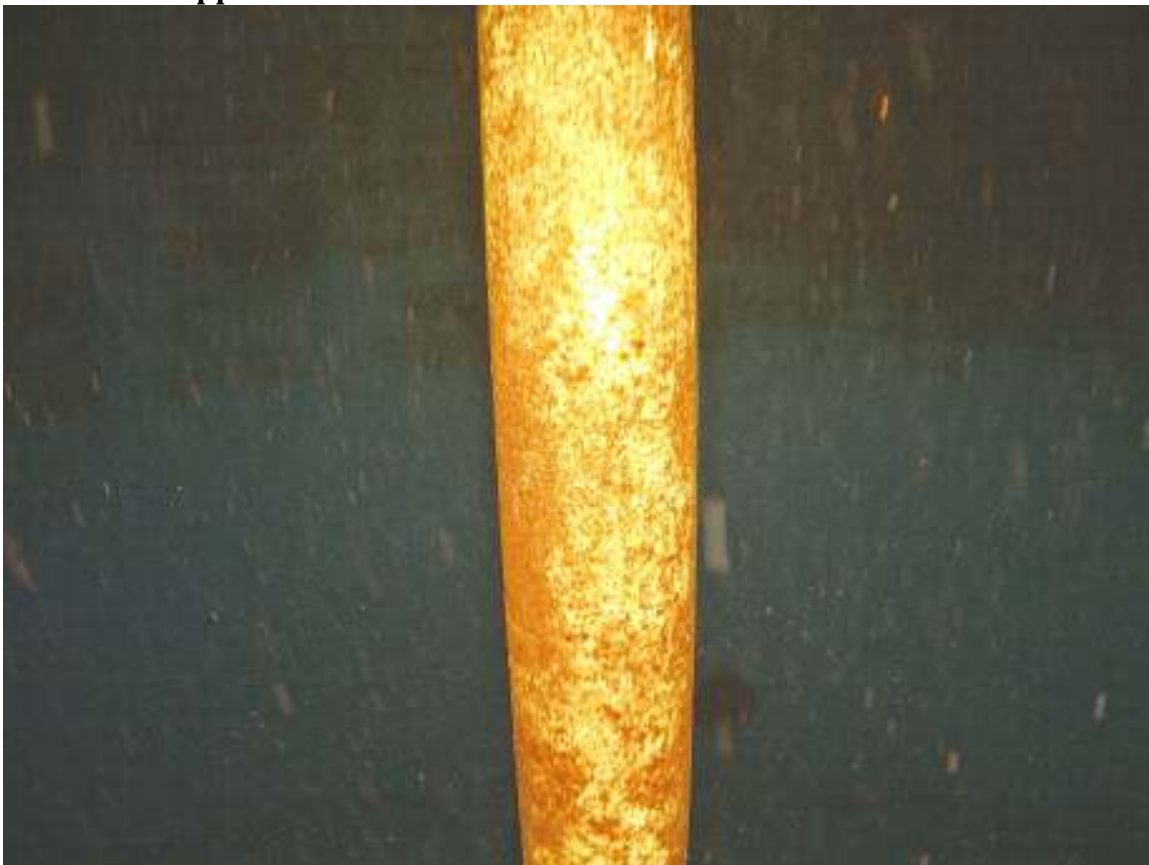
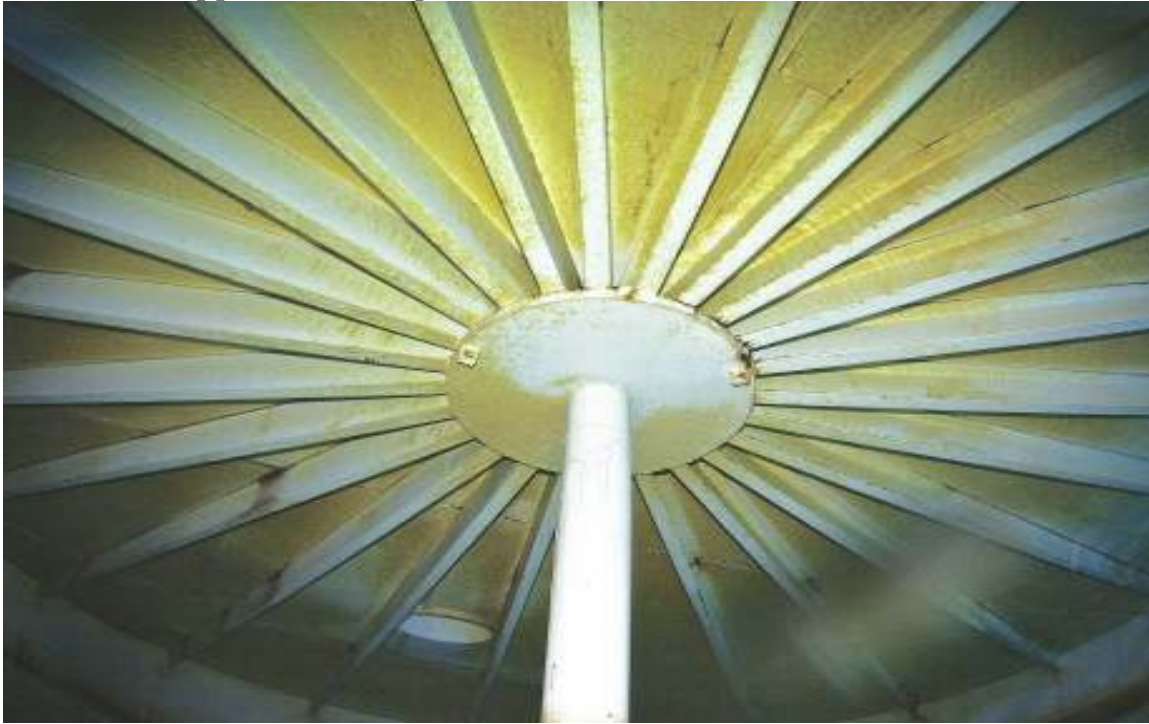
- **1 Center support pole is structurally sound with coating in Poor condition.**
- Alligator cracking on upper ½ of pole with rust seeping thru.
- Isolated rust spots on lower ½ of pole due to holidays in the coating.
- Rust in crevices where base meets floor.
- Recommendations:
 - See shell.

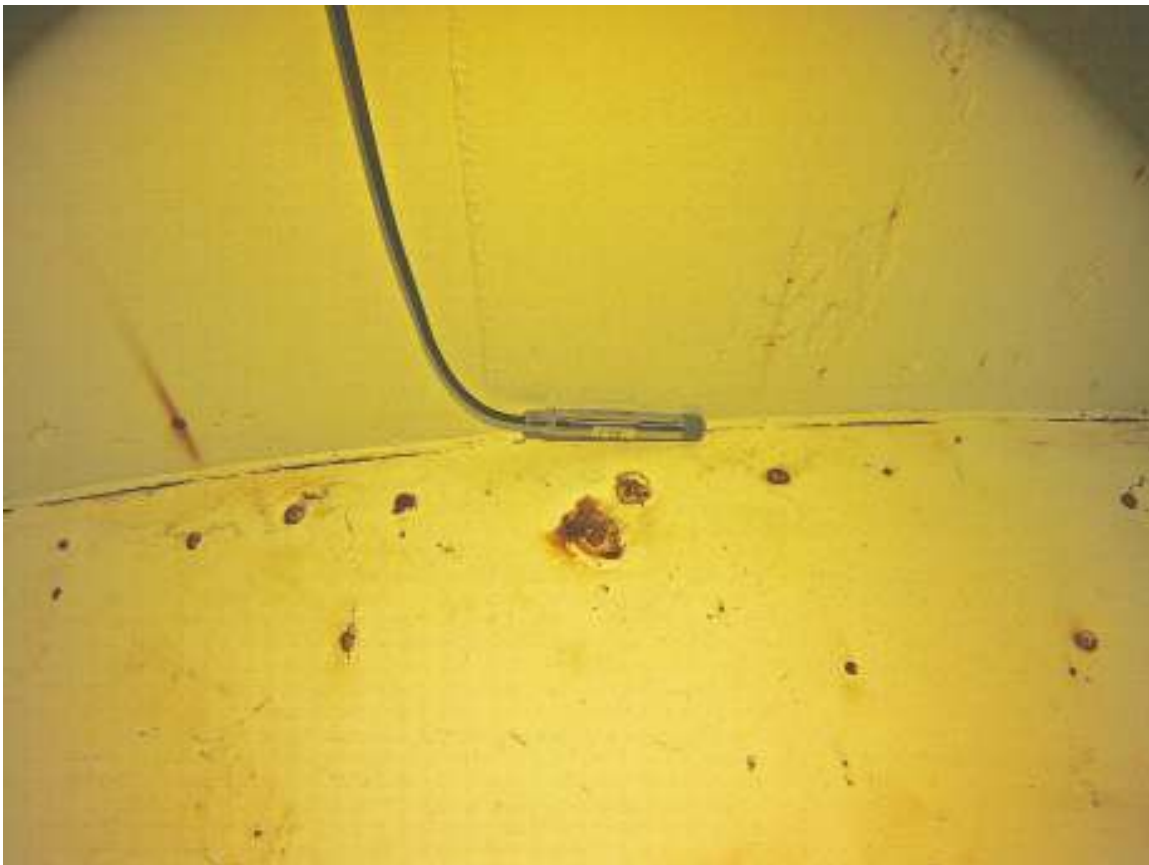
34. W.L.I. Transducer

- **W.L.I. Transducer appears functional.**
- Transducer is touching floor.
- **Water level sensor at 12:00 position in ceiling appears functional.**
- **Mechanical W.L.I. has been abandoned with no float in reservoir & guide wires broken.**
- Recommendations:
 - None.

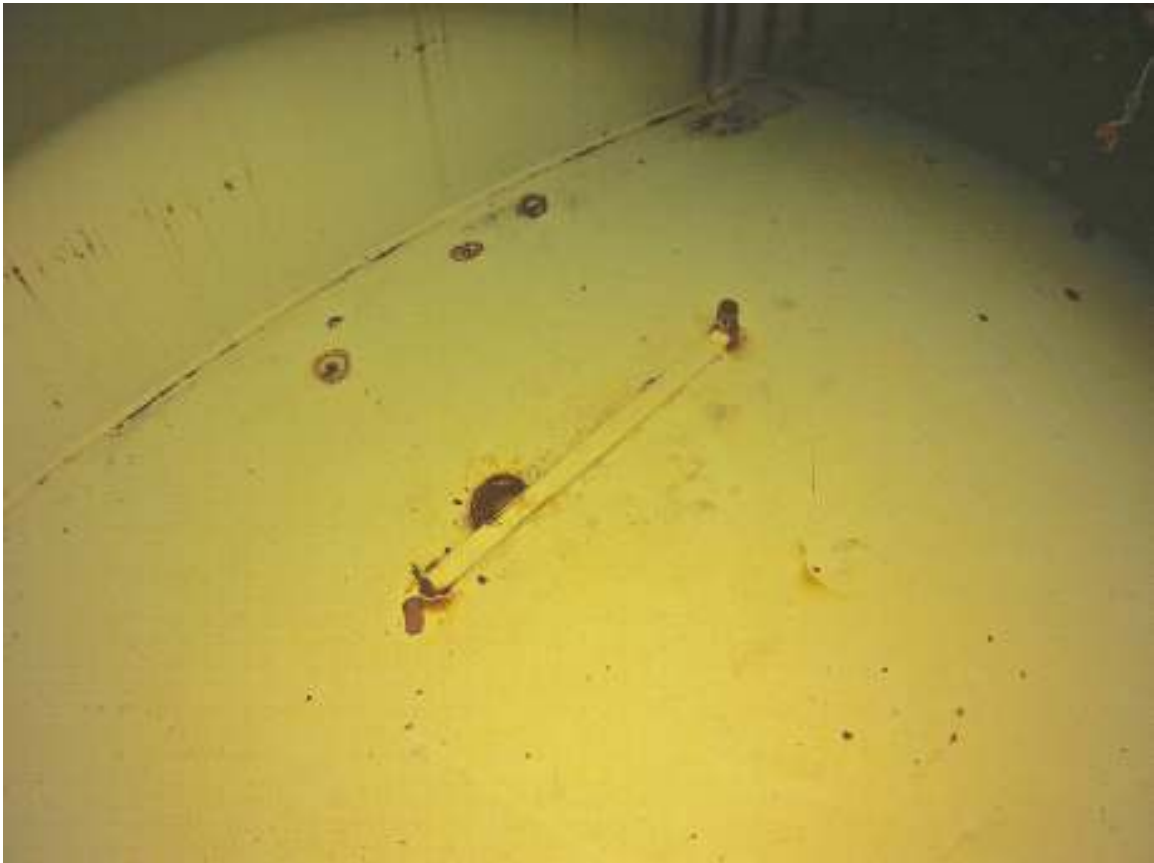
36. Mechanical W.L.I. - Abandoned

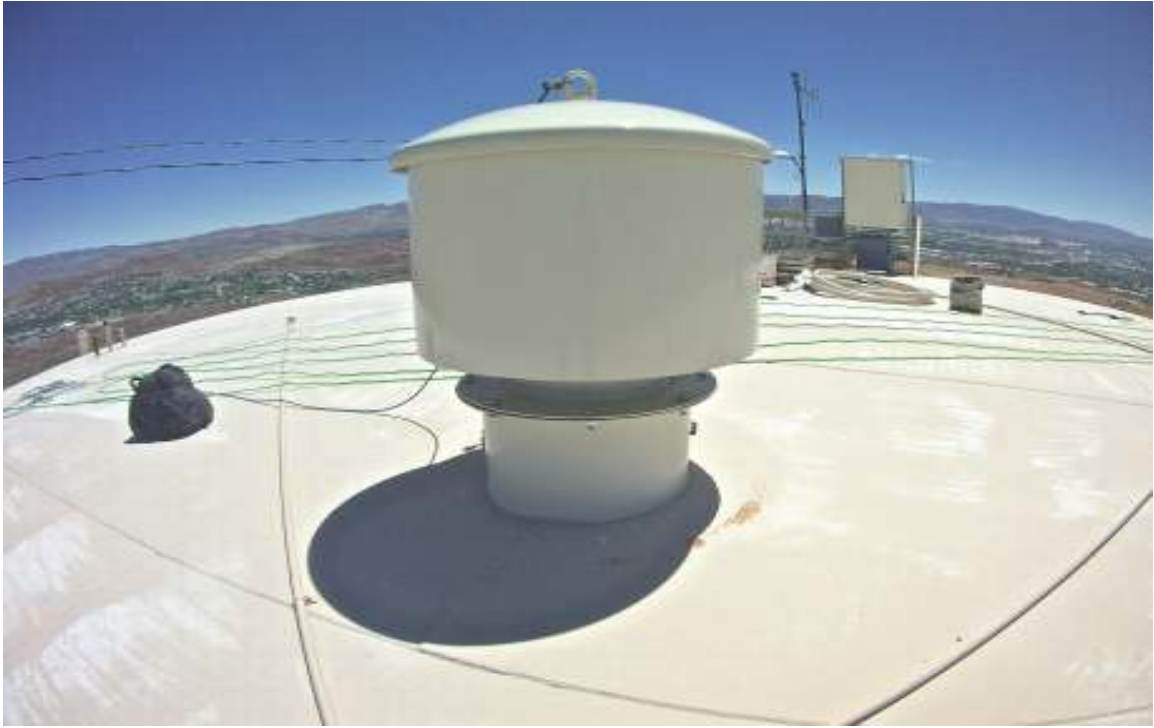
37. Roof Vent

- **24" diameter - Roof vent - Good condition with screen intact and secure.**
- Recommendations:
 - Ensure screen mesh is 22-24 mesh per NAC 445A.6708.5

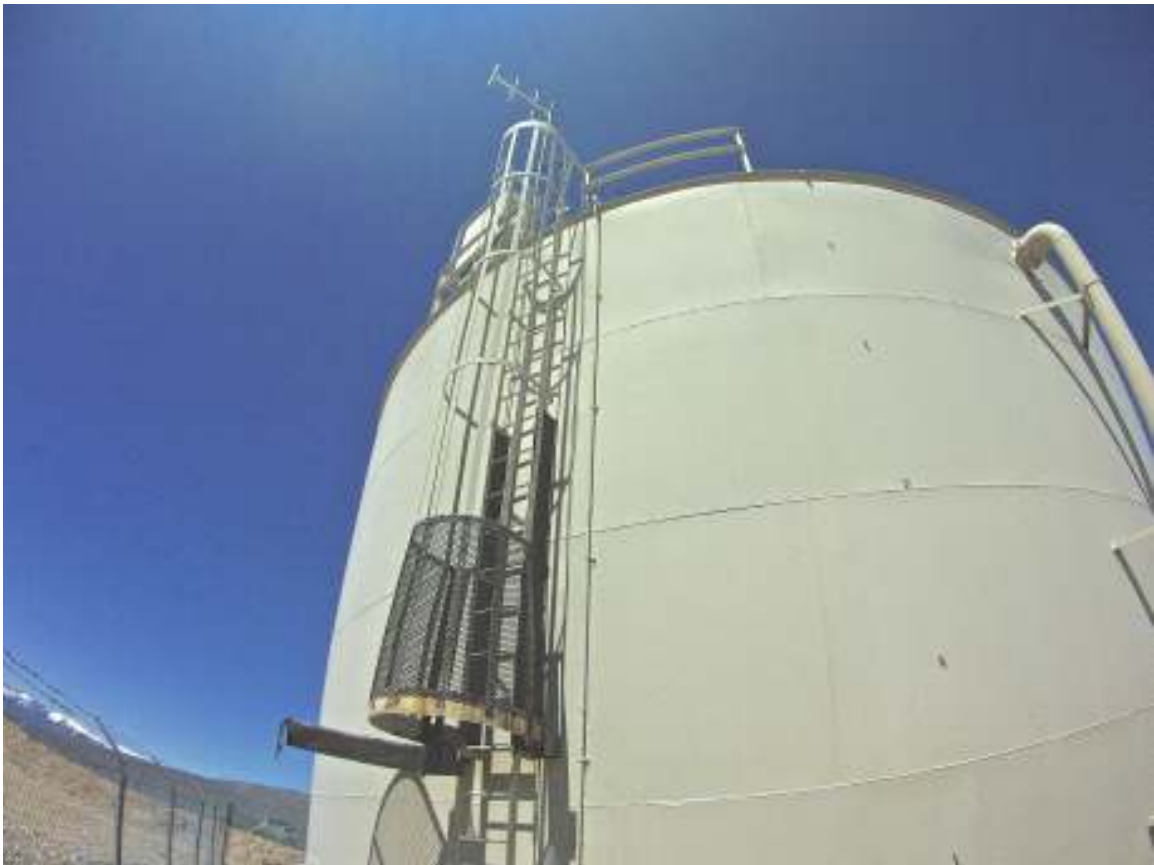
38. Exterior Ladder

- **Exterior ladder - Good condition.**
- Exterior ladder is structurally sound and secure to shell.
- Surface rust and rust spots on rungs, runners and cage.
- Safety climbing device, none present.
- Recommendations:
 - See shell.

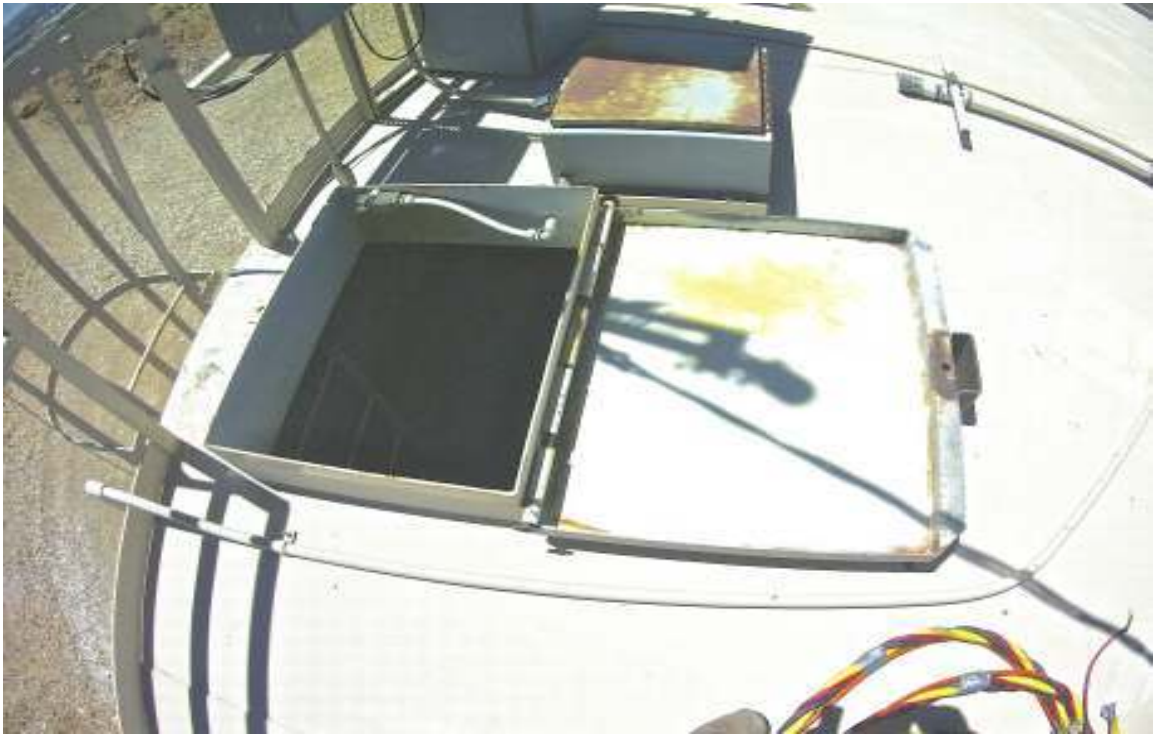
39. Access Hatch

- **24" x 30" Access hatch - Good condition.**
- Rust spots observed on opening edge.
- Surface rust observed on face of hatch cover.
- No gasket observed.
- Recommendations:
 - Repair gasket to remain in compliance with NAC445A.6708
 - Touch up coating face of hatch cover and opening edge to improve sanitary conditions of the hatch.

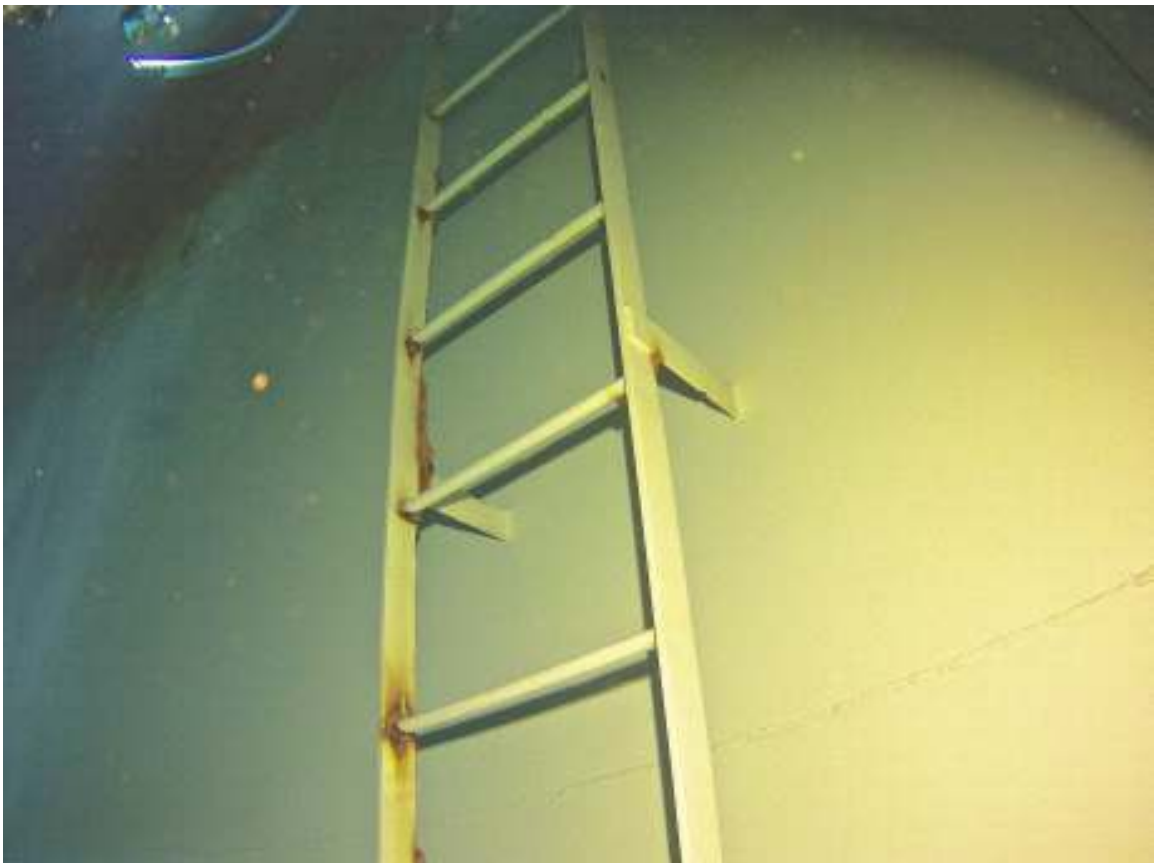
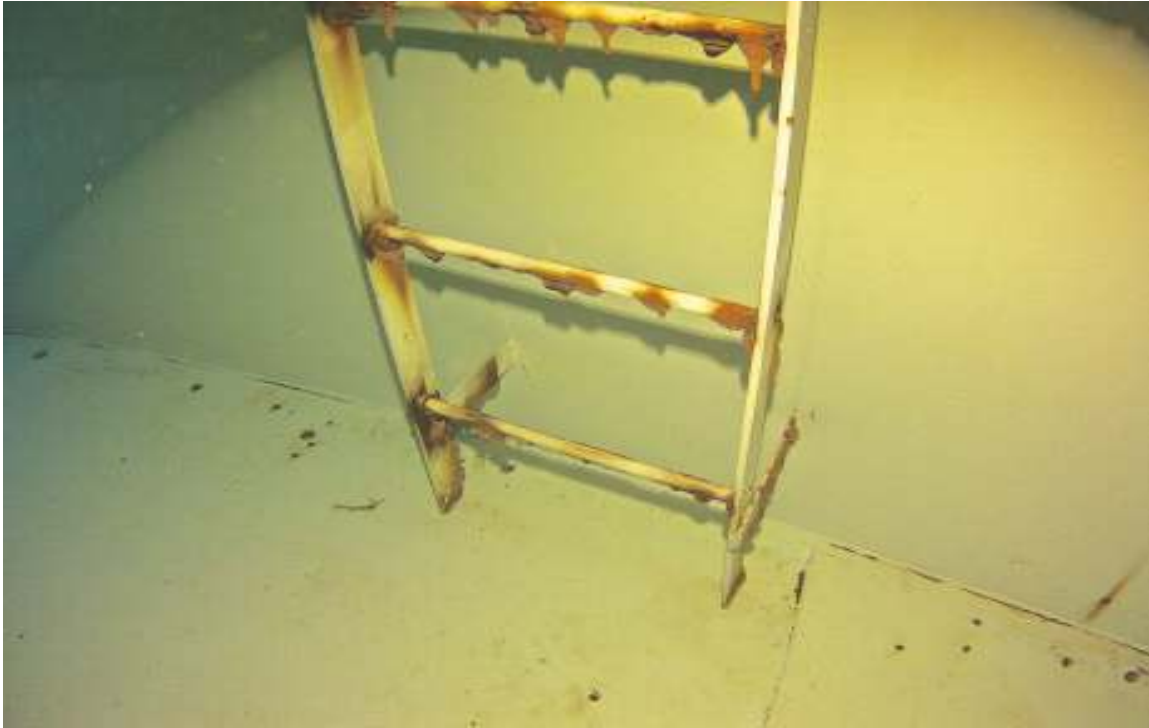
- **Interior Ladder is structurally sound and secure to shell.**
- Alligator cracking on upper half of ladder.
- Isolated rust nodules on lower ½ of ladder on rungs and runners.
- Safety climbing device, none present.
- Recommendations:
 - Exercise caution when entering and exiting reservoir on ladder.
 - See shell.

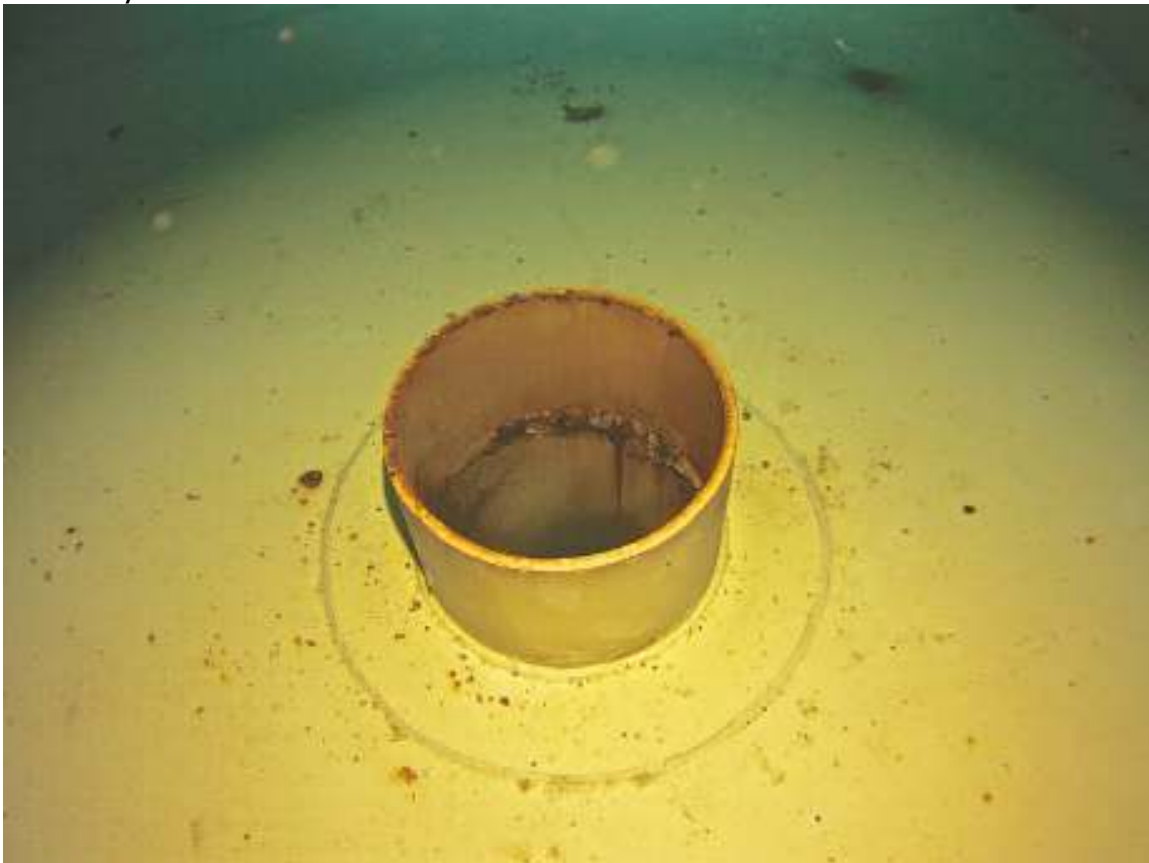
42. Inlet/Outlet

- **10" diameter penetration opening with 8" tall Mudguard - Good condition.**
- Structurally sound and unobstructed.
- Rust on opening edge and at weld seam between Mudguard and floor.
- Sediment observed in interior of pipe.
- Recommendations:
 - See shell.
