Blue Locker

Community College Reservoir

05-19-2017

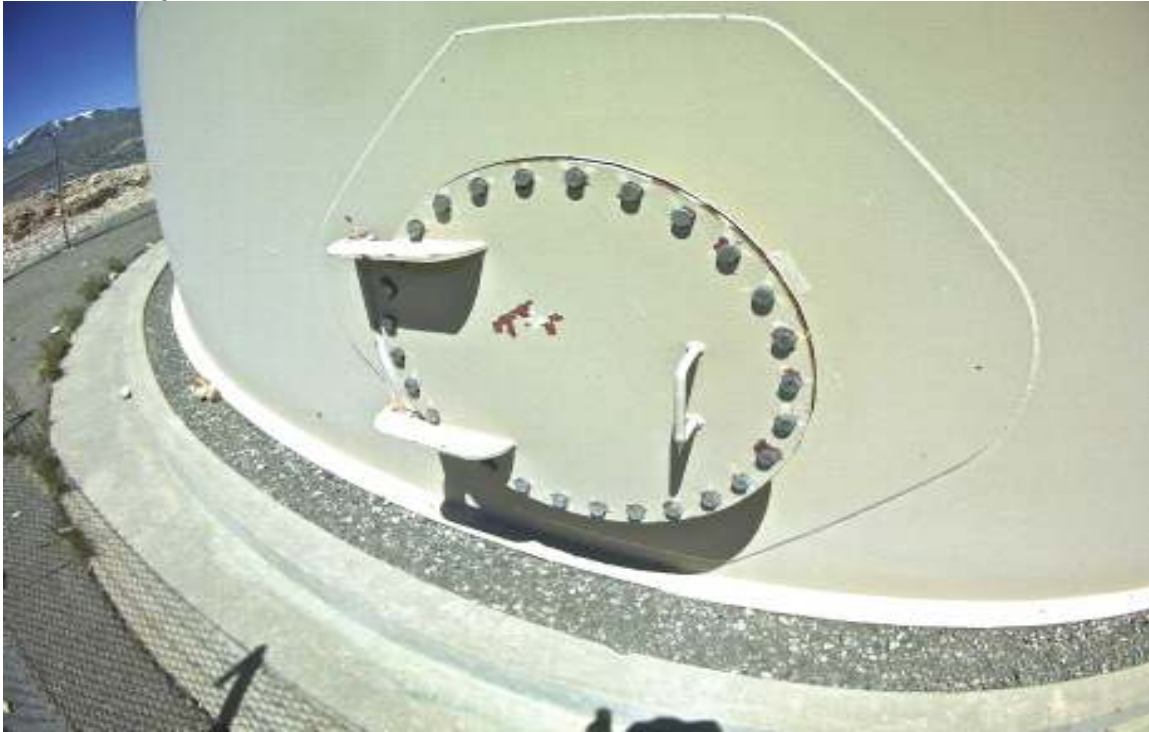
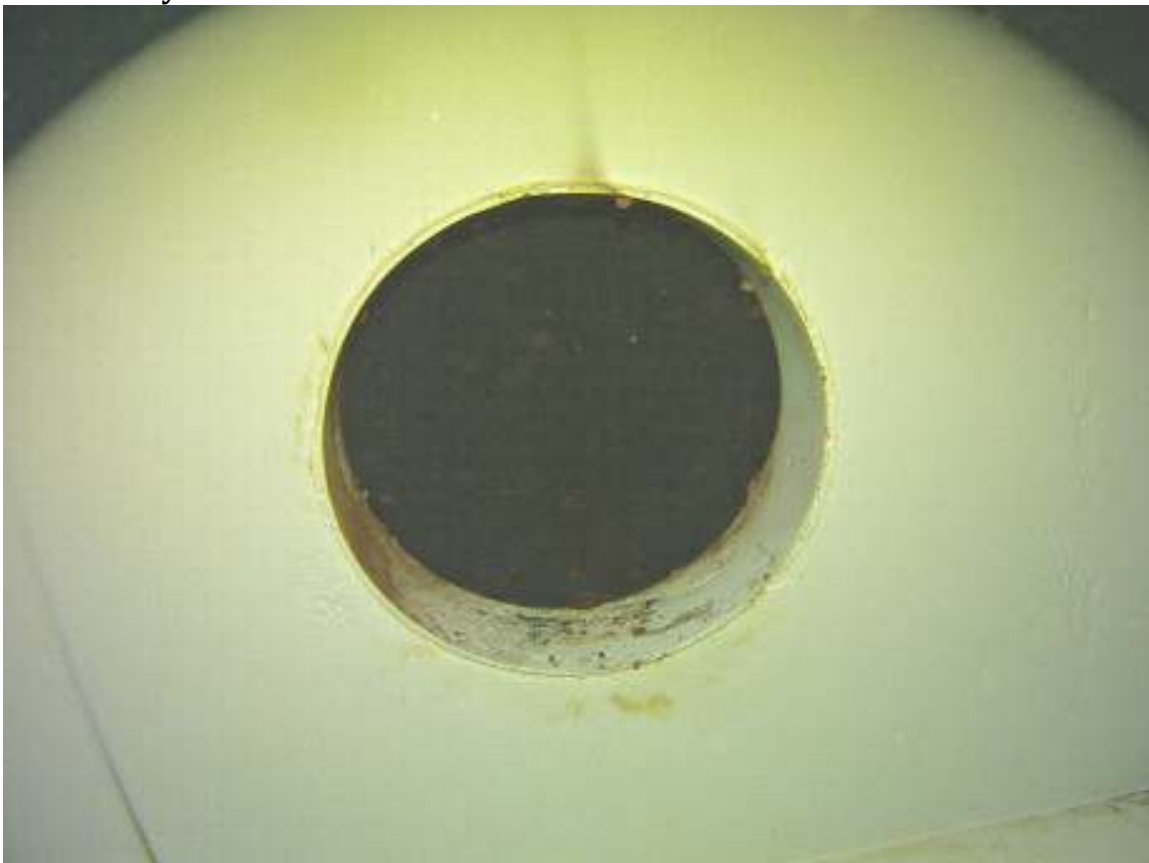
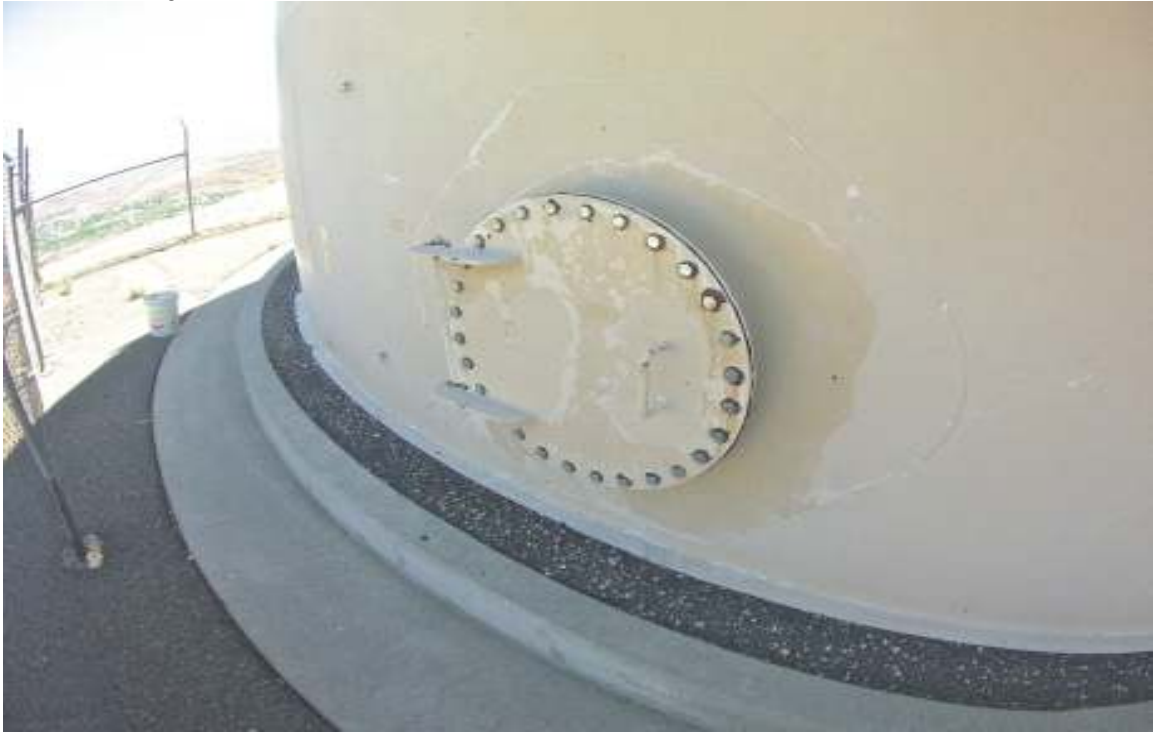
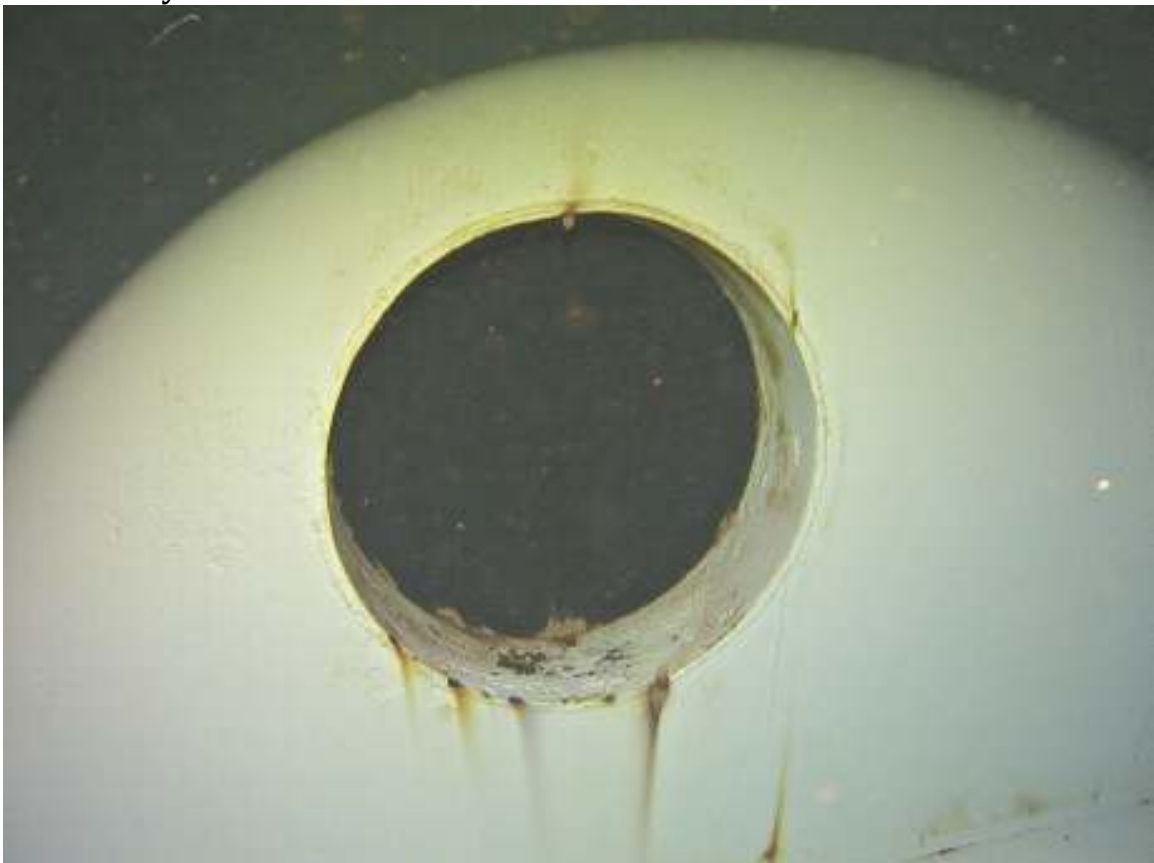
- **2 @ 24” diameter Manways - Good condition.**
- Seals are intact on both Manways.
- Rust nodules forming on opening edges of both Manways.
- Recommendations:
 - See shell.
