Desert Springs #3

04-11-2016

On April 11th, 2016, Blue Locker Commercial Diving Services, L.L.C. performed a cleaning and inspection of the Desert Springs #3 reservoir for Truckee Meadows Water Authority. This report, along with the provided video, documents the findings of the inspection. All observations are observed strictly for your own considerations.

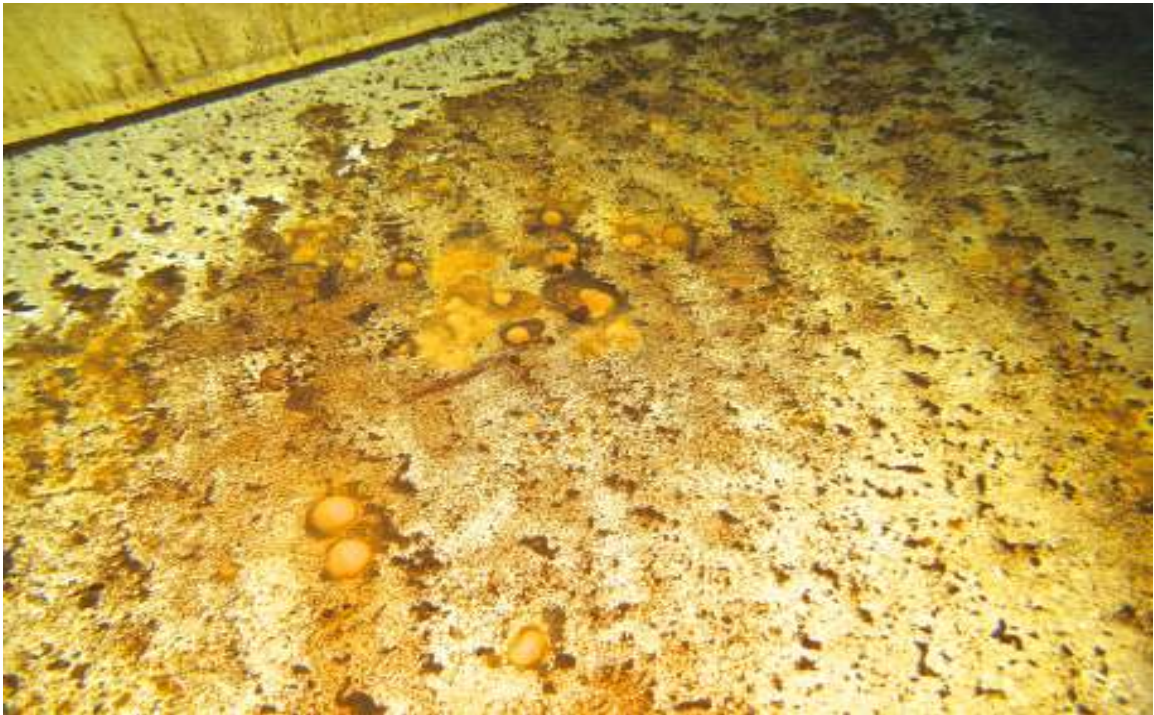
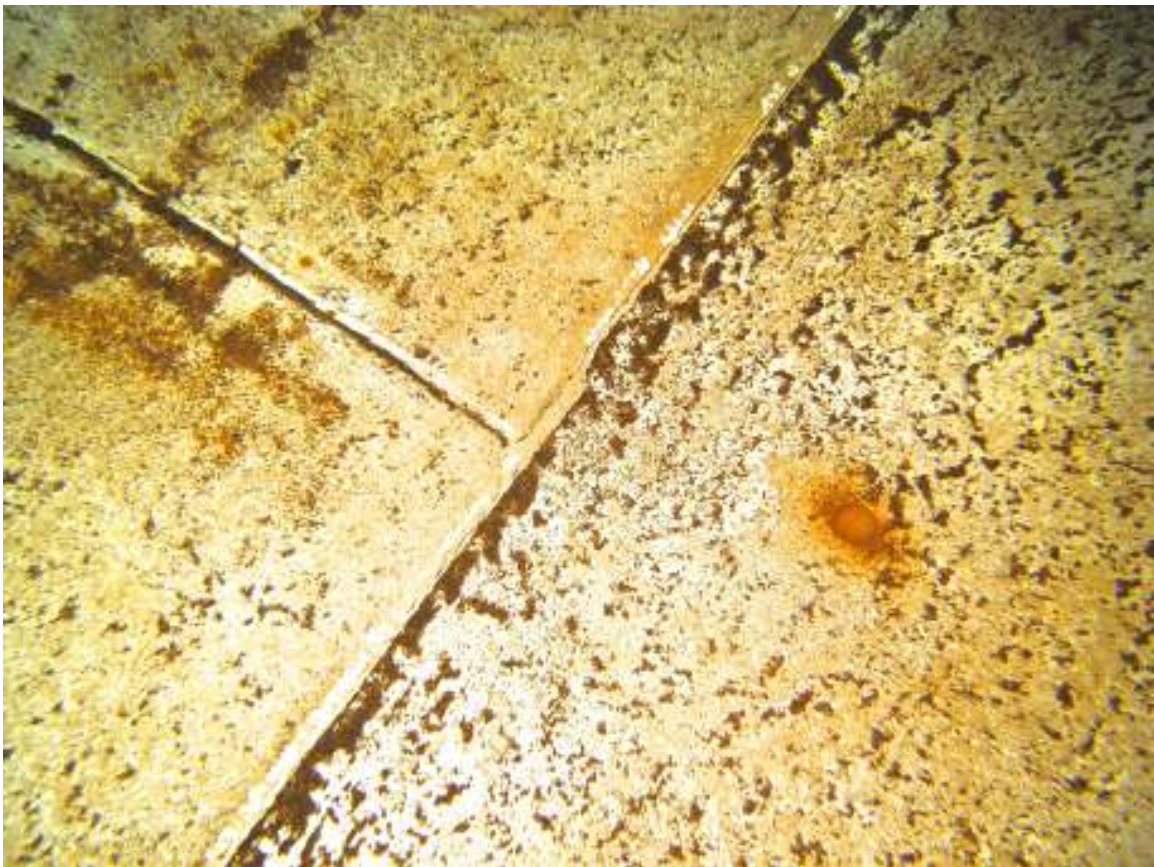
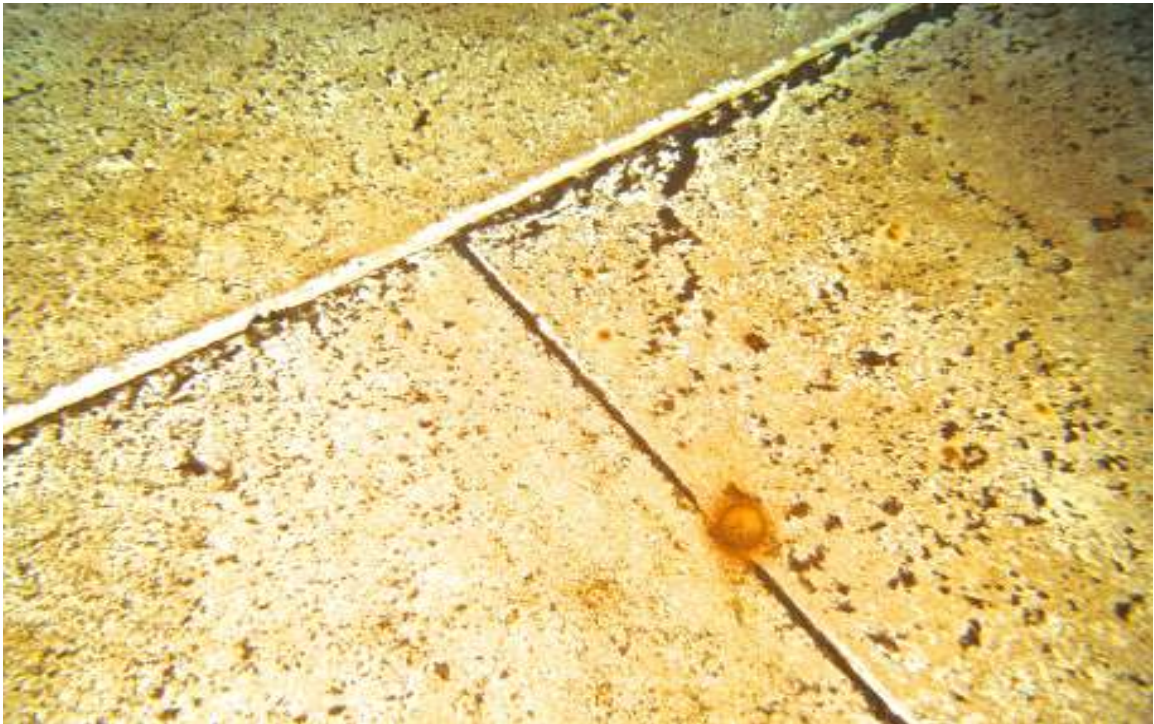
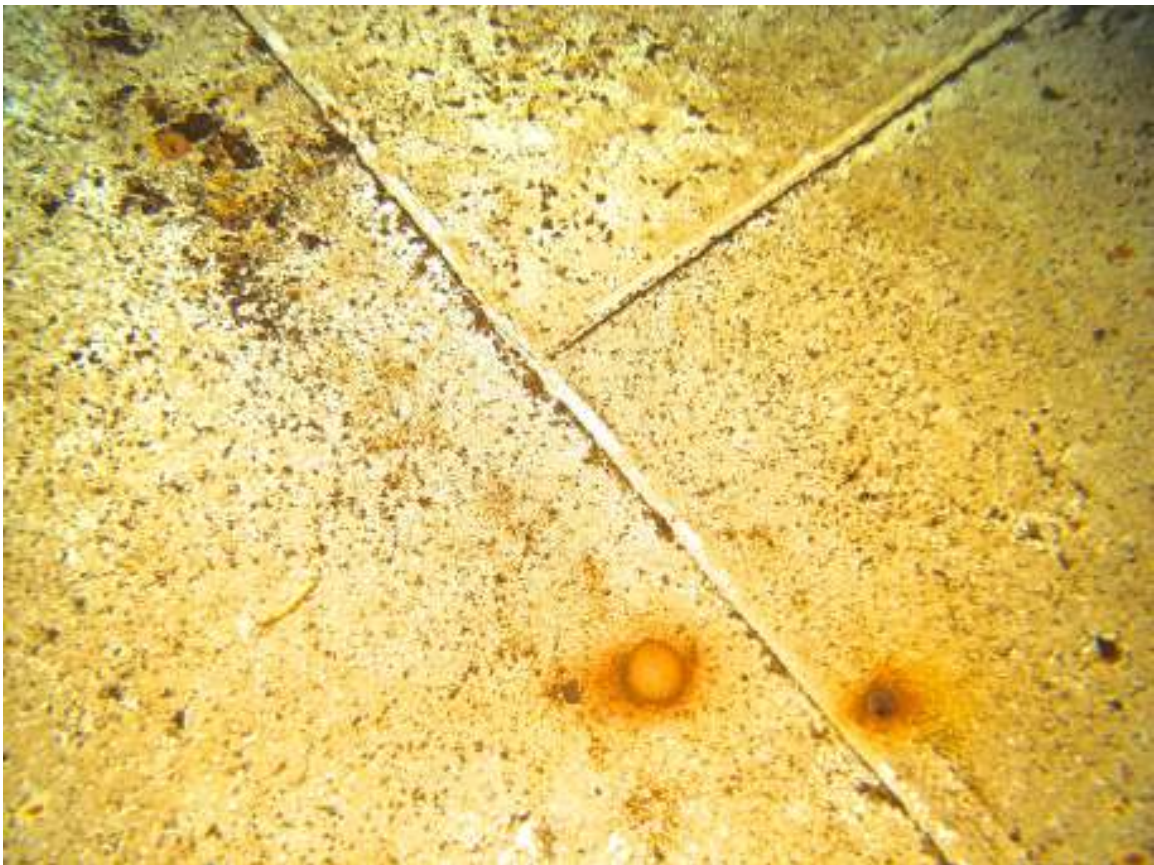
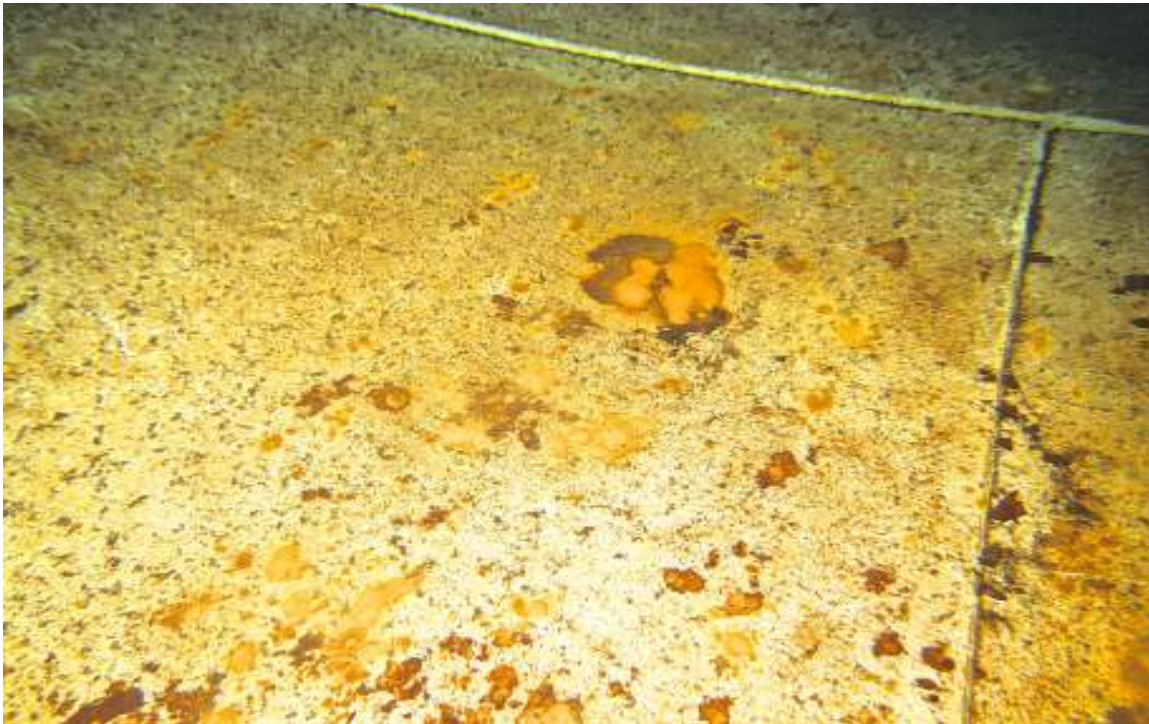
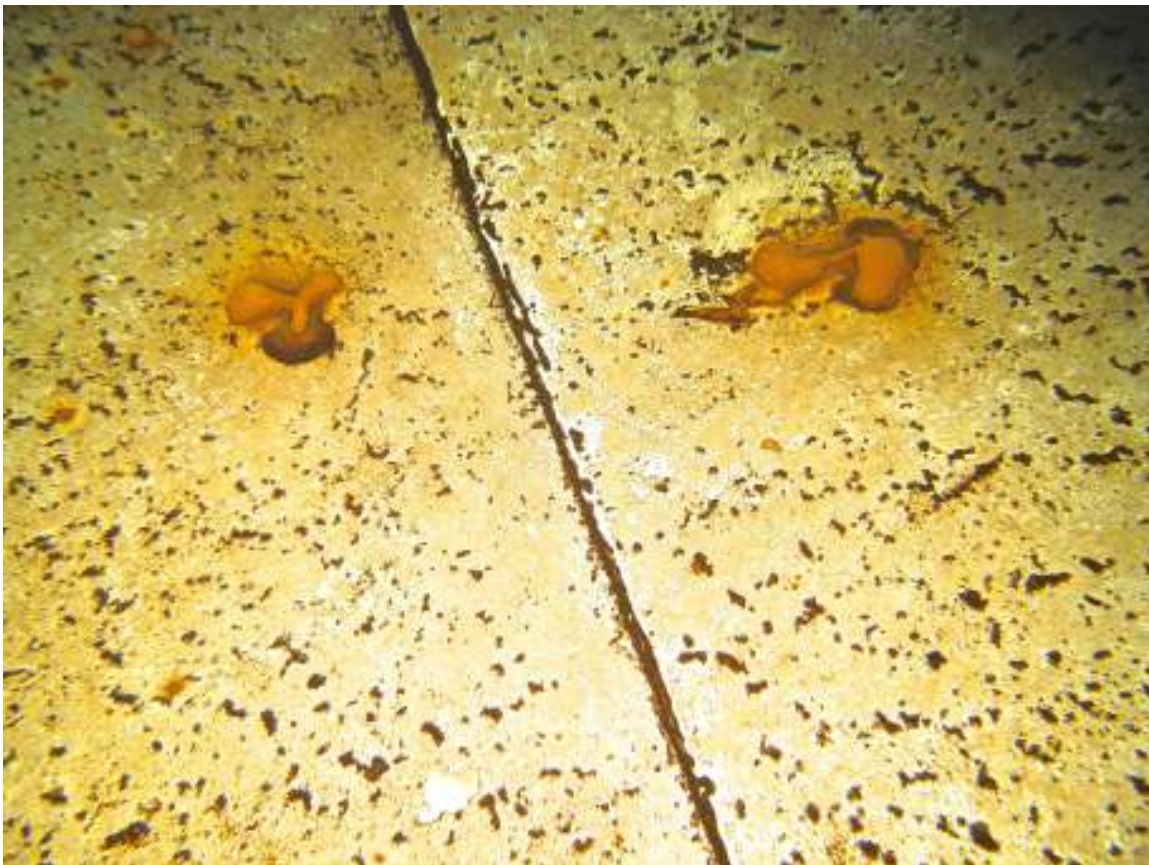
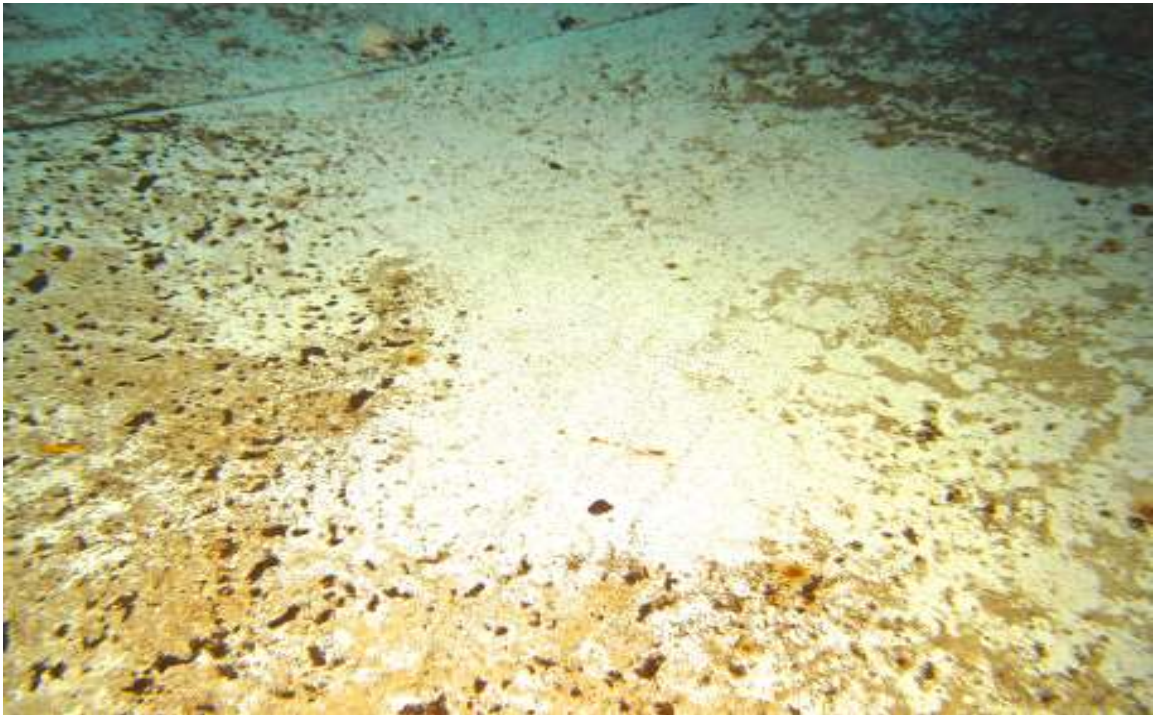
- **Coating - fair condition.**
- No cracking or peeling observed.
- Rust spots and rust nodules in all 4 quadrants.
- Less than 1/8" of sediment on floor was not removed by divers prior to inspection.
- Observations:
 - **Tank is in need of a blast and recoat and may not be structural sound due to the amount of rust and coating failure throughout tank. We were not able to see the coating on the support pole.**

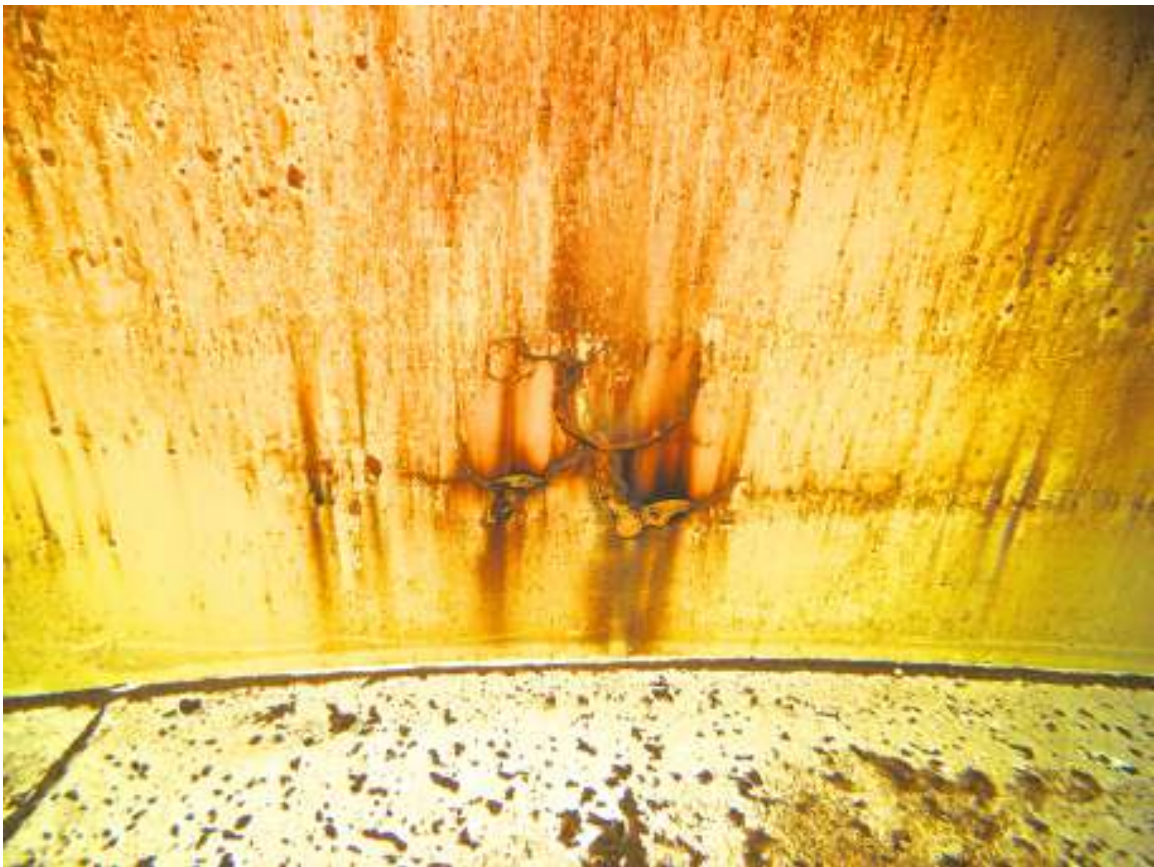
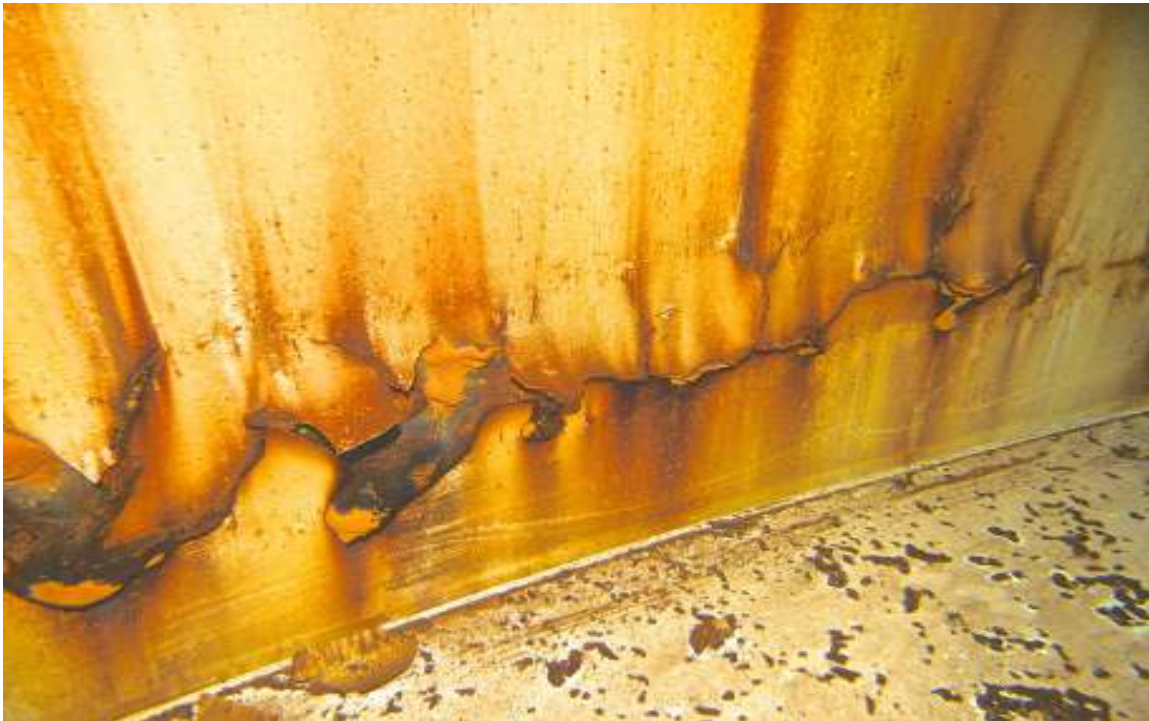
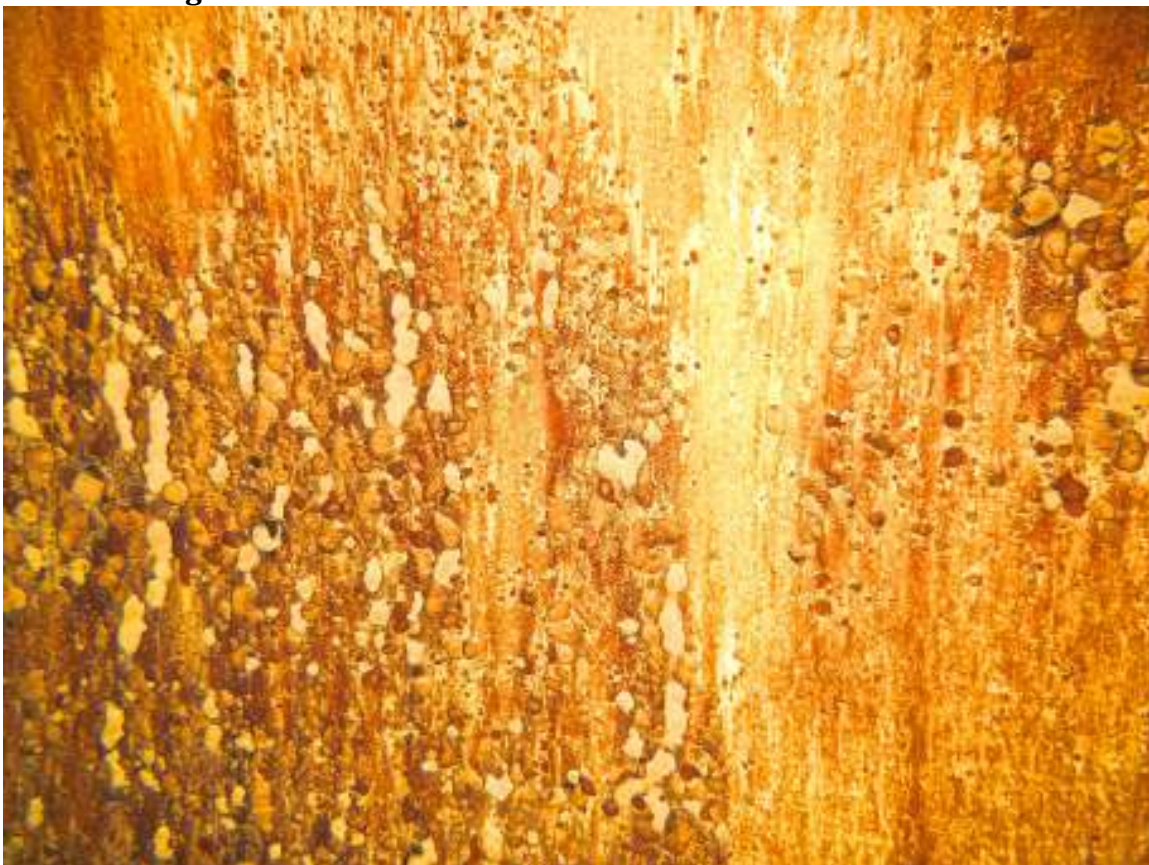
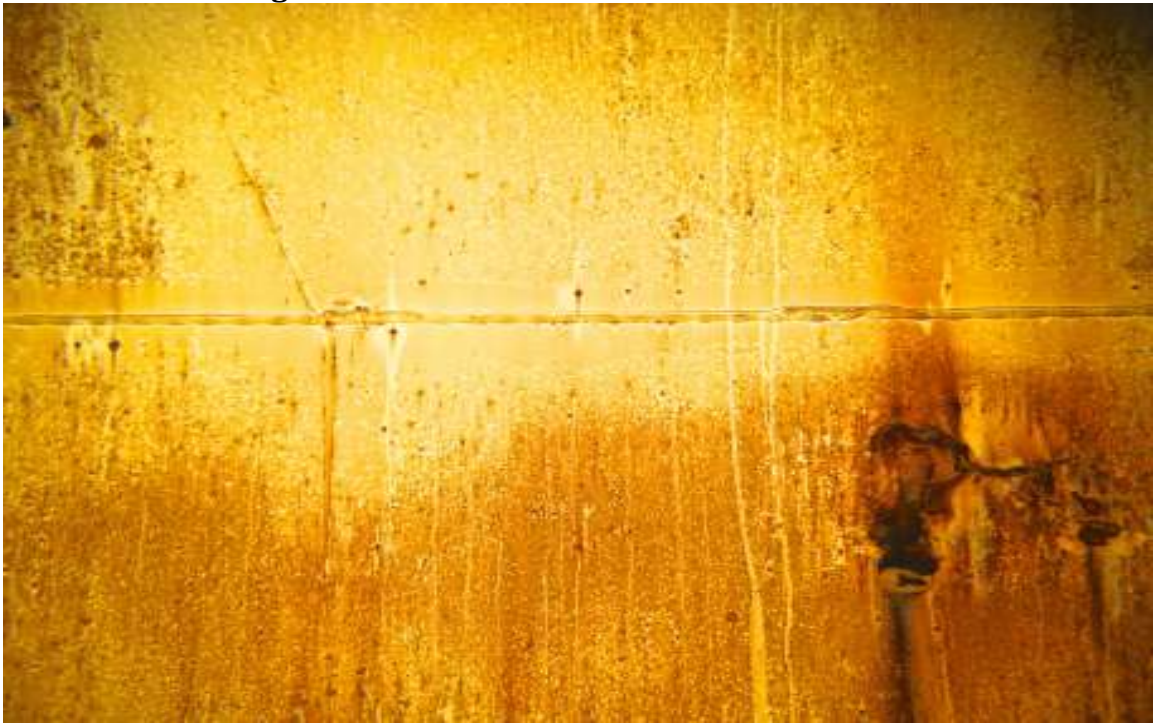
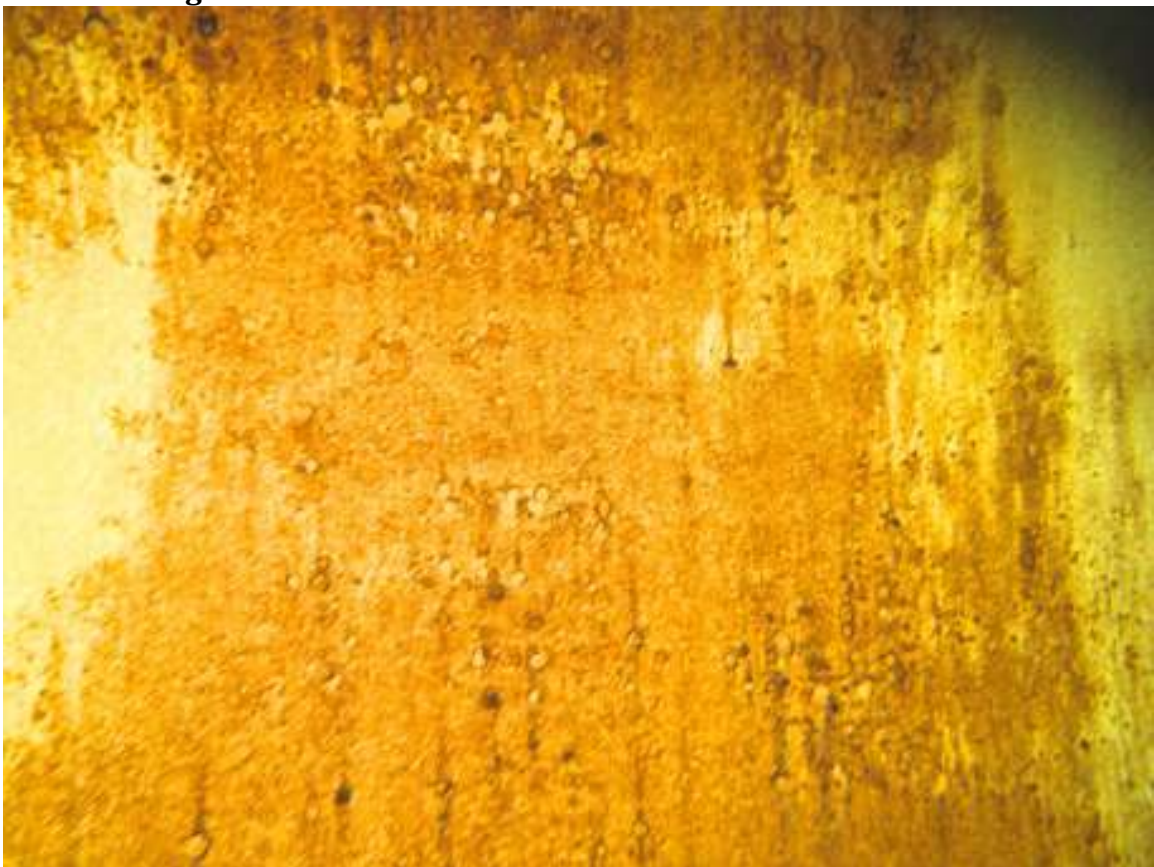
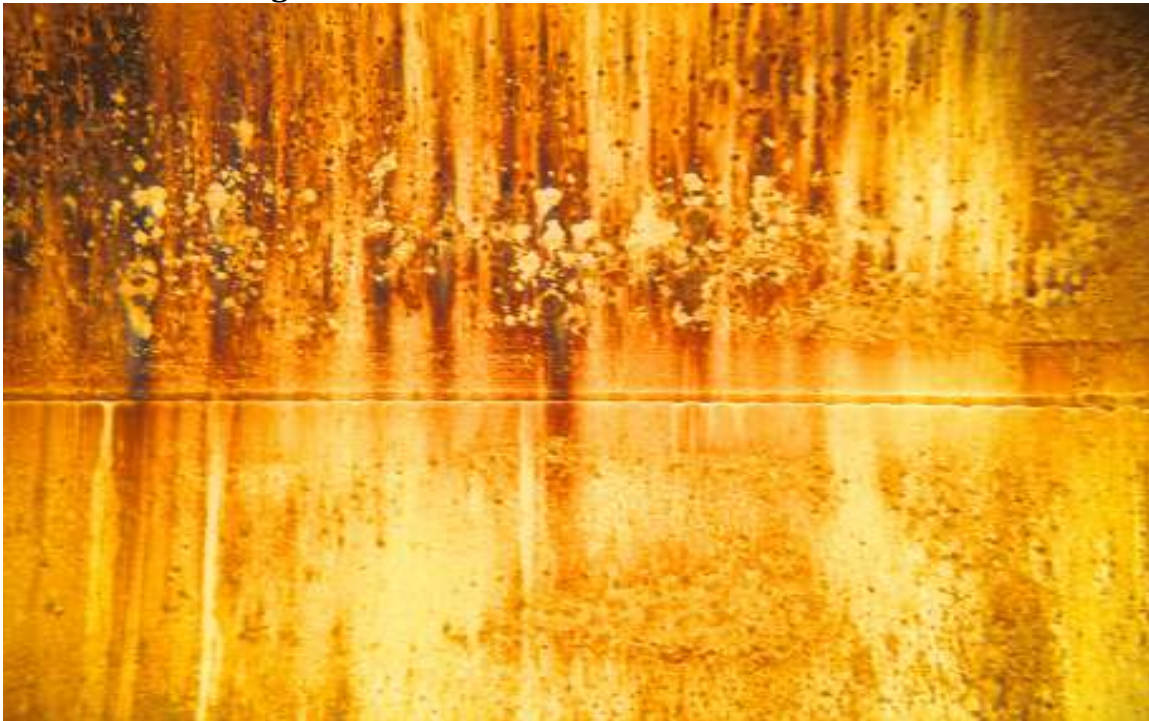
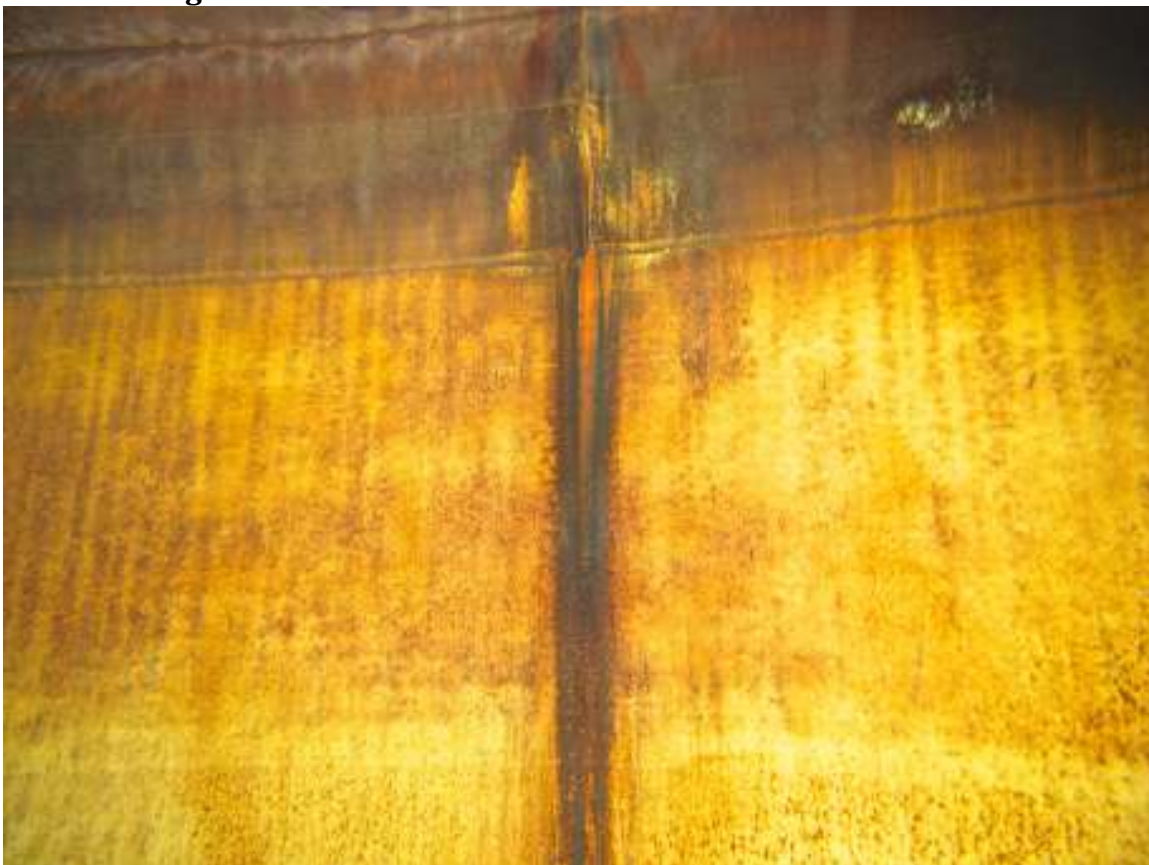
- **Coating - poor condition.**
- Cracking and peeling in rings #1 & #3 of quadrant A, exposing rusted steel.
- Rust spots and rust nodules in all three rings throughout tank, worst in quadrants A & D.

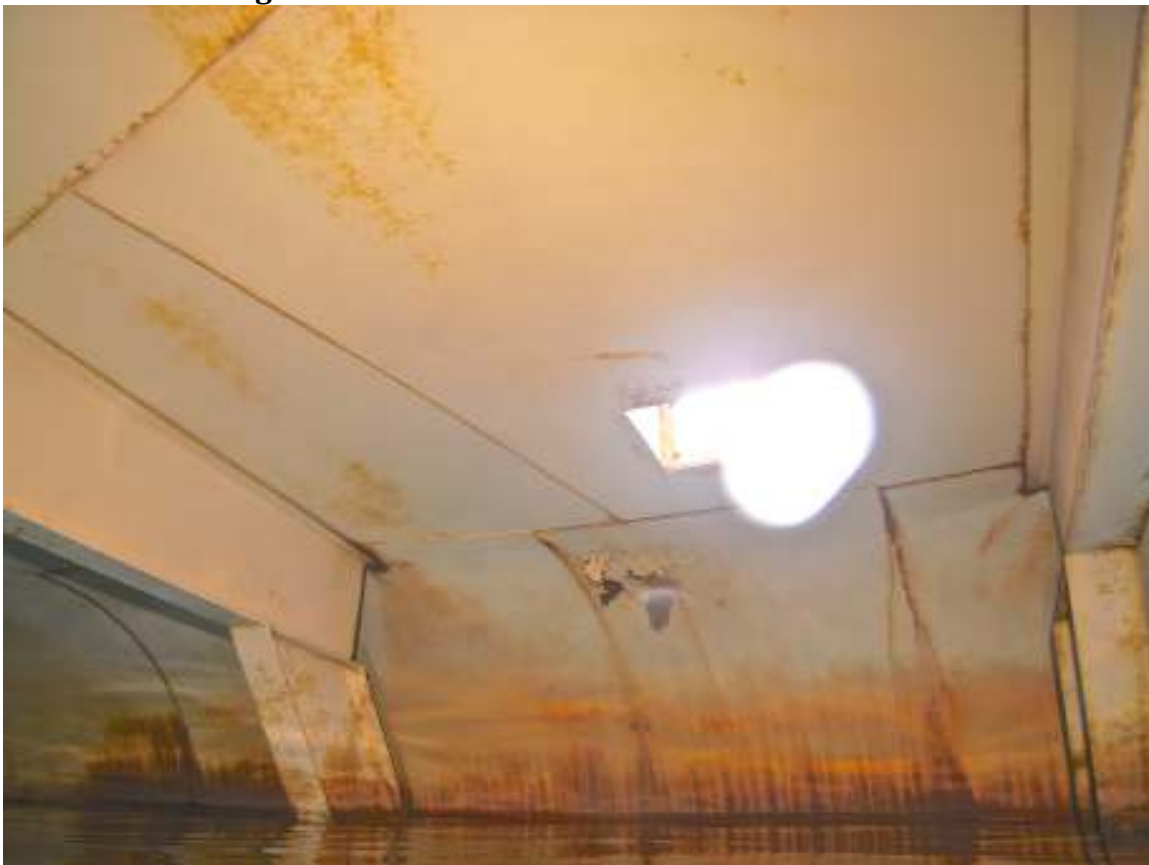
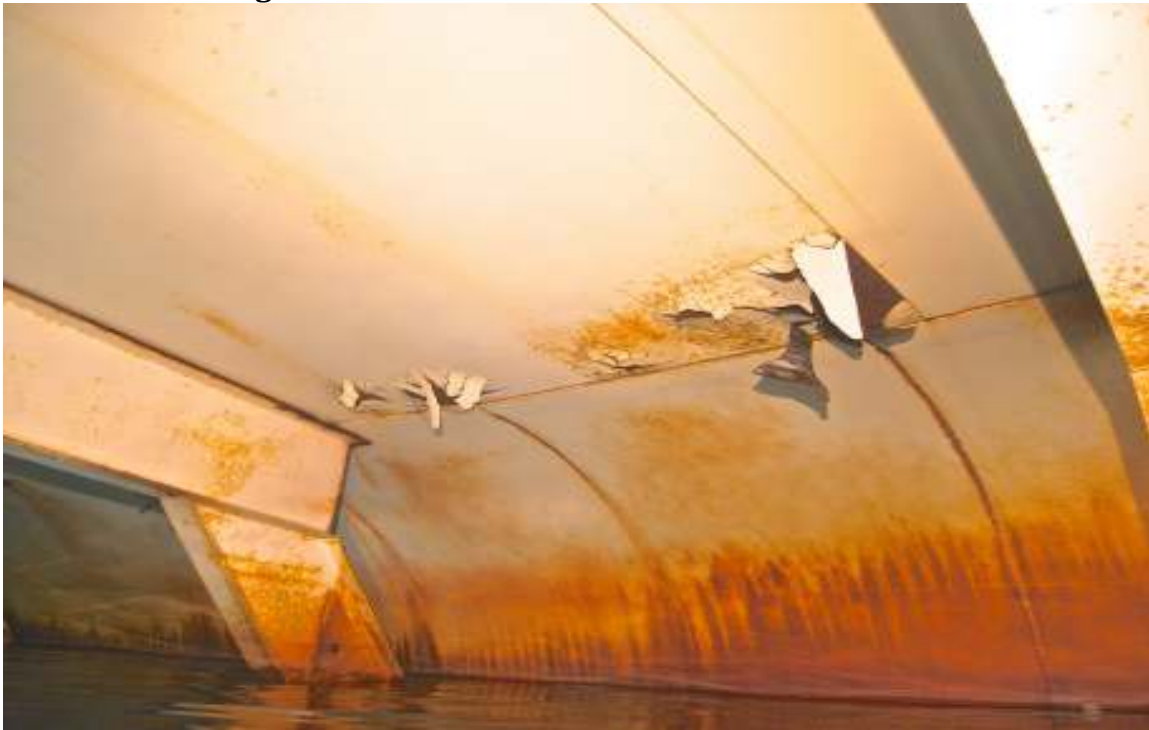
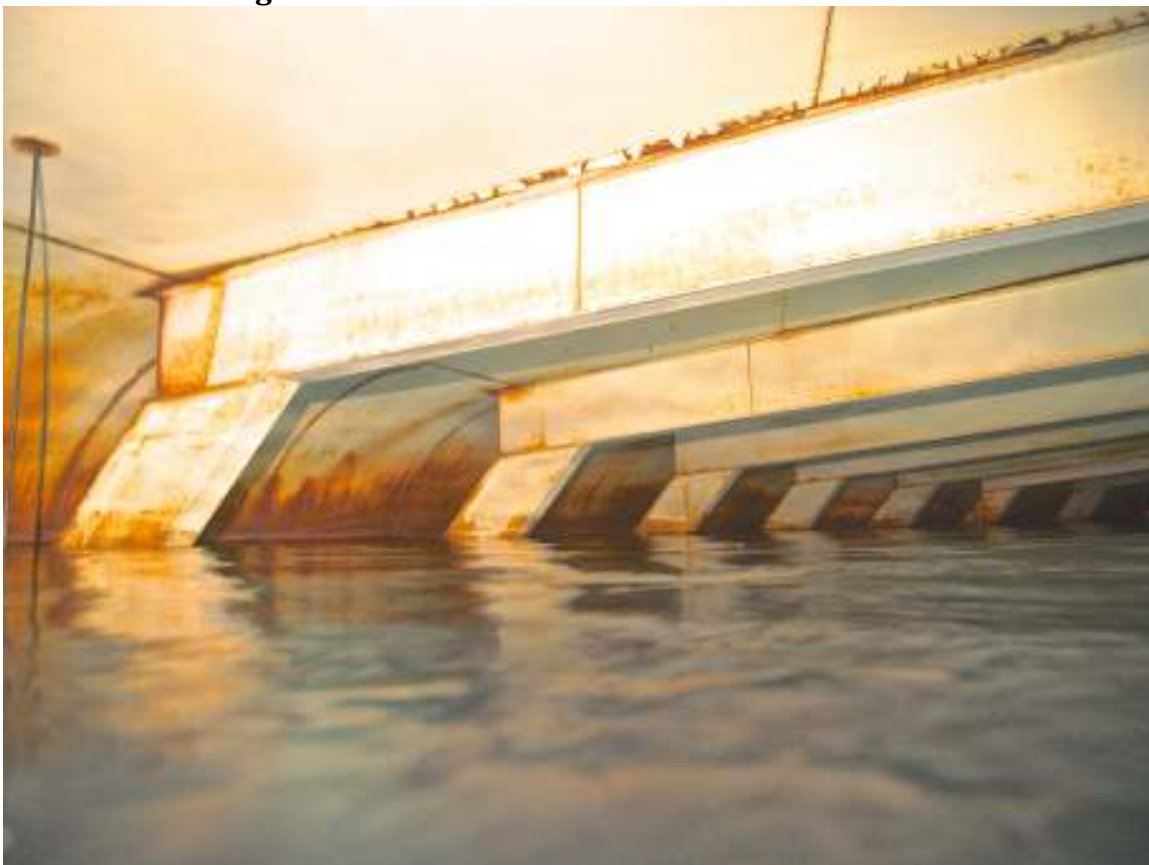
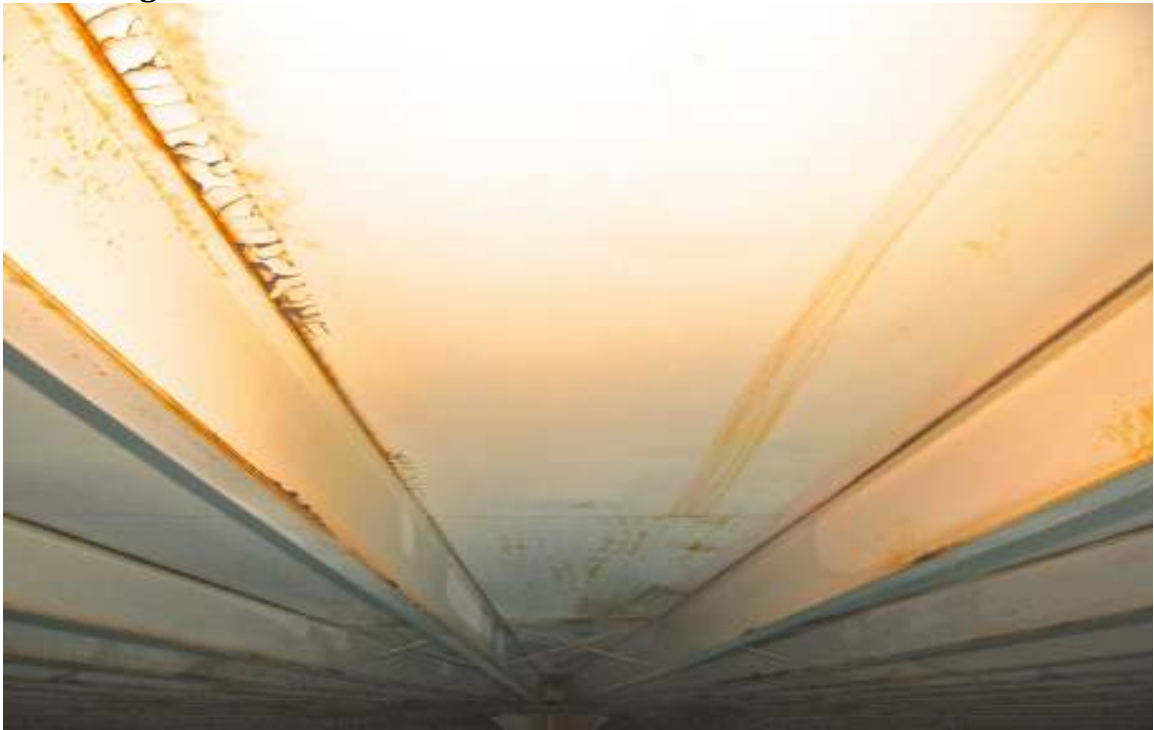
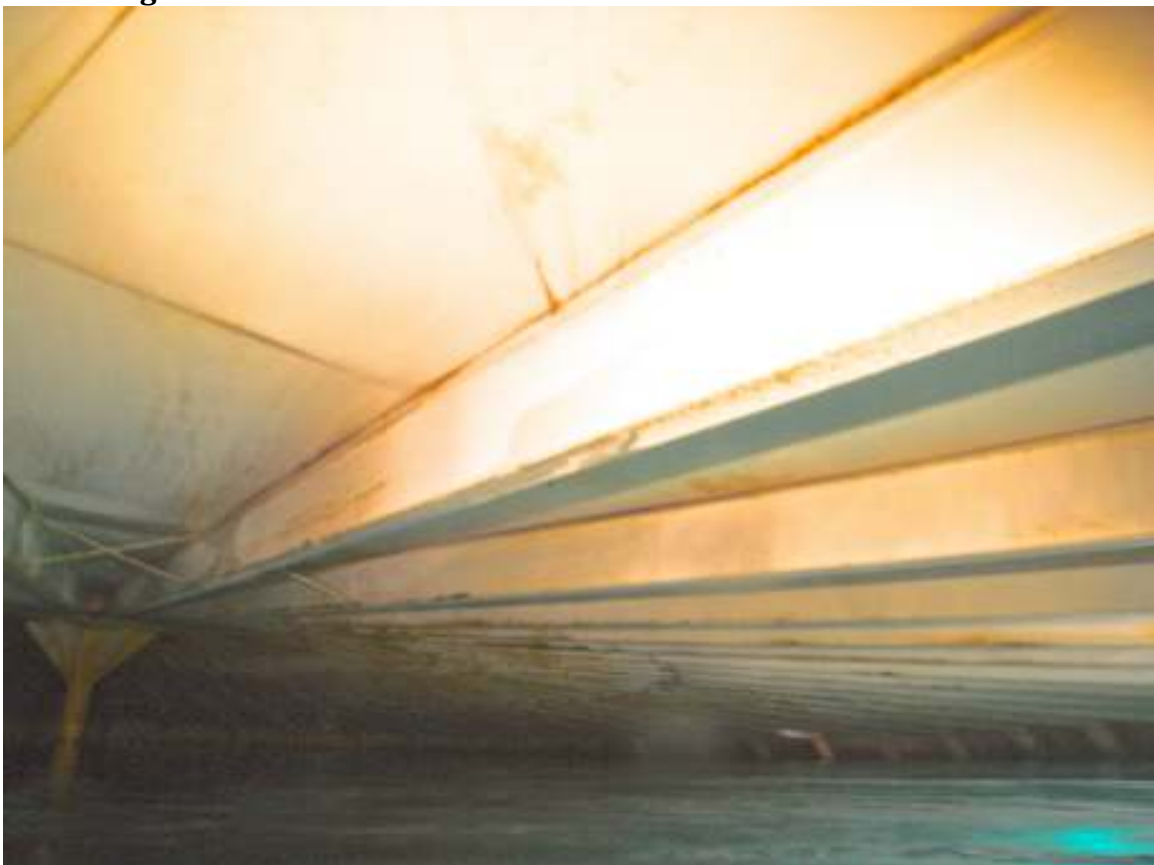
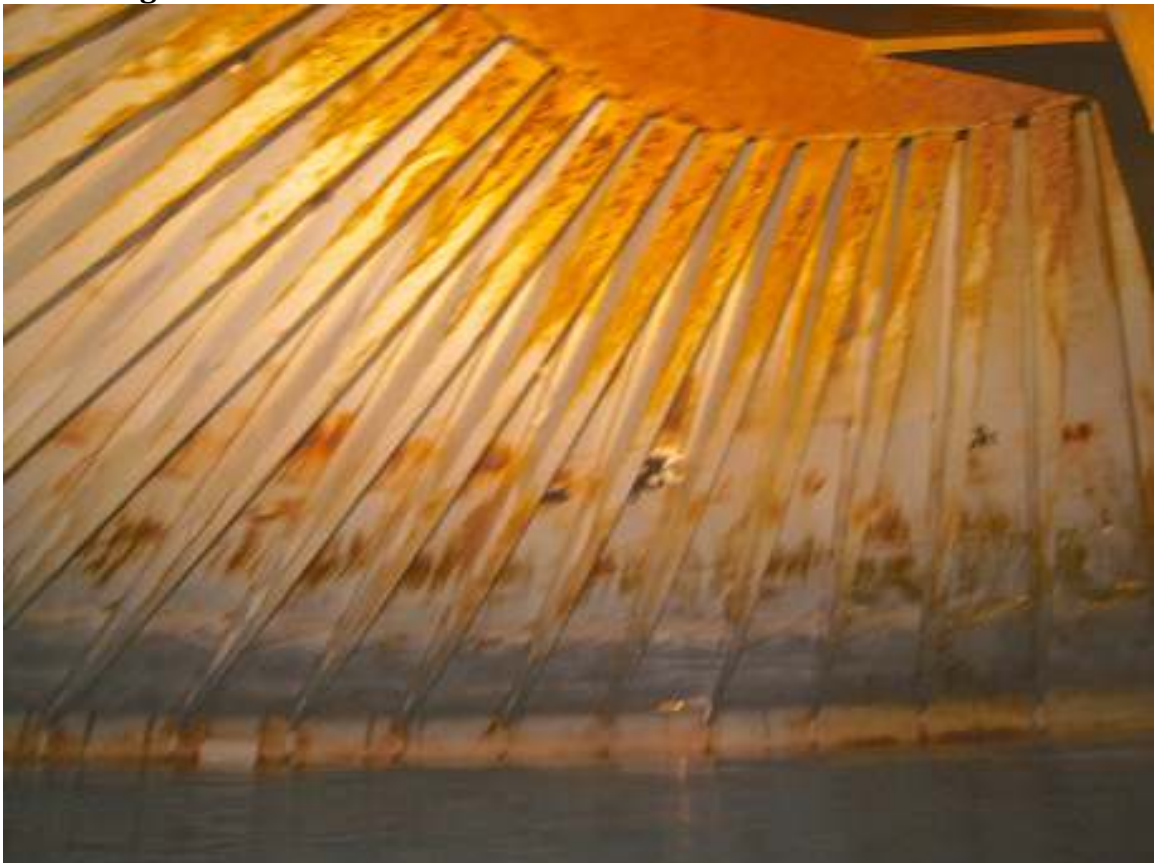
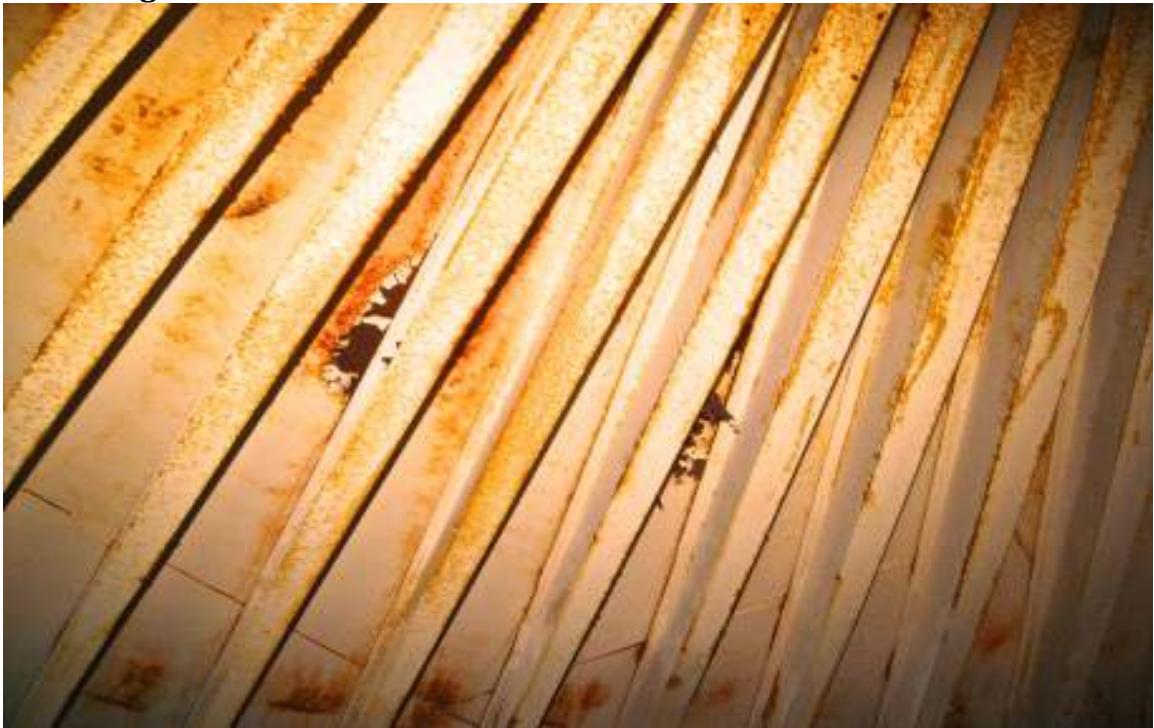
- **Coating – fair condition.**
- No blisters observed.
- Cracking and peeling in isolated spots all around tank exposing rusted metal and steel.
- Surface rust and rust staining on ceiling panels throughout tank.

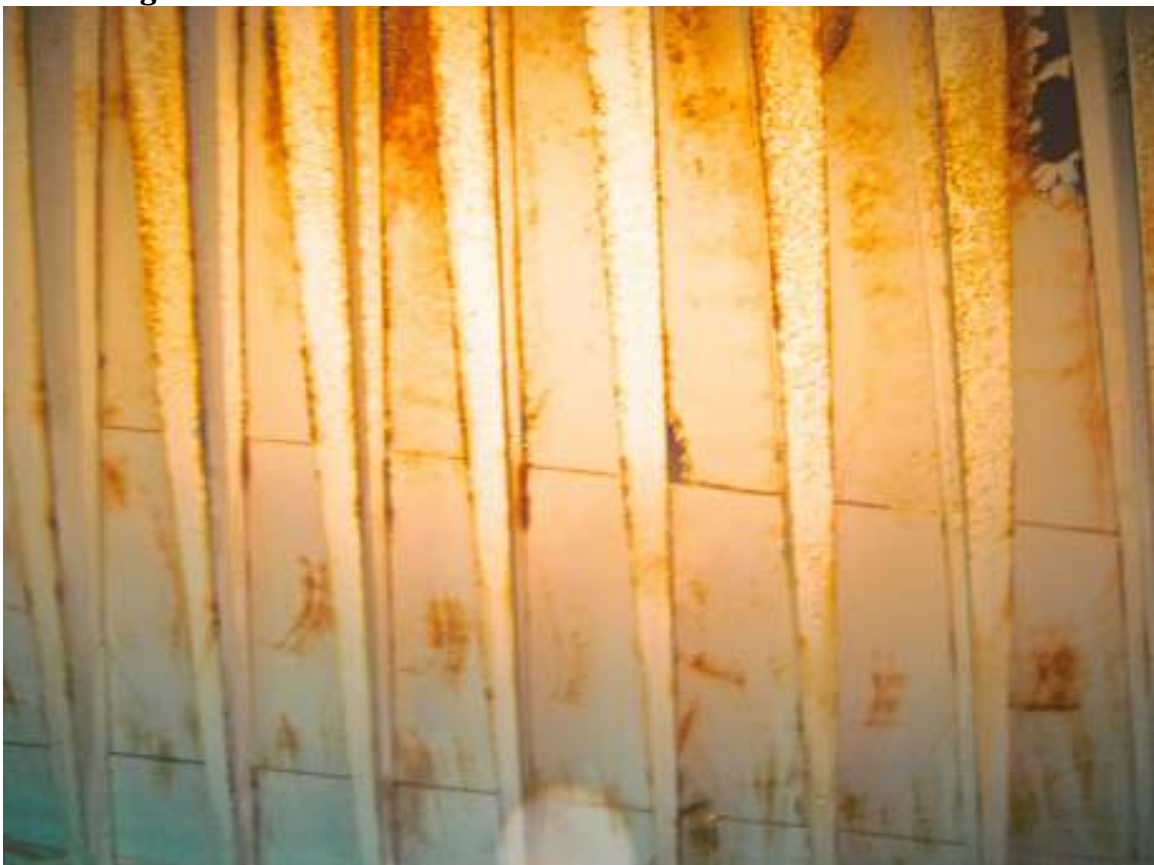
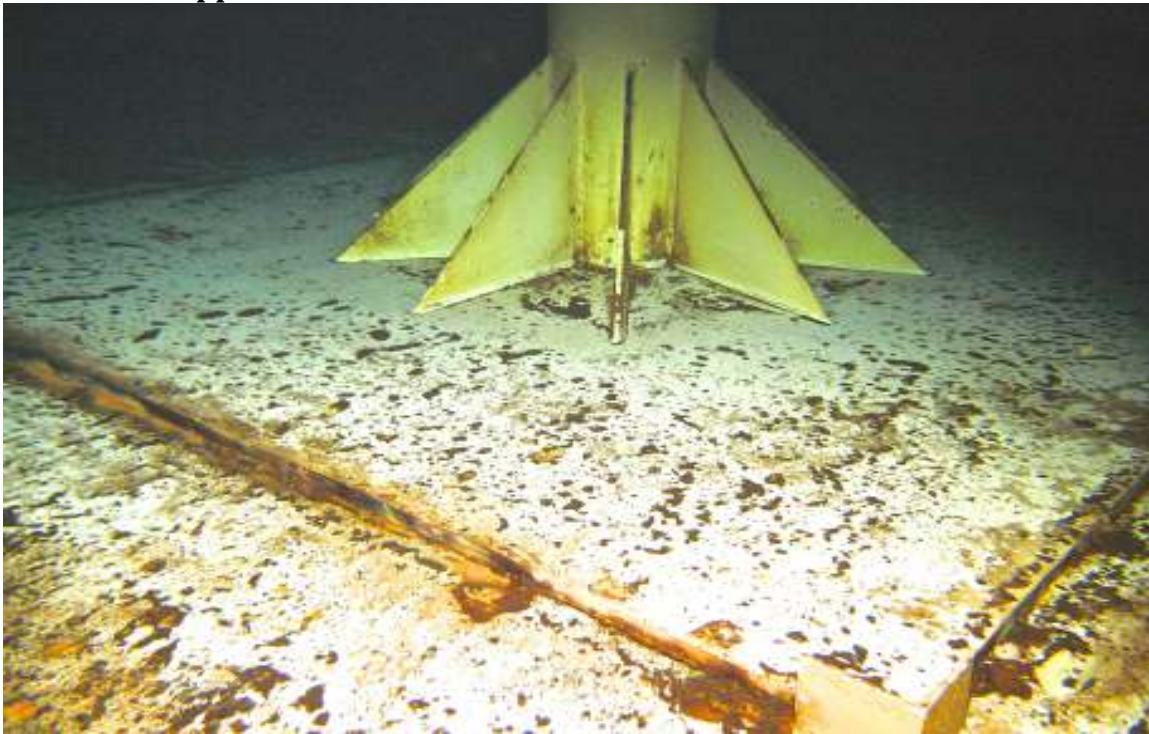
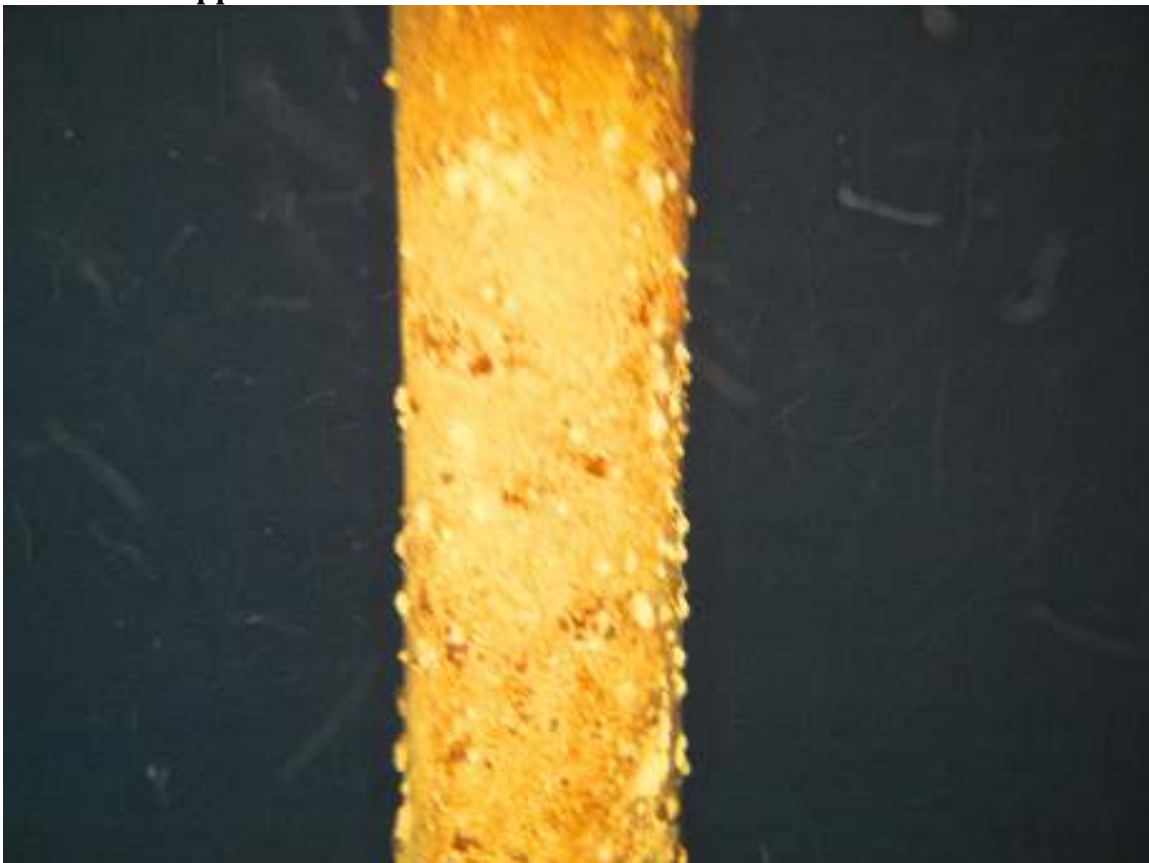
- **1 center support pole - coating is in poor condition.**
- May not be structurally sound, 90% of pole is covered in rust spots and rust nodules.
- Rust in crevices between base and floor.
- Surface rust and staining on top hat.

- **Keep up with regularly scheduled maintenance & cleanings on a 3-5 year rotation.**
- **Rust observed throughout the entire tank but particularly worried about rust condition on center support pole.**
- **Overall the coating in this tank is in poor condition.**
