Desert Springs #3

04-11-2016

On April 11th, 2016, Blue Locker Commercial Diving Services, L.L.C. performed a cleaning and inspection of the Desert Springs #3 reservoir for Truckee Meadows Water Authority. This report, along with the provided video, documents the findings of the inspection. All observations are observed strictly for your own considerations.

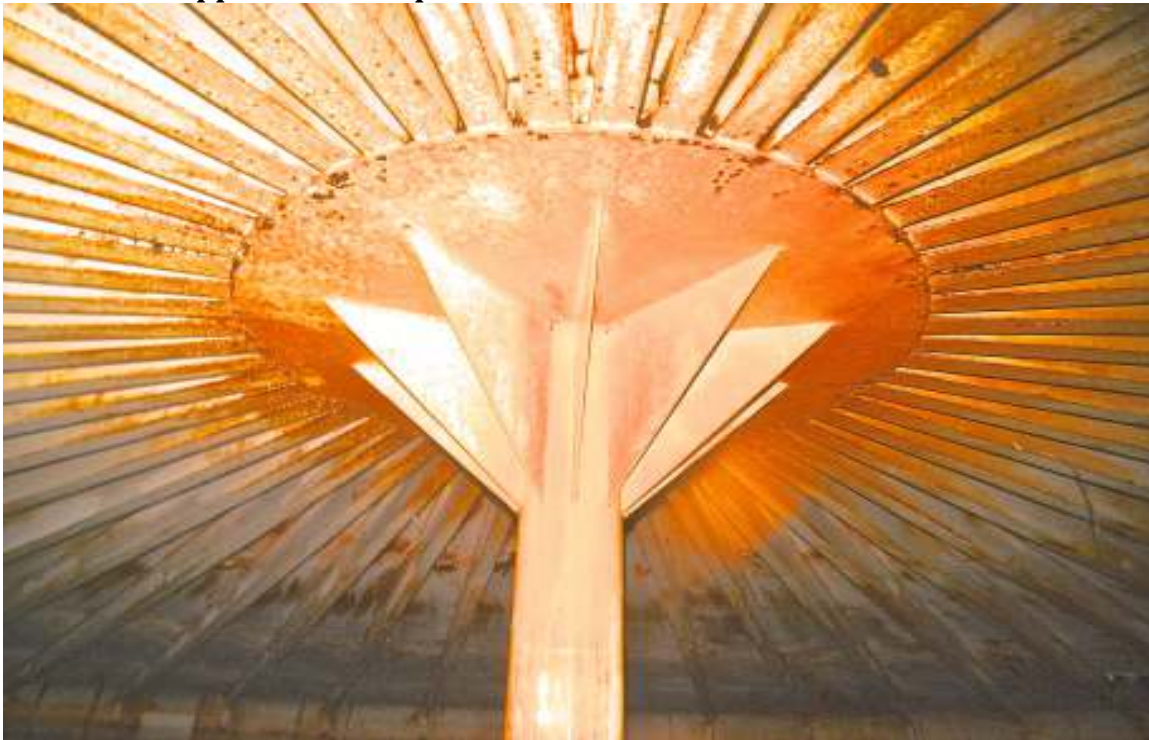
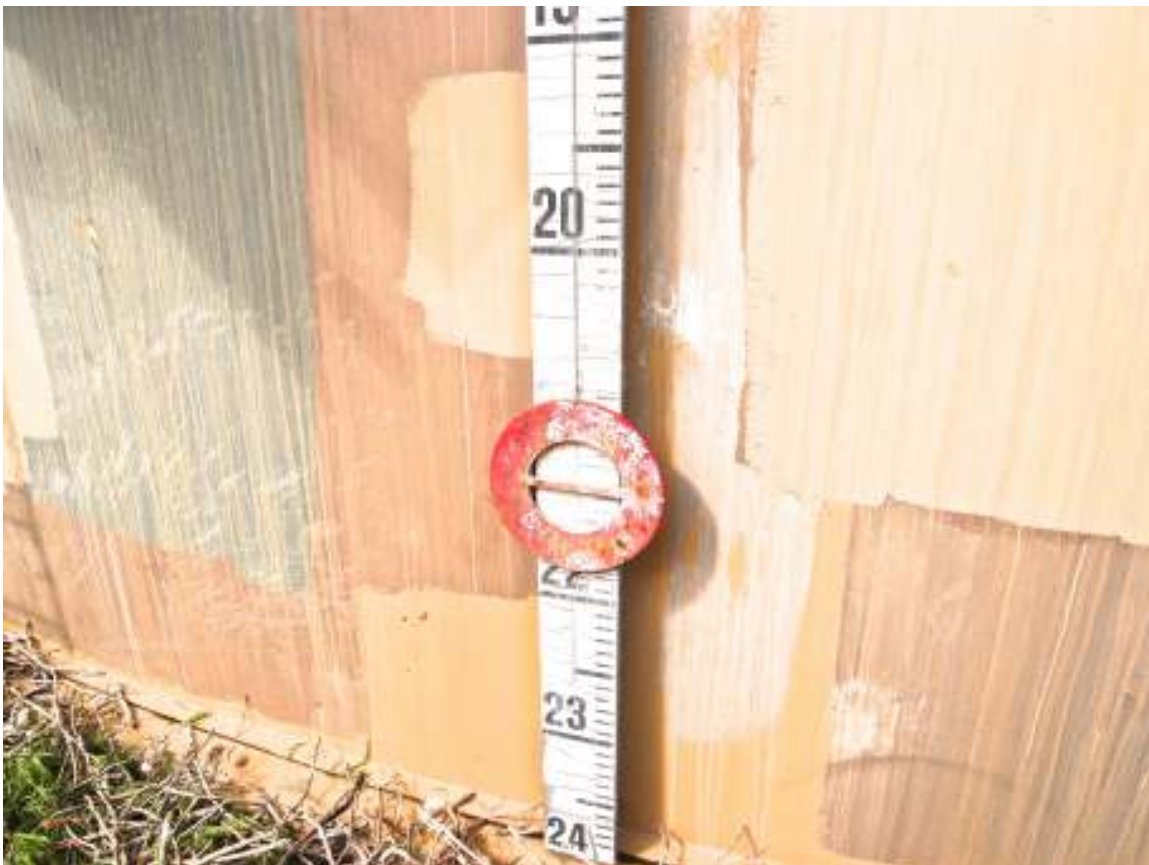
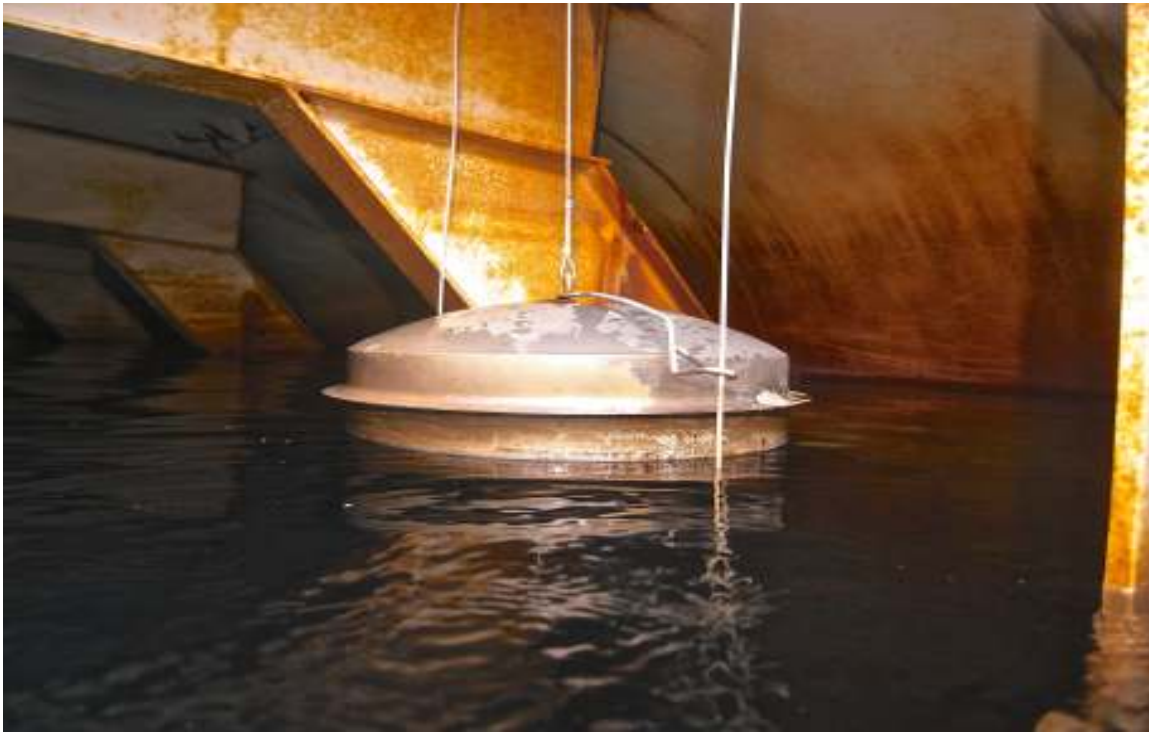
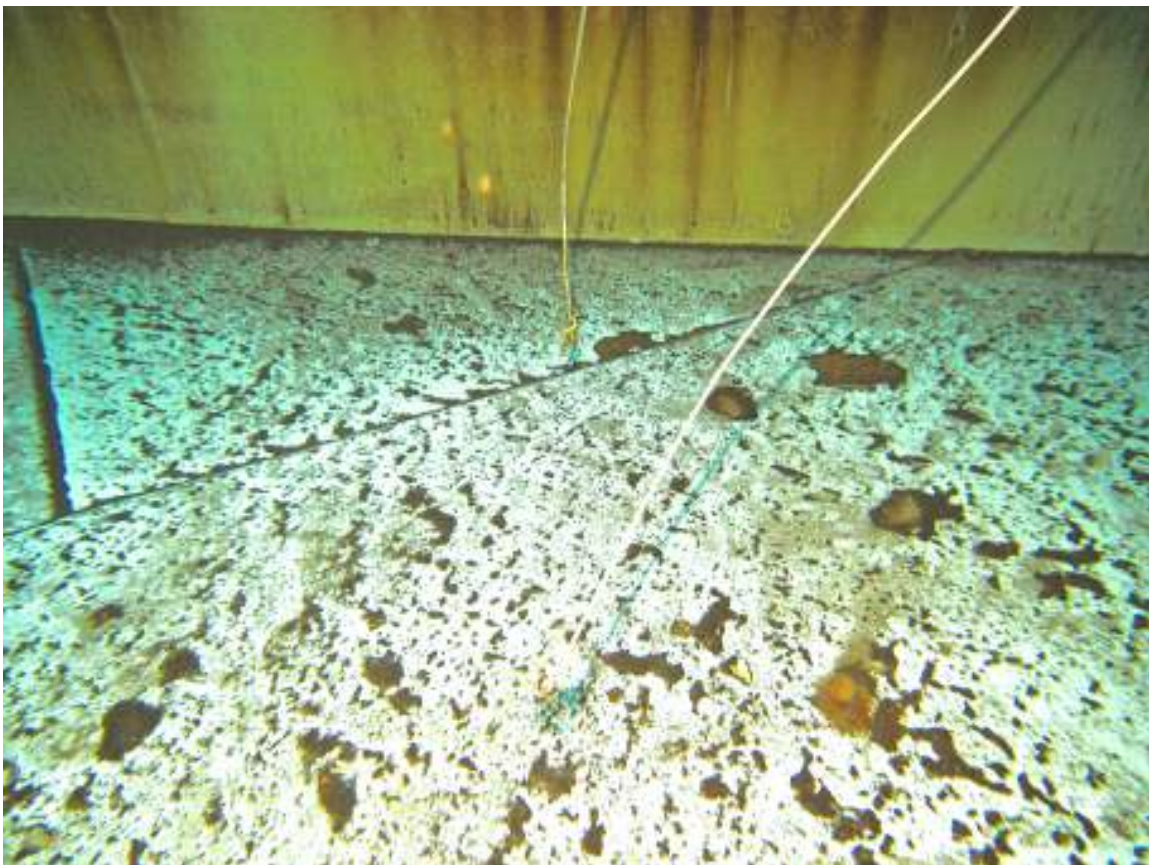
- **Mechanical water level indicator is functional with float at surface with guide wires no longer attached to the floor.**
- **Transducer is in place and appears functional.**
- Observations:
 - Ensure electronic level measurement is functioning to remain in compliance with NAC 445A.6708.7

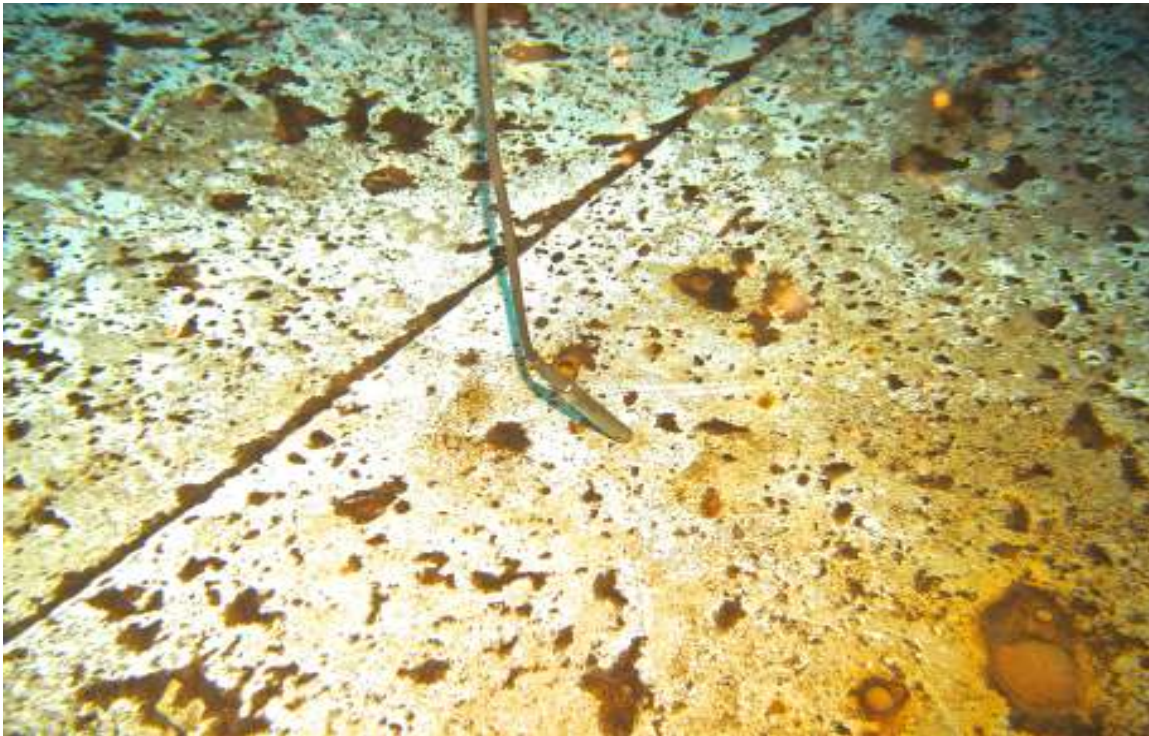
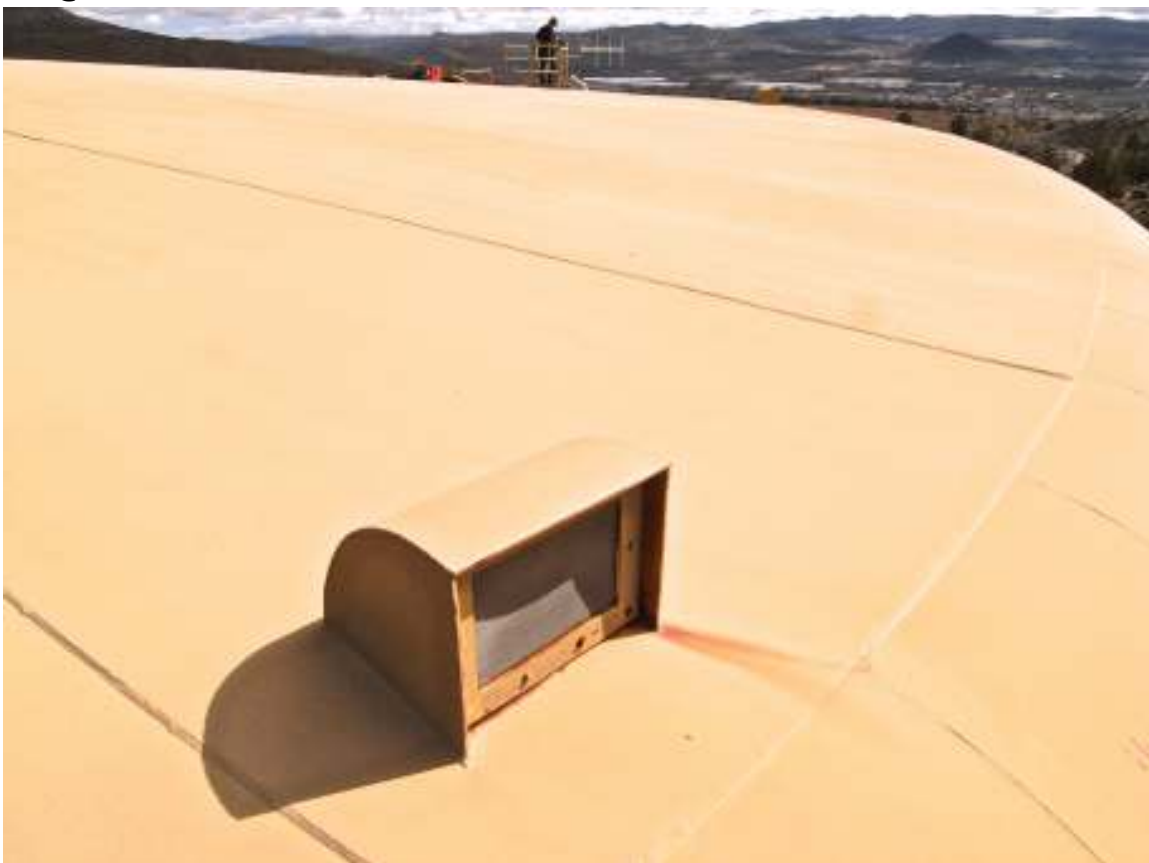
- **6 @ 9"x 12" perimeter roof vents in good condition - screens intact.**
- **36" diameter center roof vent in good condition - screen intact.**
- Observations:
 - Ensure screen mesh is 22-24 mesh per NAC 445A.6708.5

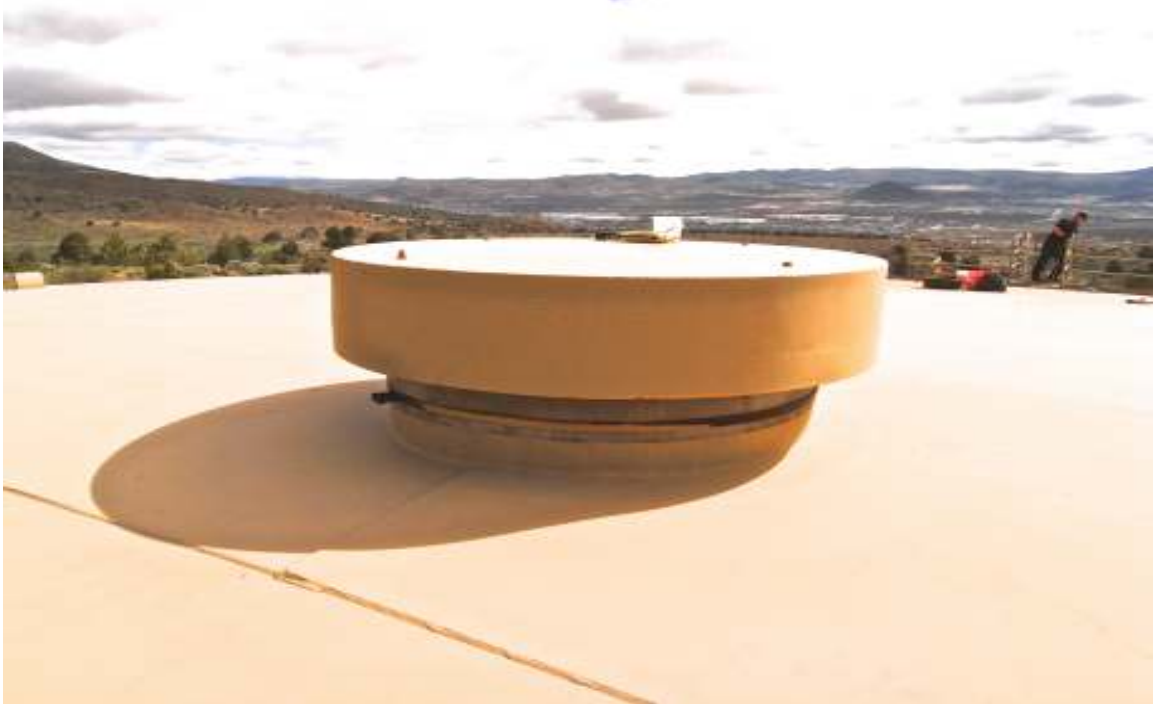
40. Exterior Ladder

- **Exterior ladder- good condition.**
- Structurally sound and secure to shell.
- No flaws observed on rungs, runners or cage.
- Bird's nest removed from bottom of cage door by T.M.W.A. operators.
- Safety climbing device - none present - good condition.

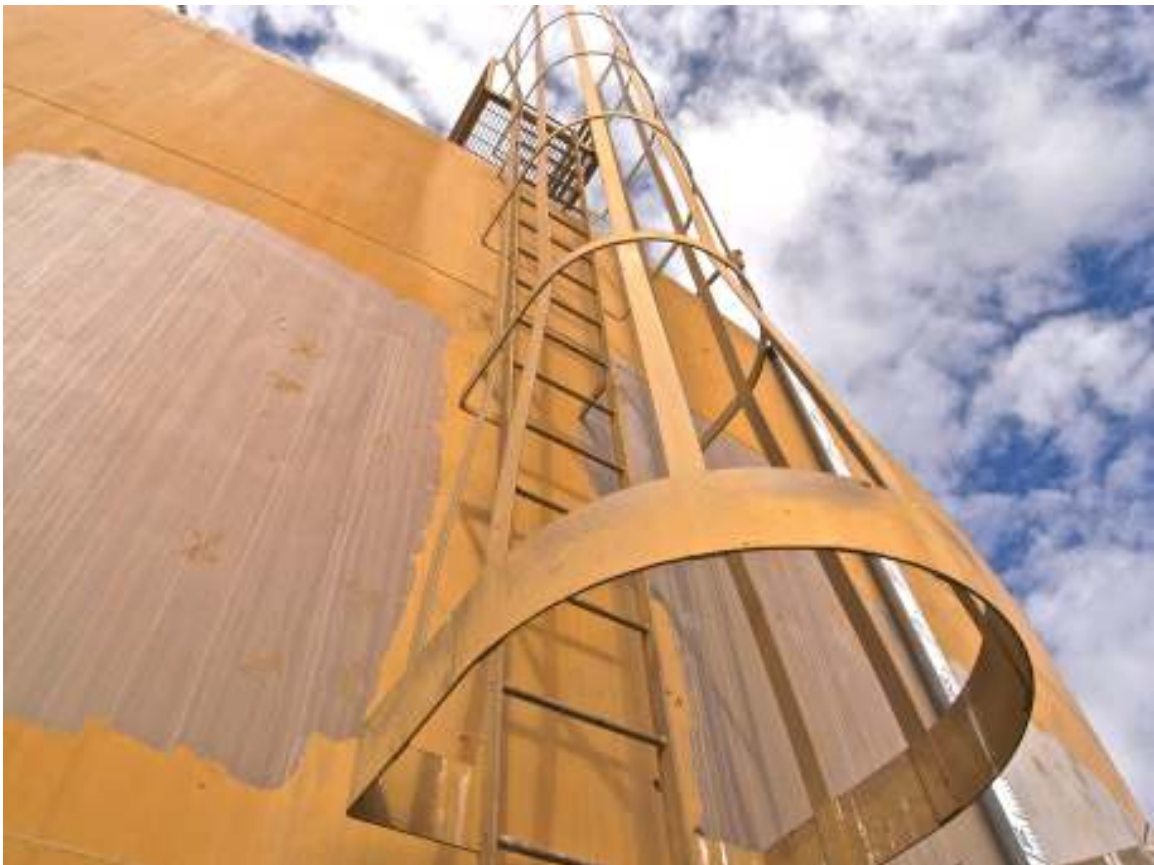
41. Access Hatch

- **36" x 36" access hatch - fair condition.**
- Peeling on hatch cover exposing rust and rust on opening edge.
- Observations:
 - May consider installing a gasket to improve seal.
 - May want to touch up coating on hatch to improve sanitary conditions.

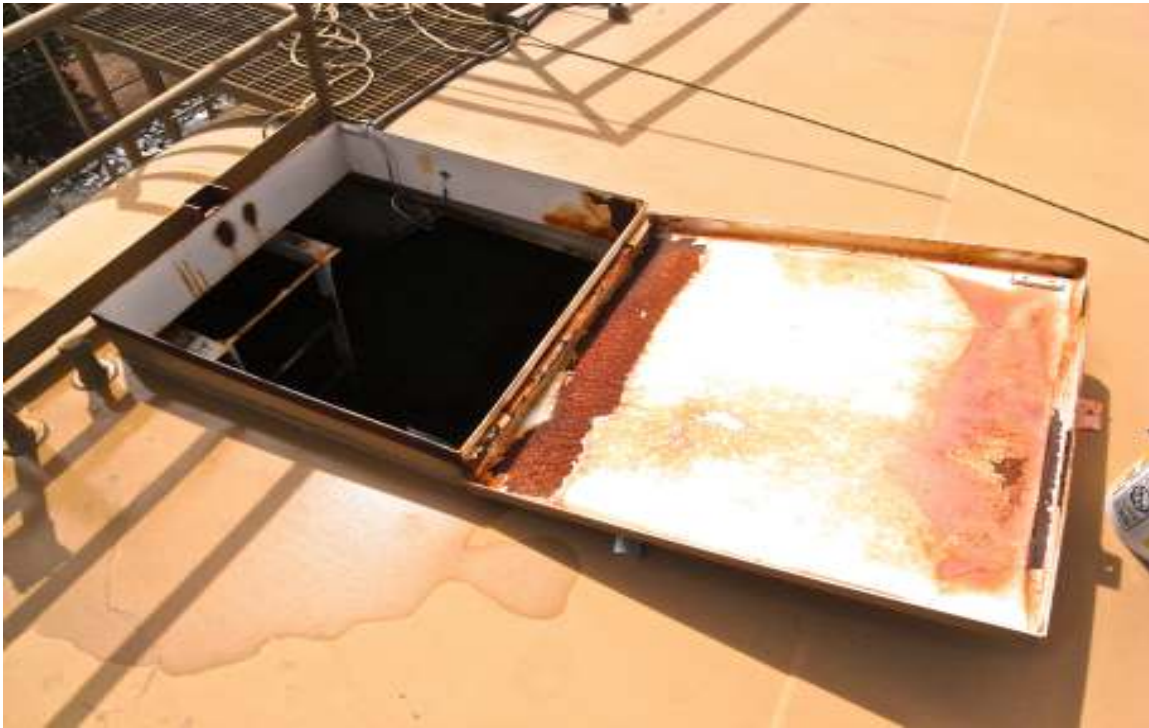
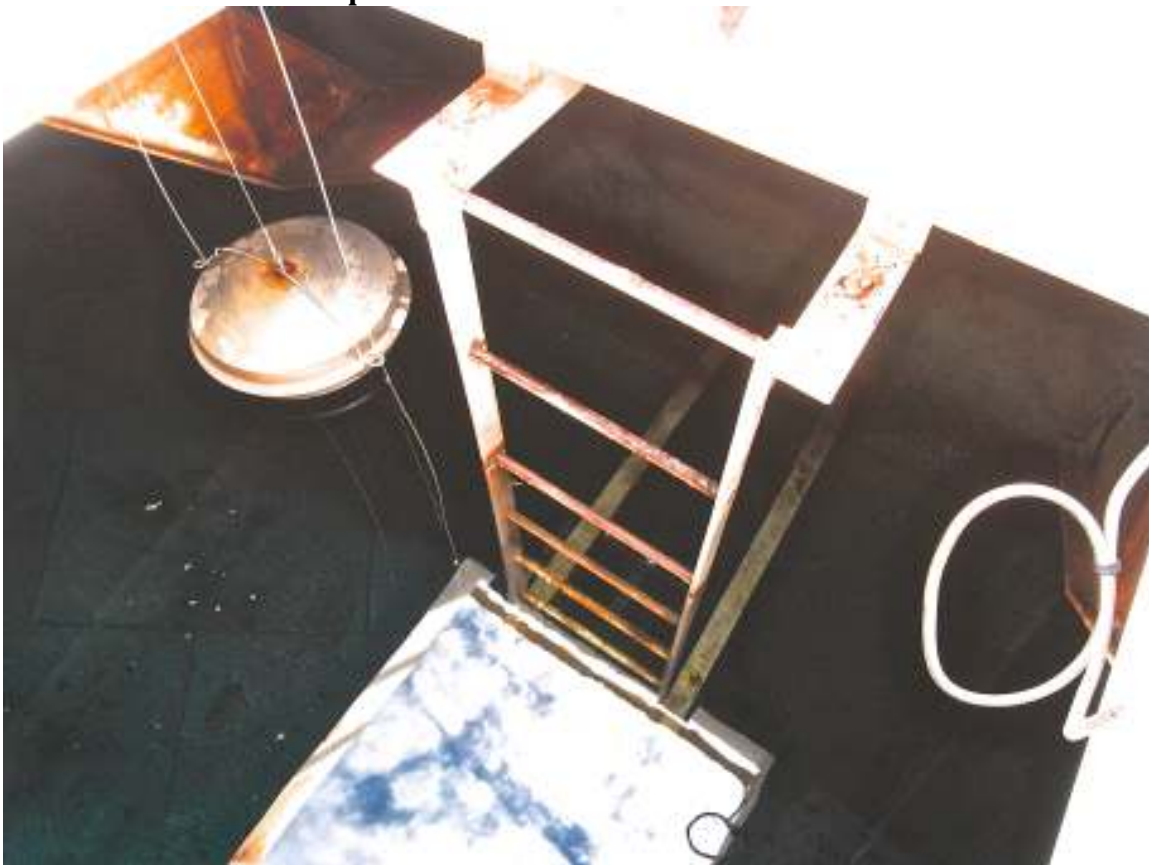
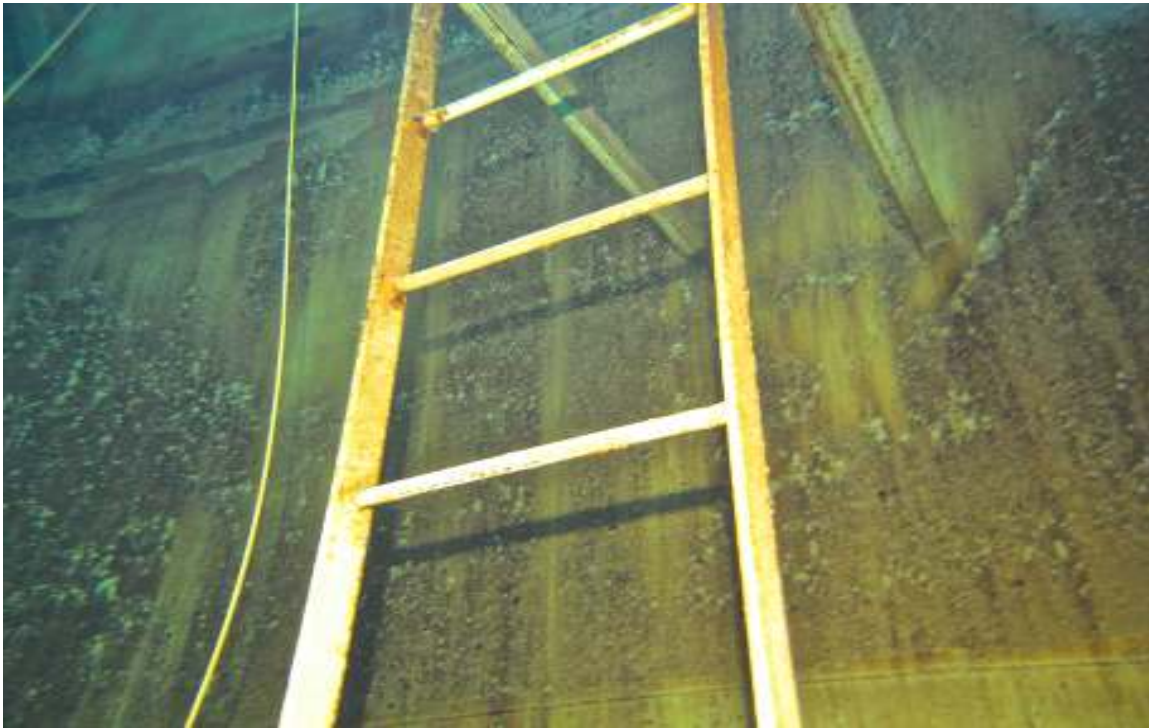
- **Interior ladder - fair condition & structurally sound.**
- **Ladder coating is in fair condition with peeling of top 6 rungs exposing rusted steel.**
- Rust also observed on rungs and runners near floor.
- Safety climbing devices, none present.

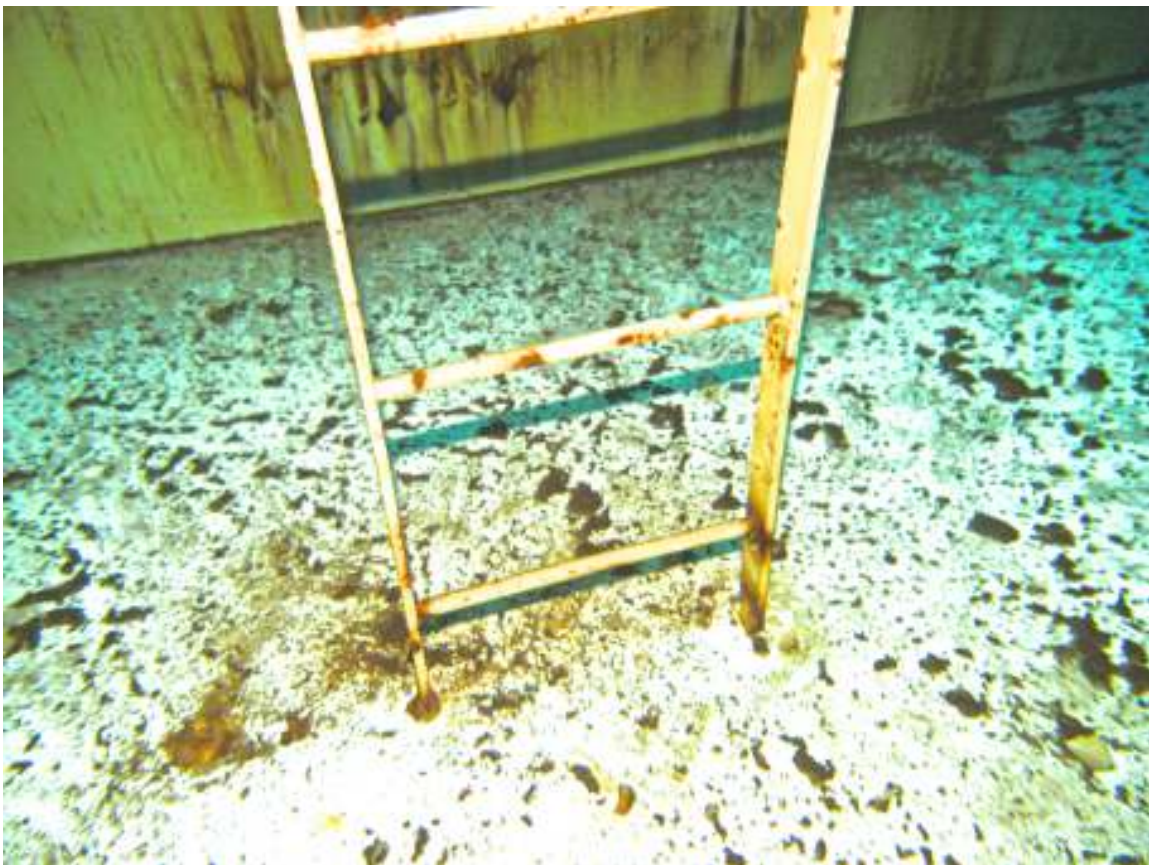
45. Inlet/Outlet/Drain

- **12” diameter penetration with mud-guard is in poor condition.**
- Rust around opening edge on mud-guard and interior of pipe.
- Rust spots on mud-guard edge and in crevice between mud-guard and penetration edge.
- Rust on interior of mud-guard exposing steel.
- 1”- 2” gap between mud-guard and penetration edge.

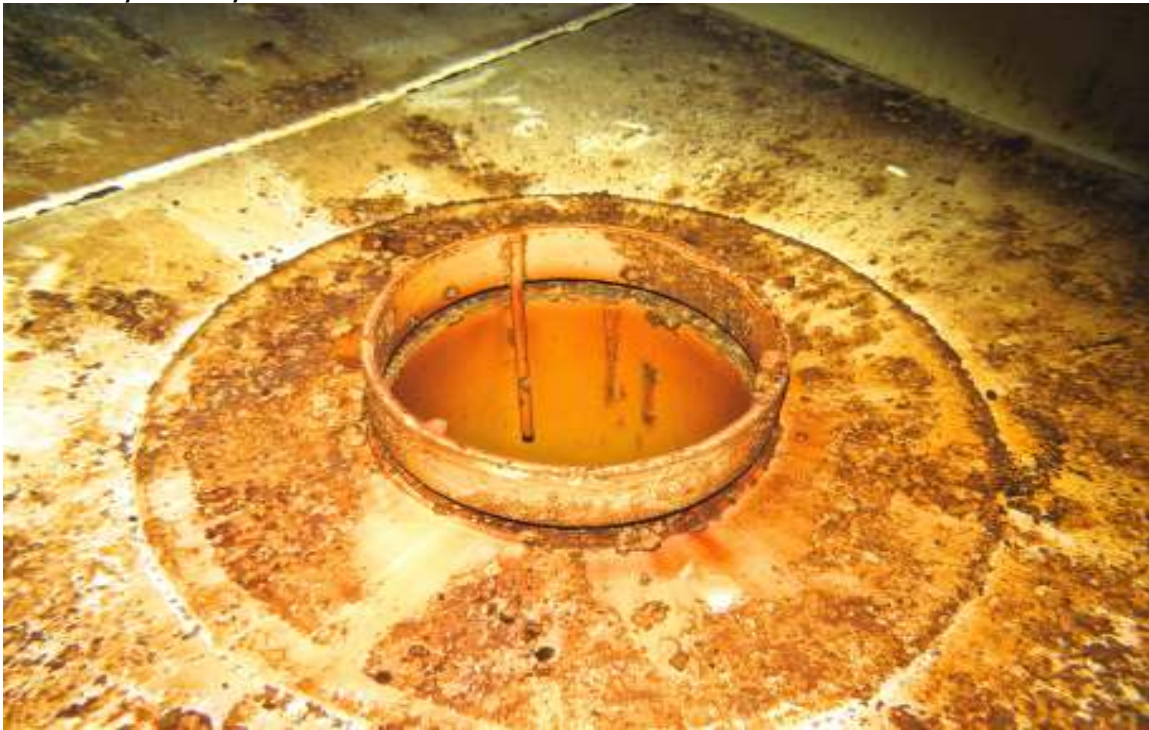
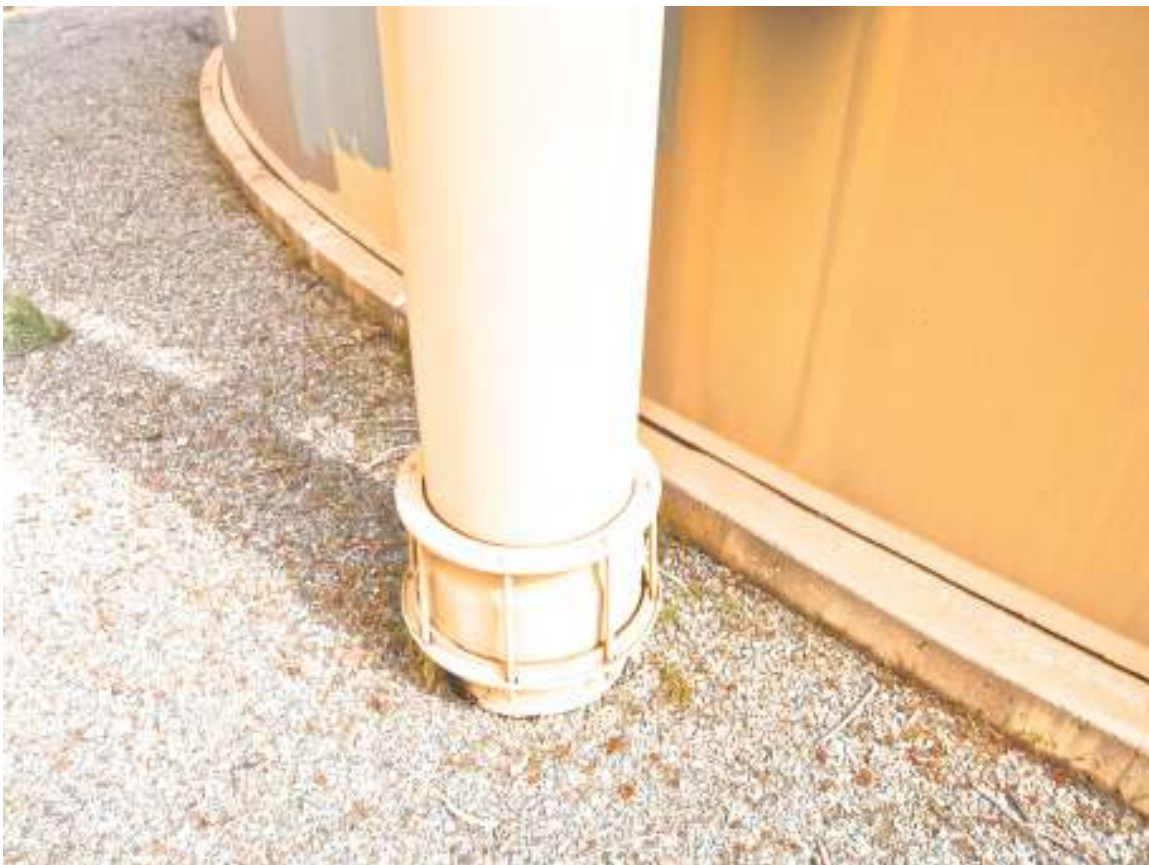
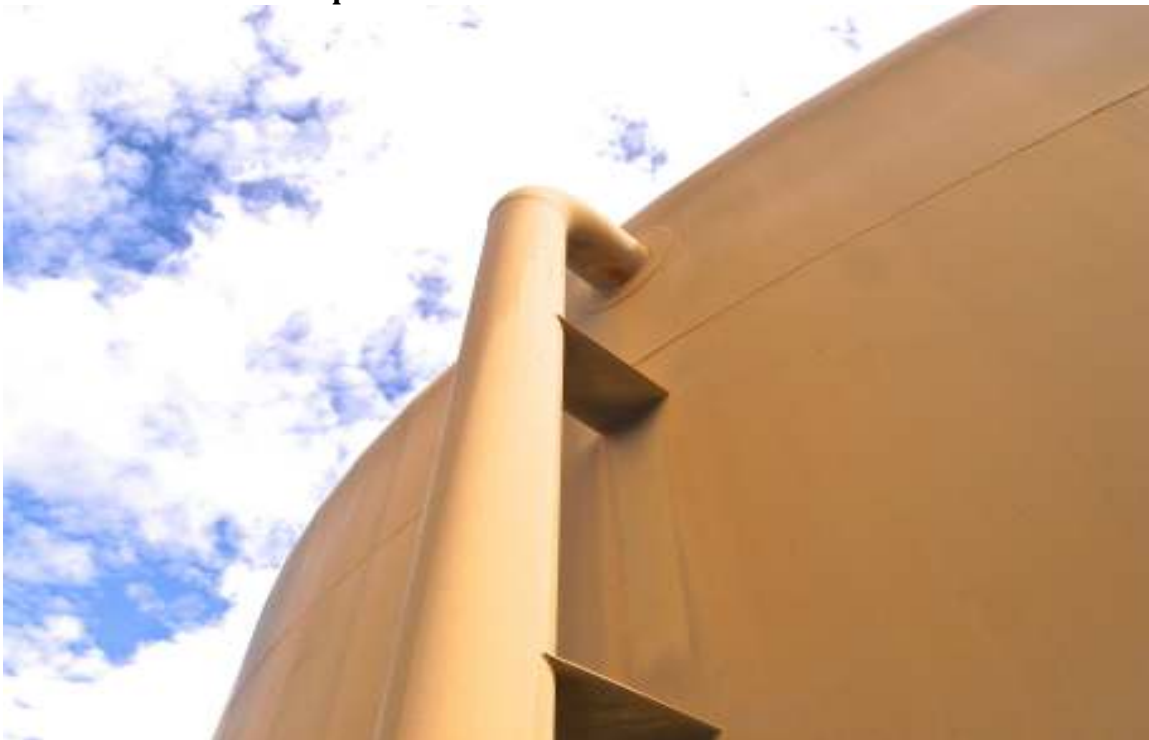
- **16” diameter overflow – sound and unobstructed - good condition.**
- Surface rust and staining on overflow box.
- No other flaws observed.

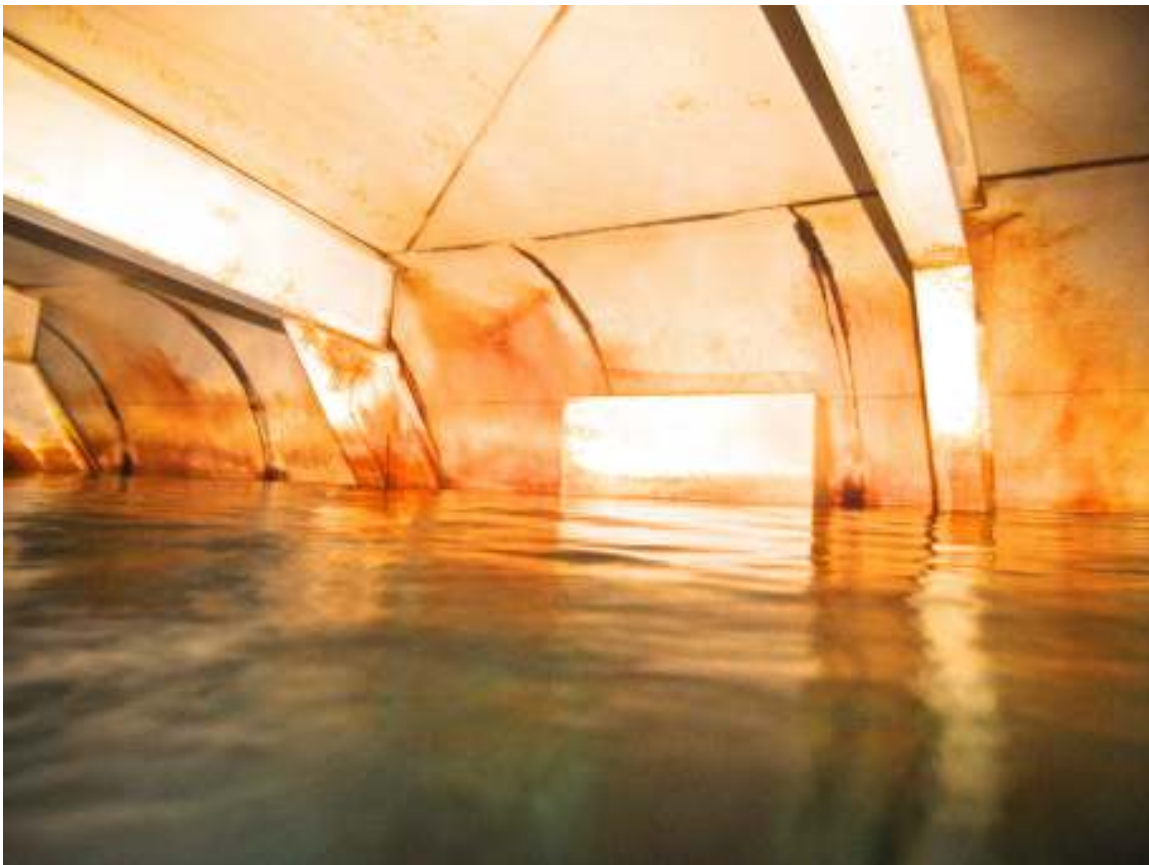
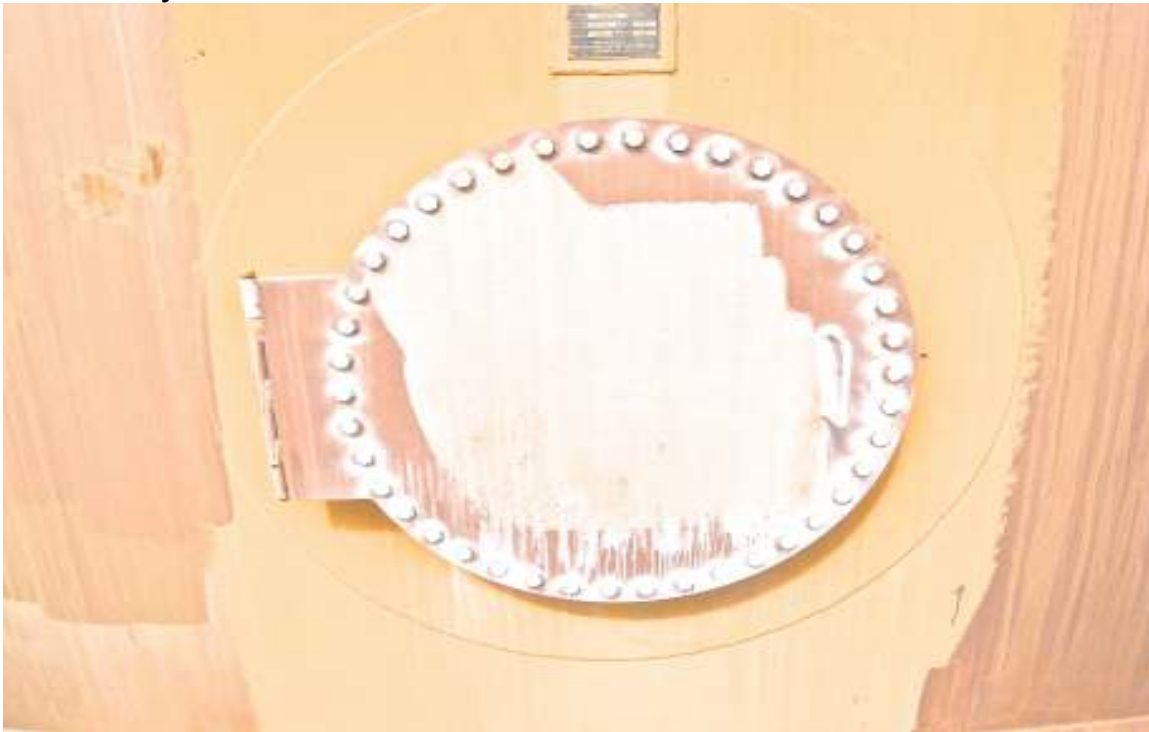
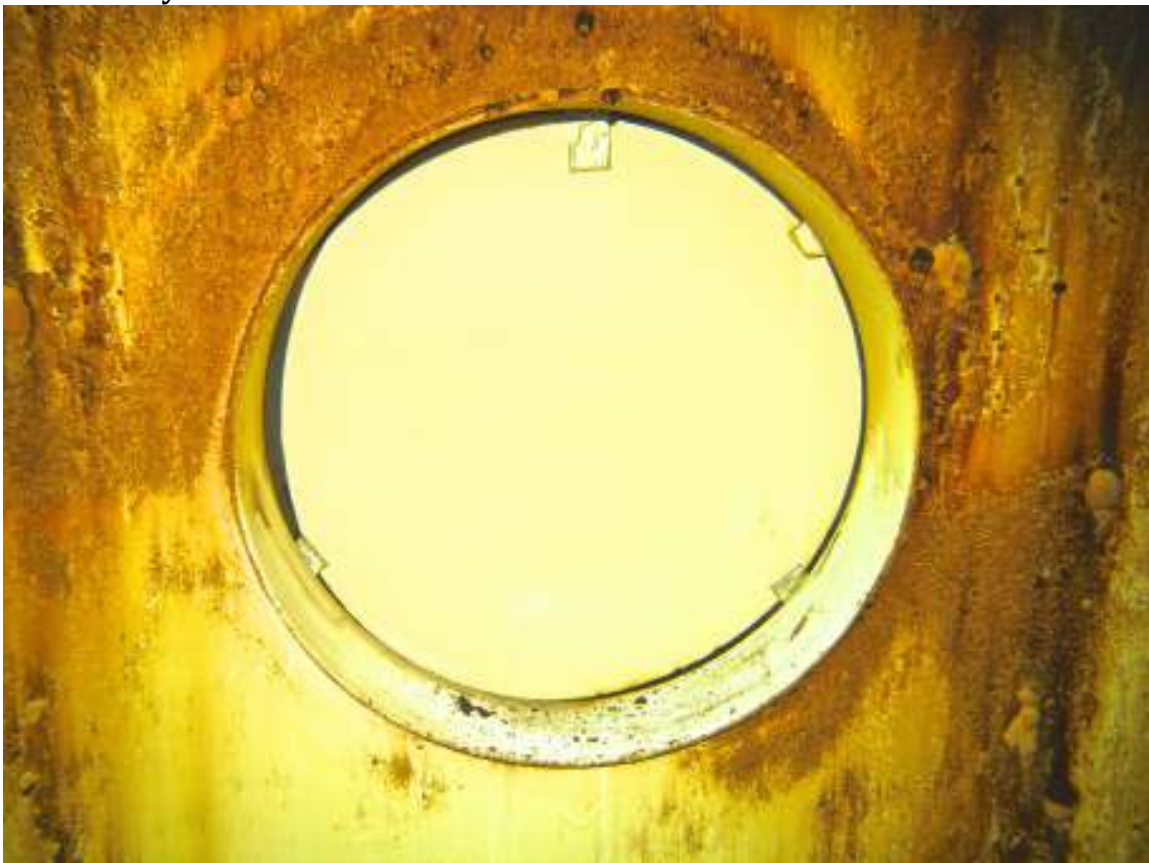
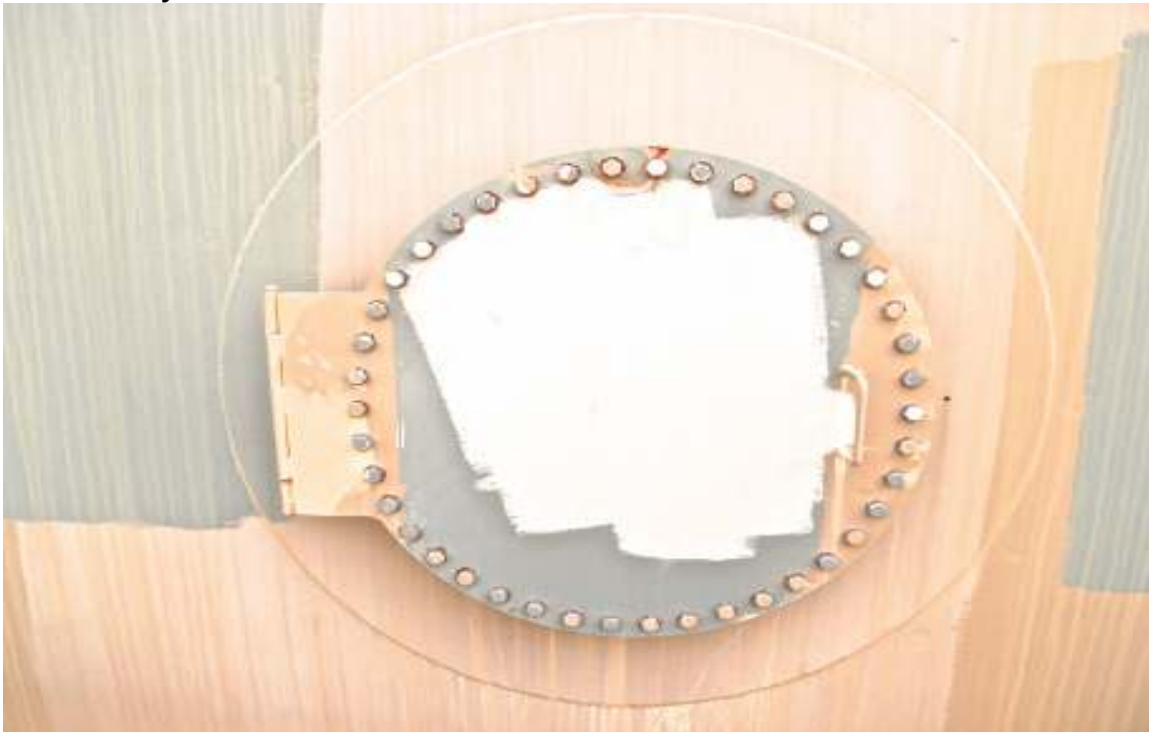
- **2 @ 30” diameter manways - good condition.**
- Seals appear to be intact.
- Rust observed on both manways around outside edges.
- No other flaws observed.
