T.M.W.A.

Mt. Rose #2

03-31-2016

On March 31st, 2016, Blue Locker Commercial Diving Services, L.L.C. performed a cleaning and inspection of the Mt. Rose #2 reservoir for Truckee Meadows Water Authority. This report, along with the provided video, documents the findings of the inspection. All observations are observed strictly for your own considerations.

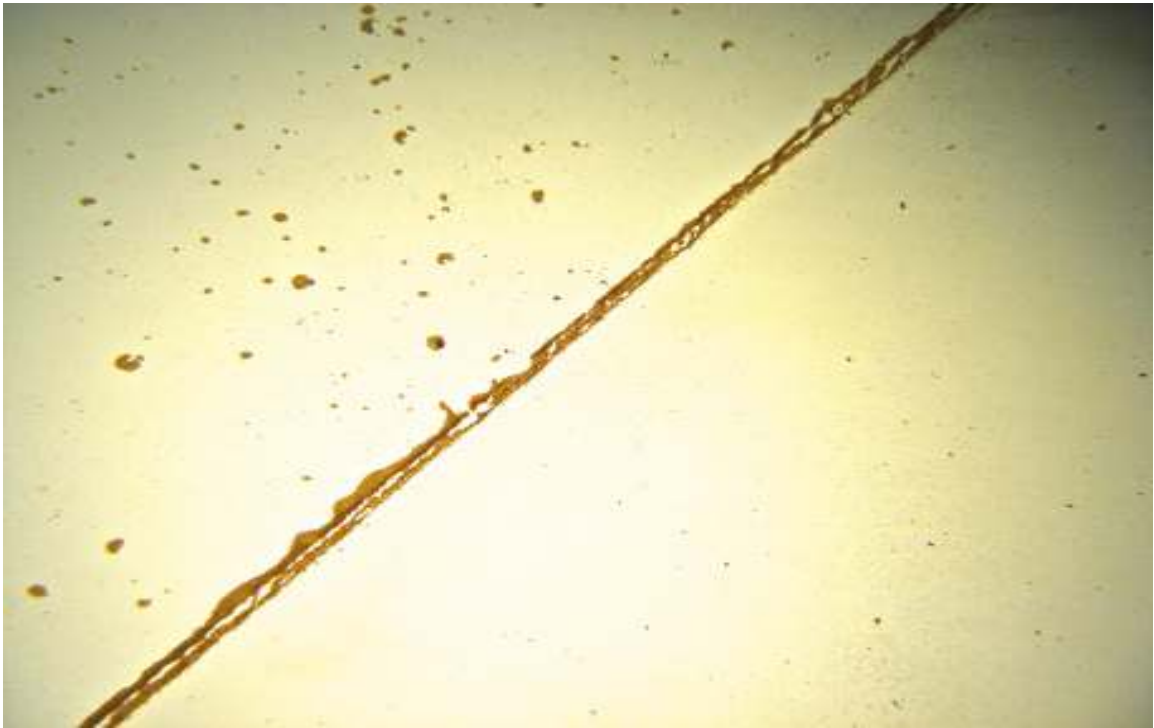
7. Floor

- **Floor coating – good condition.**
- No flaws observed through sediment.
- Less than 1/8th" of sediment was not removed by diver prior to inspection.
- No other flaws observed.

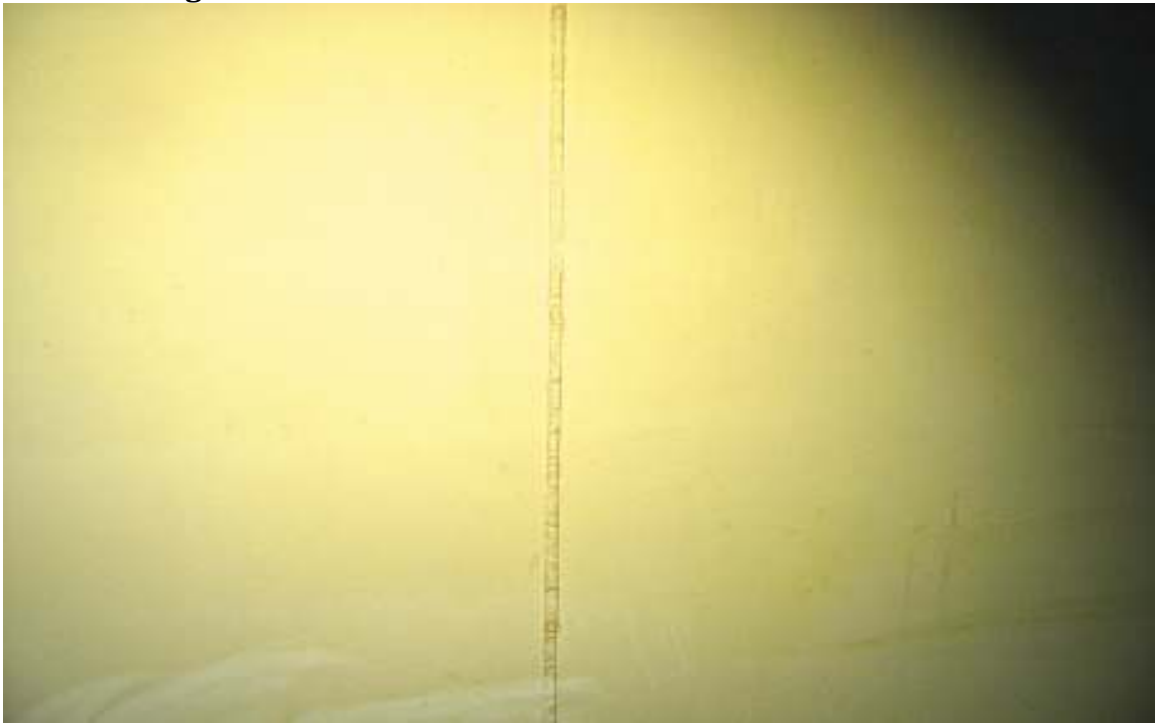
16. Shell Ring #1

- **Interior coating – good condition.**
- No blisters, cracking, peeling or rust observed.
- Rust staining and sediment staining observed in ring #2
- No other flaws observed.

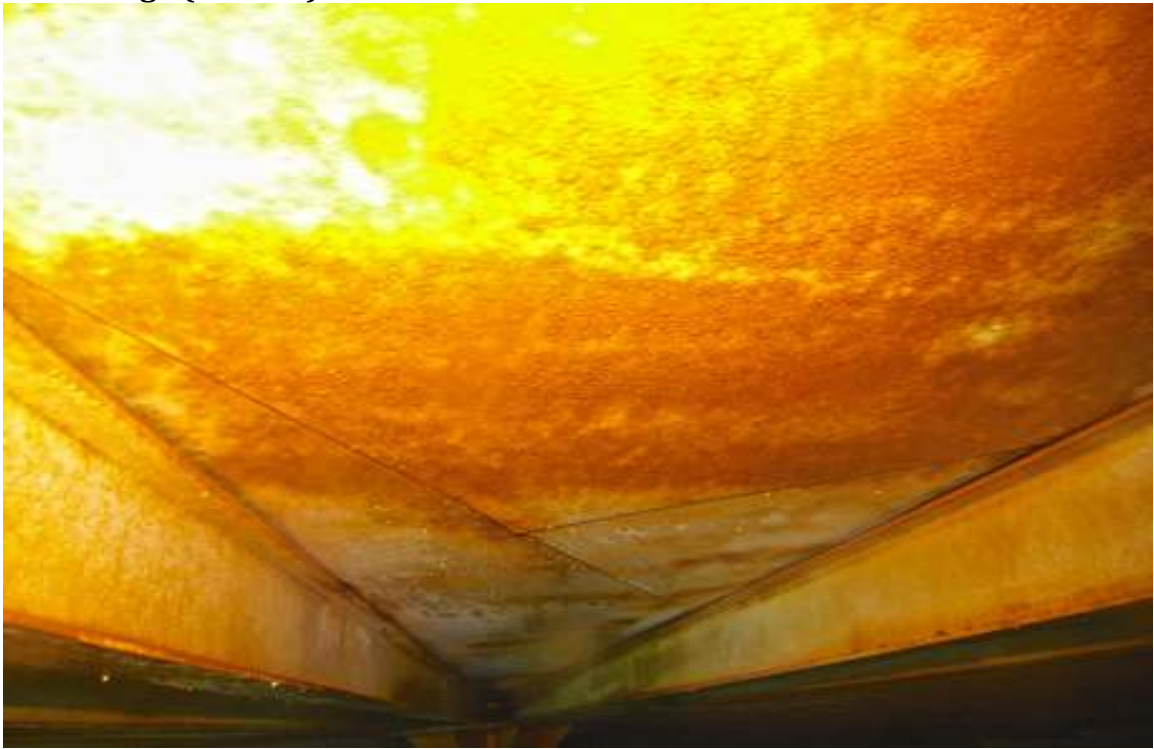
24. Ceiling - (Seismic)

- **Ceiling coating – fair condition.**
- Surface rust and rust staining throughout tank.
- Cracking & peeling in coating on beams & panels, exposing rusted steel throughout ceiling.
- No other flaws observed.

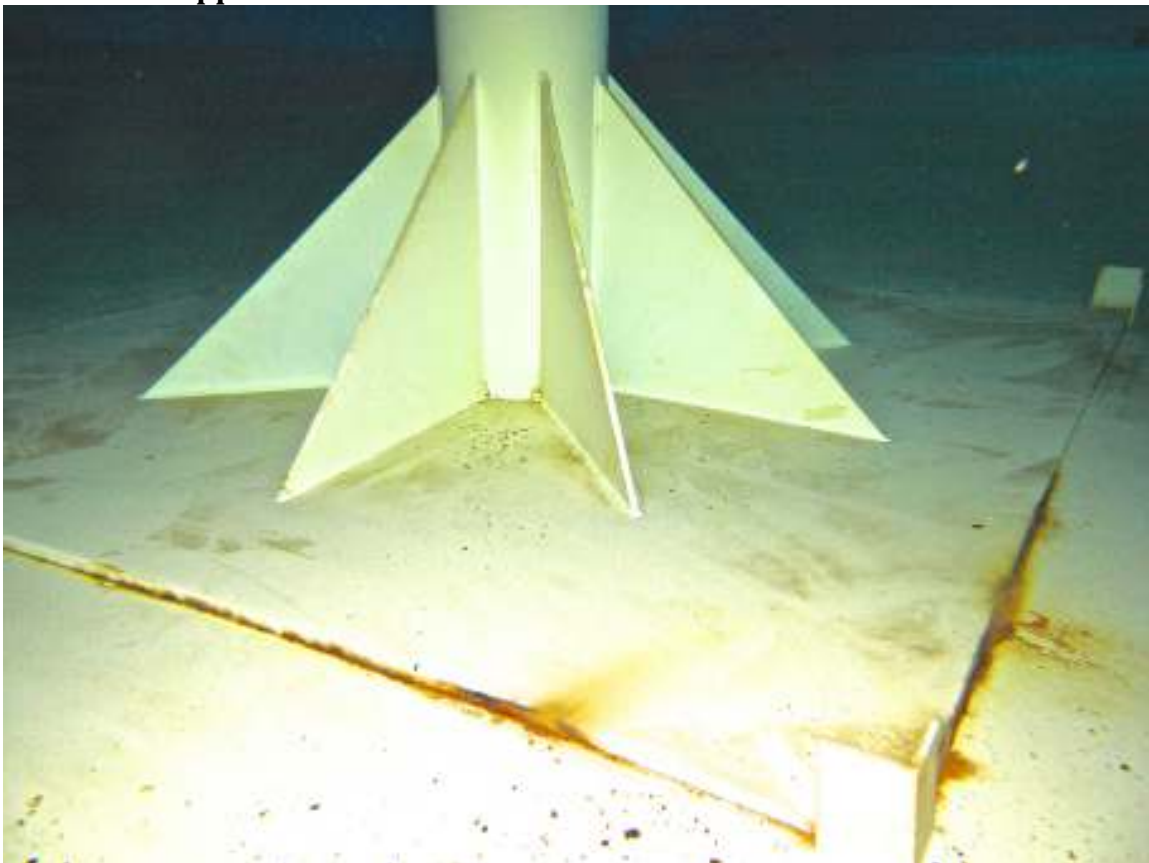
29. Center Support Pole - Base

- **1 center support pole - good condition.**
- No cracking, blisters or peeling.
- **Structurally sound with coating in good condition.**
- Rust in crevices between base and floor.
- Surface rust and rust staining on upper pole and top hat.

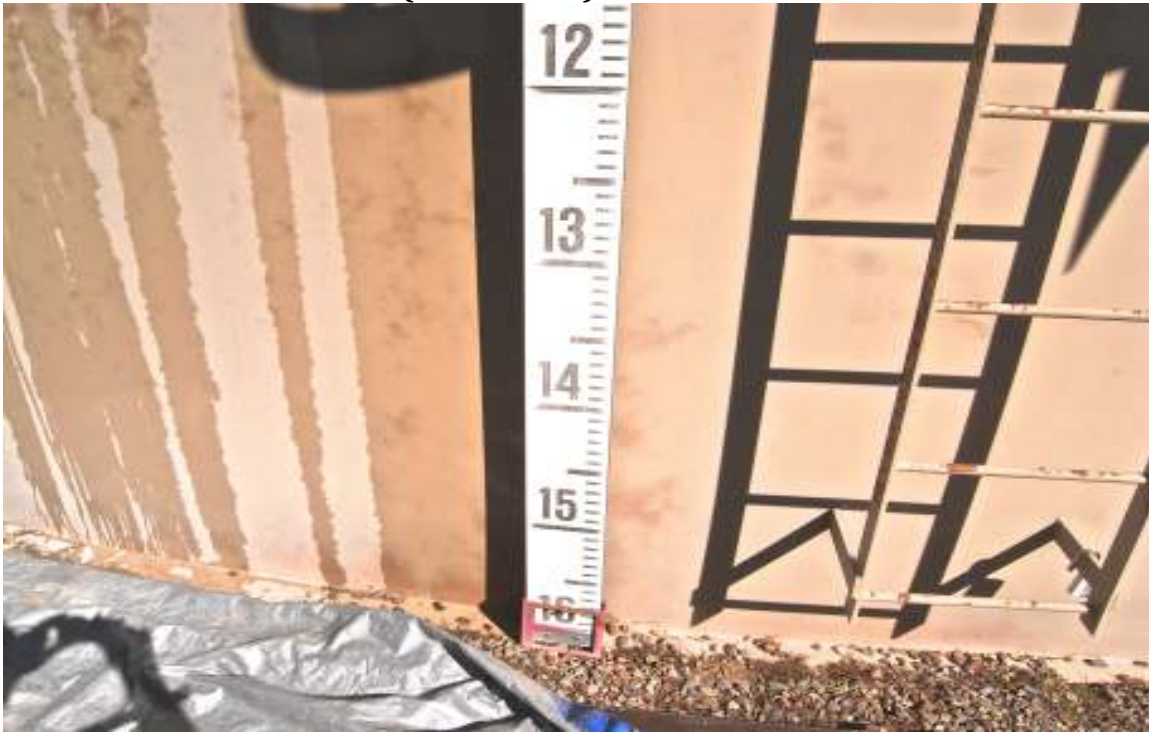
32. Water Level Indicator - (Abandoned)

- **Mechanical water level indicator - no longer in use, float removed by diver.**
- **Transducer is in good condition and appears functional and is sitting on floor.**
- Observations:
 - Ensure electronic level measurement is functioning to remain in compliance with NAC 445A.6708.7

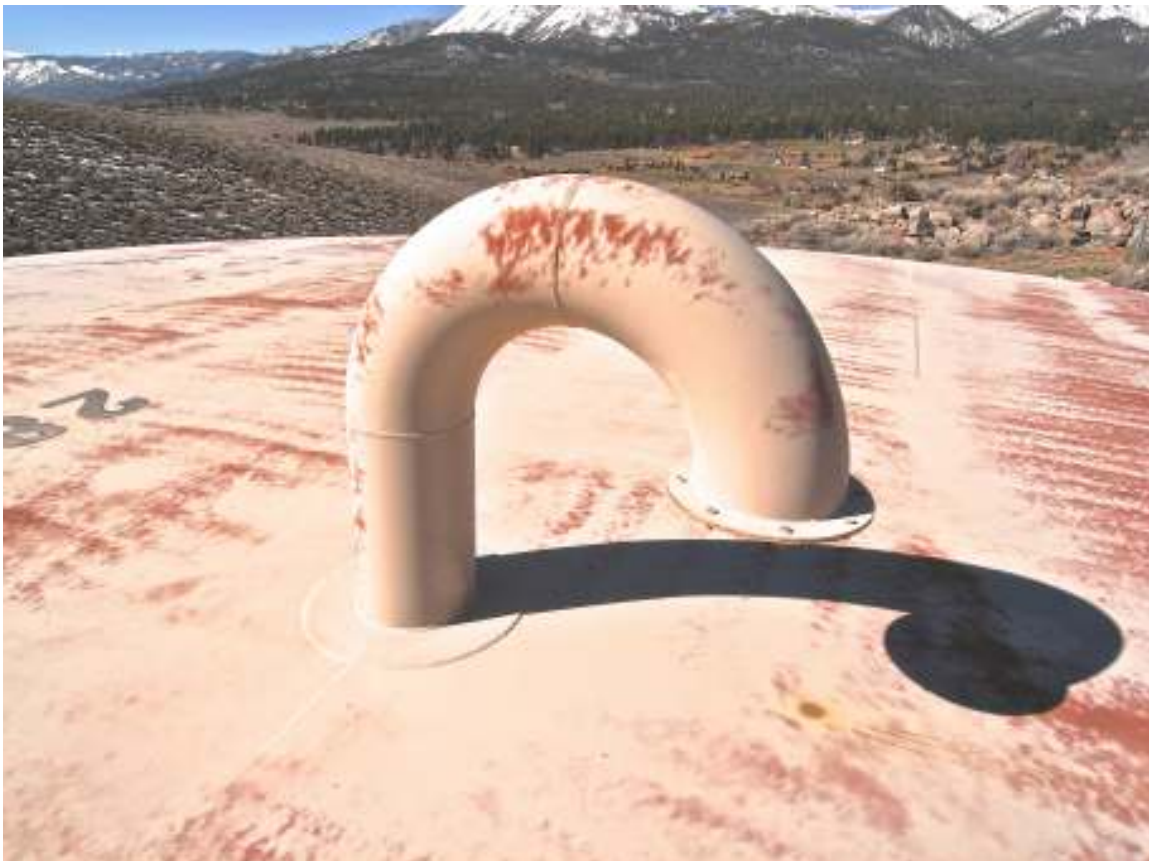
35. Center Roof Vent

- **12” diameter center roof vent - good condition - screen intact.**
- Observations:
 - Ensure screen mesh is 22-24 mesh per NAC 445A.6708.5

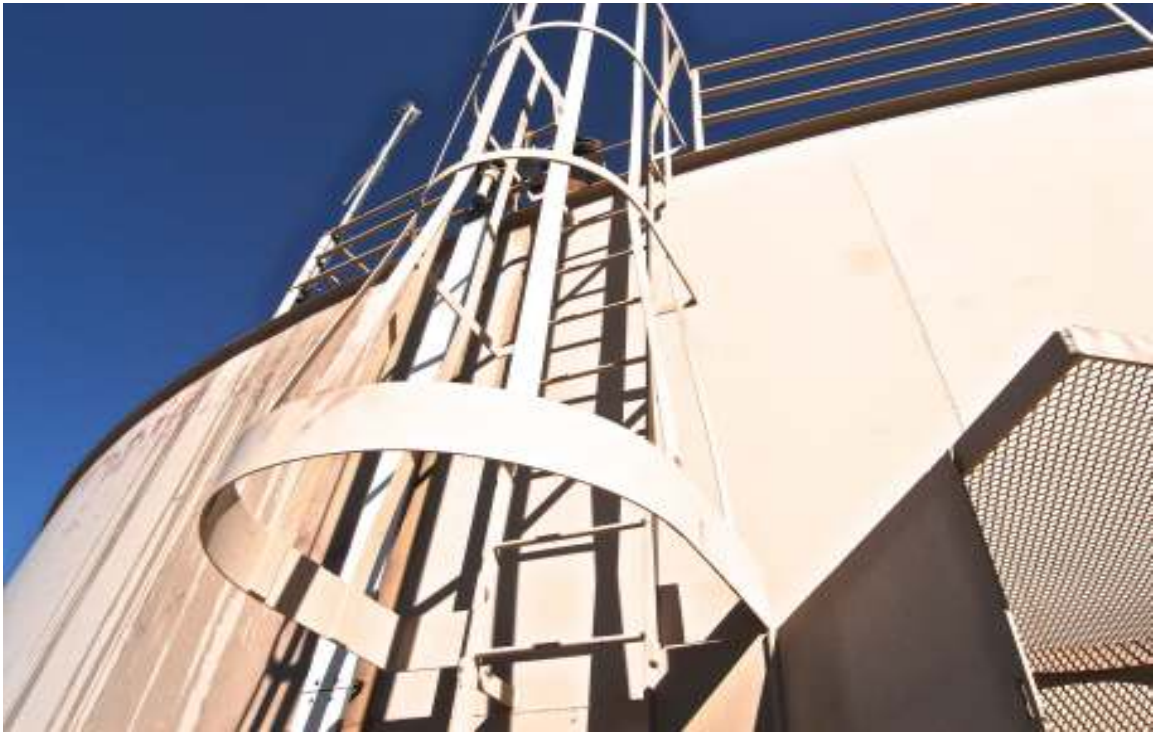
36. Exterior Ladder

- **Exterior Ladder- good condition**
- Exterior ladder is structurally sound and secure to shell.
- No flaws observed on rungs, runners or cage.
- Safety climbing device, none present.

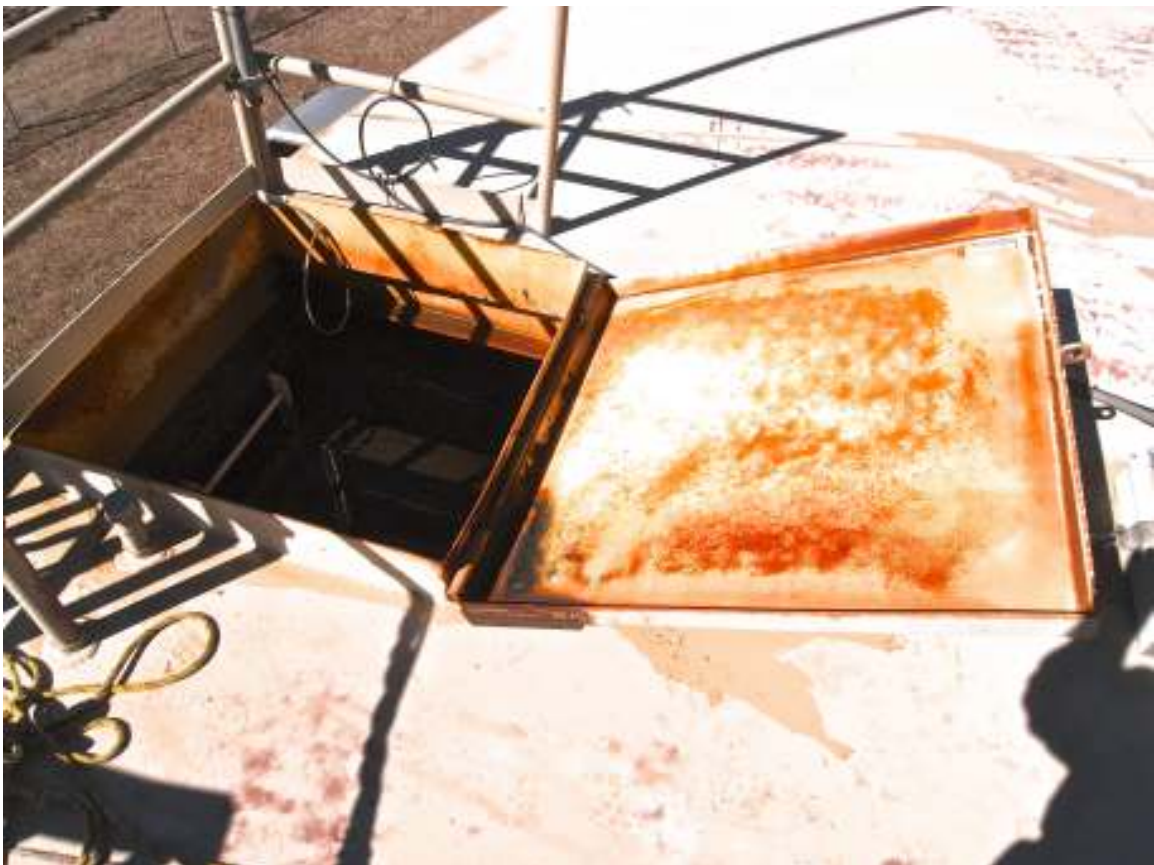
37. Access Hatch

- **36” x 36” access hatch - fair condition.**
- **Coating is in fair condition with surface rust on interior of opening and on hatch cover.**
- Observations:
 - Consider installing a gasket to ensure better seal around hatch cover.

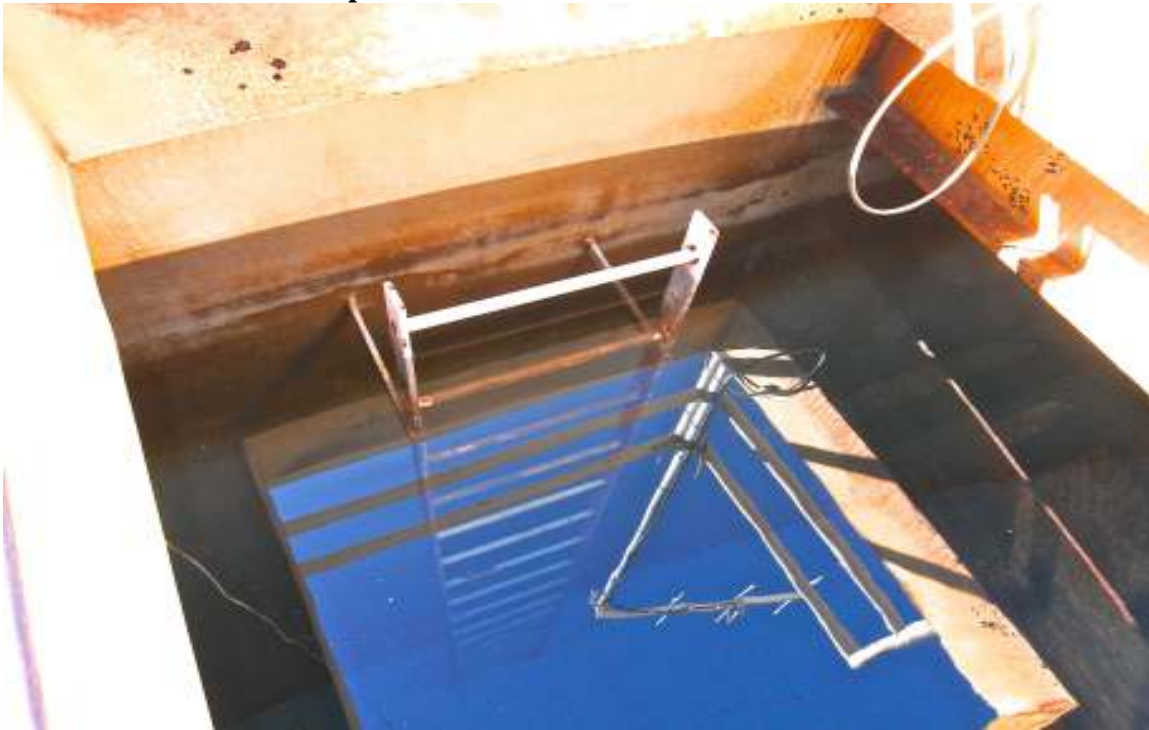
38. Interior Ladder - Top

- **Interior ladder appears to be in good condition.**
- Interior ladder is structurally sound and secure to shell.
- **Coating is in fair condition with peeling and rust observed on rungs and runners.**
- No other flaws observed.

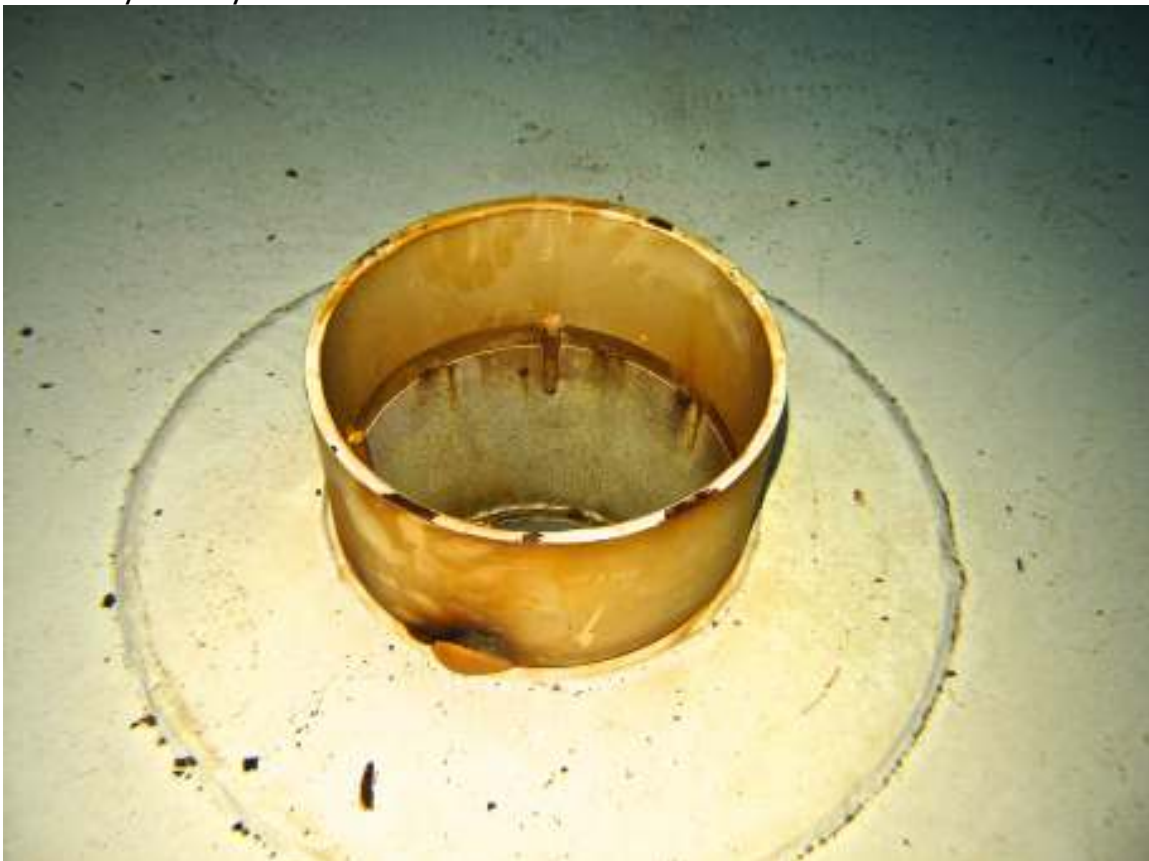
41. Inlet/Outlet/Drain

- **12” diameter penetration & mud-guard - good condition and unobstructed.**
- Rust spots on mud-guard and in crevice on penetration edge.
- No other flaws observed.

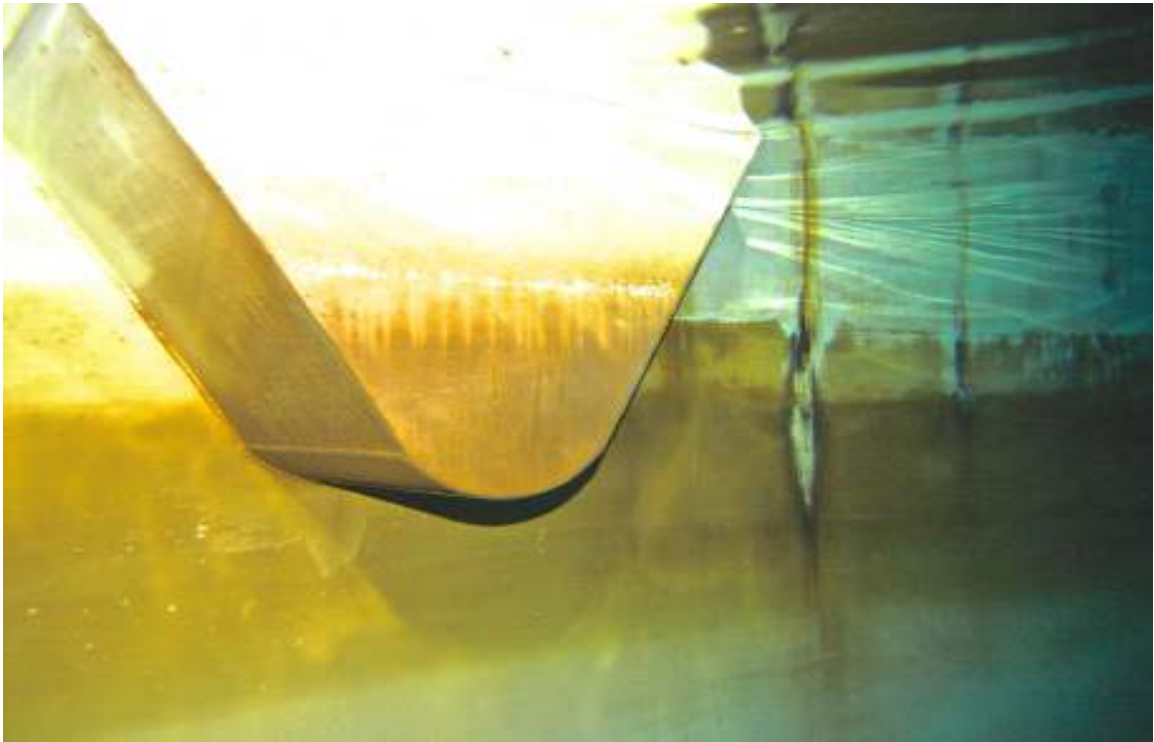
44. Overflow Box

- **12” diameter overflow pipe – sound and unobstructed - good condition.**
- Surface staining on lower half of overflow box.
- No other flaws observed.

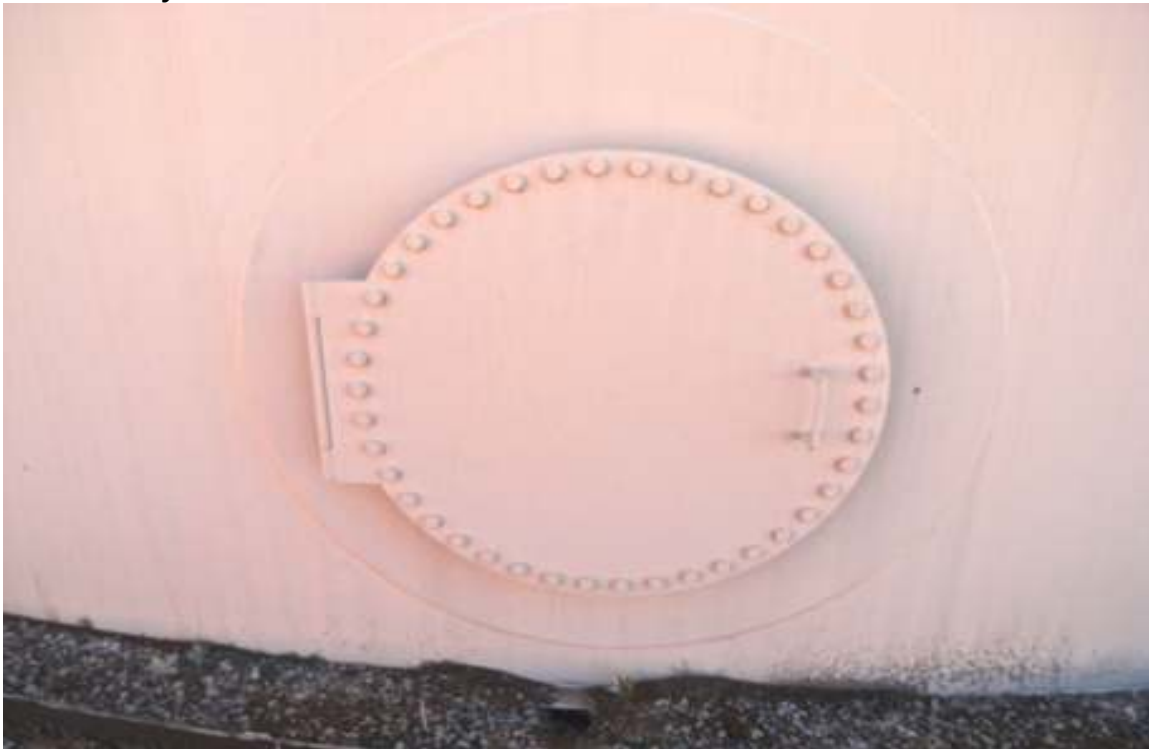
46. Manway #1

- **2 @ 30" diameter manways – good condition**
- Seals appear to be intact.
- Rust spots in crevices at seals in both manways.
- No other flaws observed.
