Northgate Reservoir #1

Northgate Reservoir #1
04-18-2018

Blue Locker Diving - Photo Documentation

Horizon Hills #1

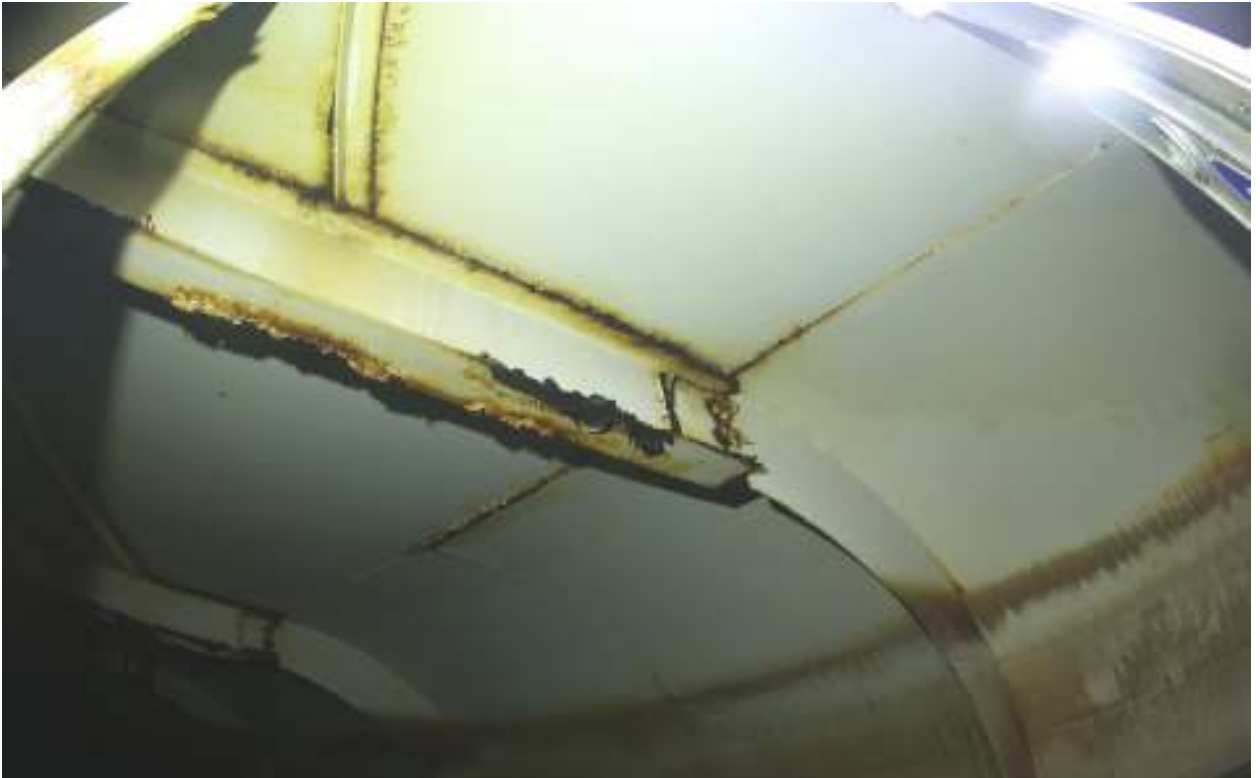
23. Ceiling At Shell

- **Ceiling – Coating is in poor condition.**
- **Cracking and peeling on beams exposing rusted steel.**
- Steel on beams is beginning to delaminate.
- Rust and rust staining on ceiling panels and on beams near center.
- Observations:
 - Blast and recoat is recommended due to the condition of coating on ceiling.
 - Prepare funding for a blast and recoat and check the condition of the beams prior to performing work. (Delamination of the steel is occurring)
 - Use caution when walking on top of reservoir.

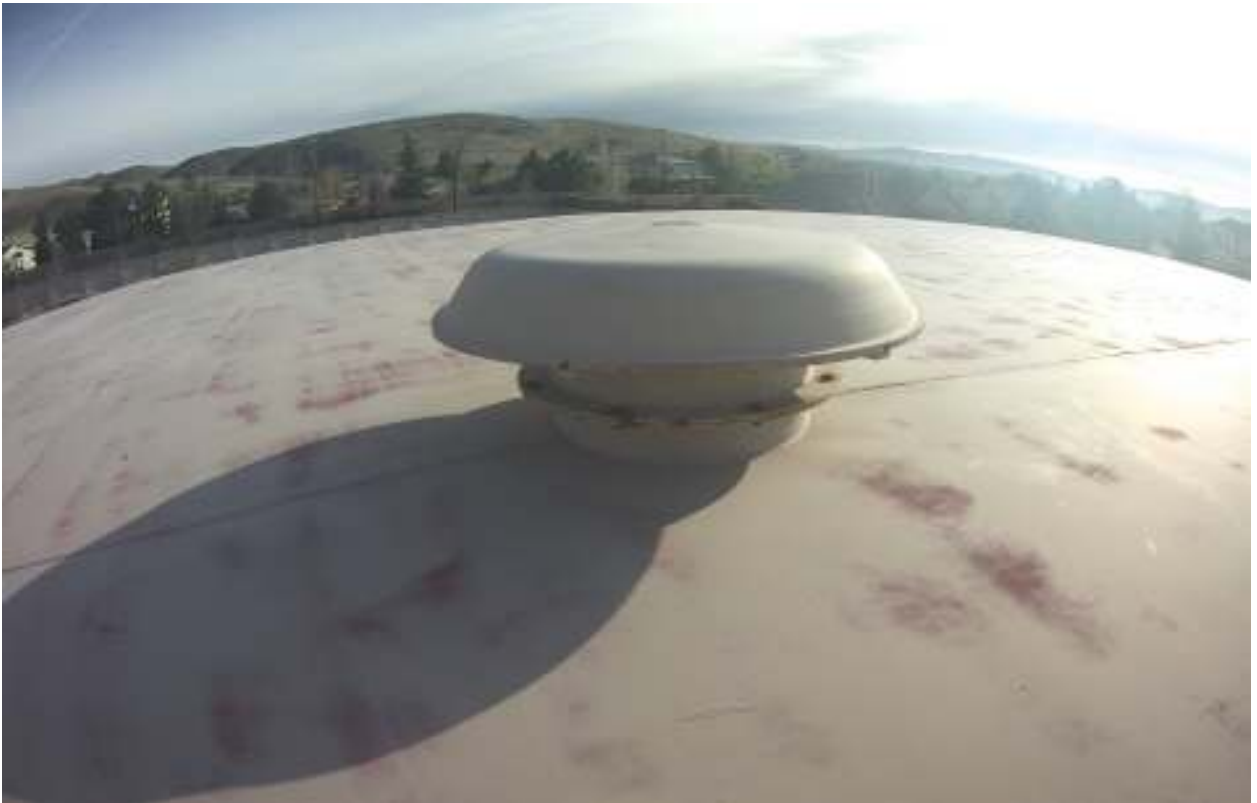
41. Center Roof Vent

- **Center Roof Vent –24” diameter is in good condition with screen intact.**
- Observations:
 - Ensure screen mesh is 22-24 mesh per NAC 445A.6708.5

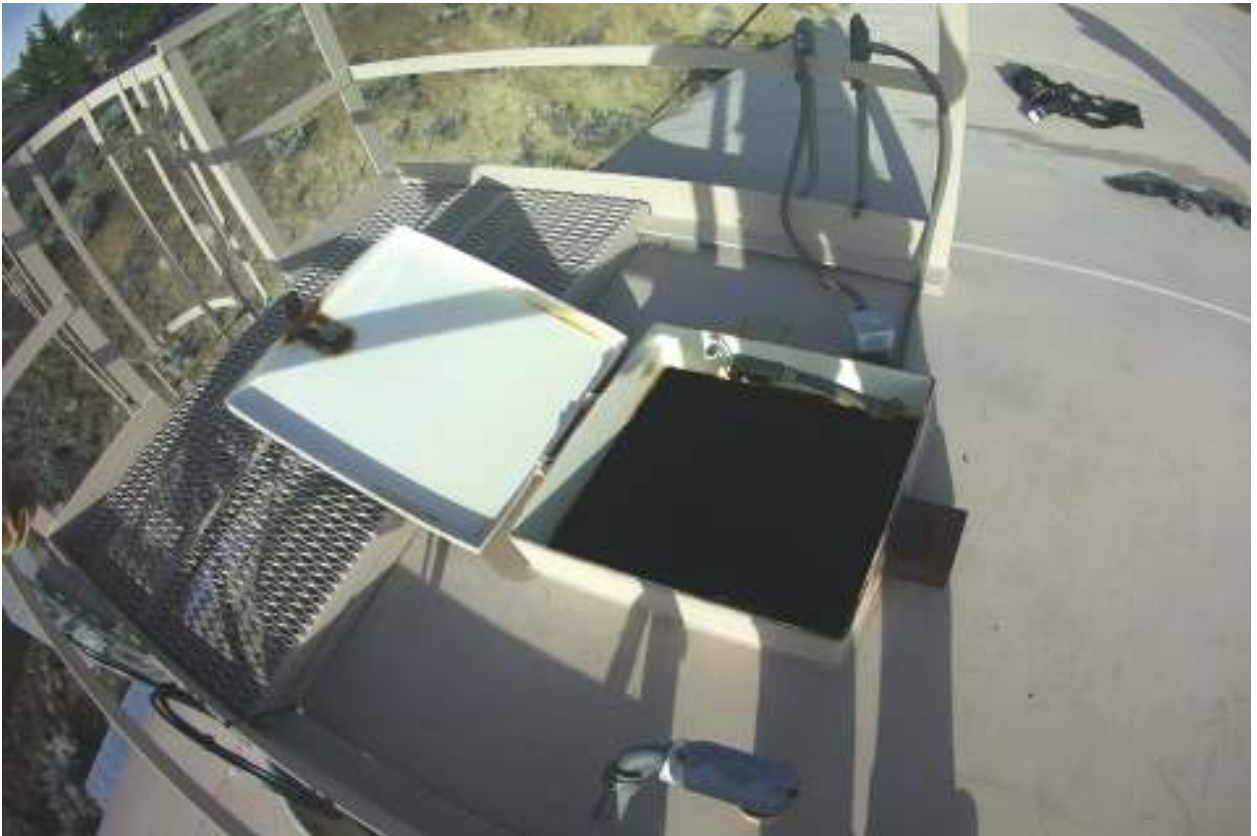
43. Access Hatch

- **Access Hatch – 24” x 24” diameter in good condition with rust on opening edge and on cover where it hits opening edge. (No Gasket)**
- Observations:
 - Consider installing a gasket to ensure better seal around hatch cover.

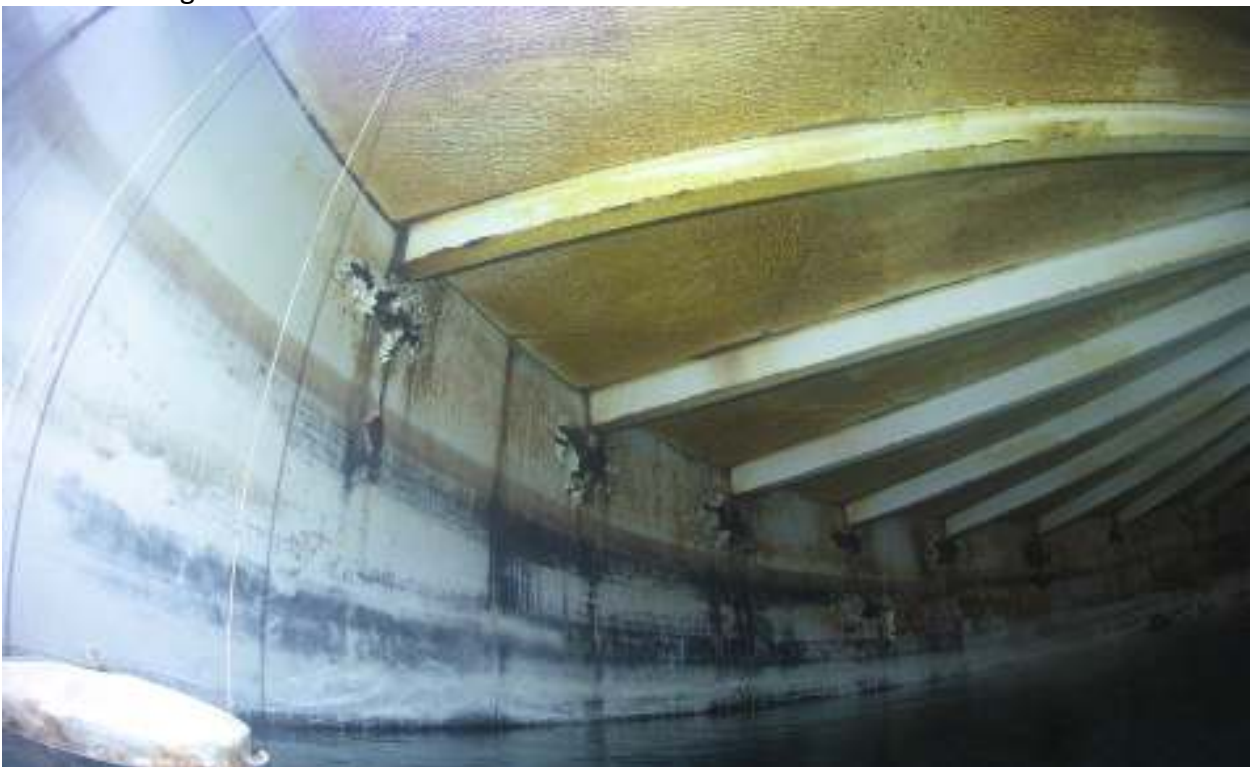
20. Shell At Ceiling - South Side

- **Interior coating – poor condition.**
- Alligator cracking and peeling of coating in Ring #3 and mostly on south ½” of reservoir, exposing rusted steel.
- Isolated rust spots and patches of blisters on bottom 2 rings along with heavy sediment staining.
- Observations:
 - This reservoir is overdue for a blast and recoat.
 - Put this one at the top of the list for interior coating rehabilitation.

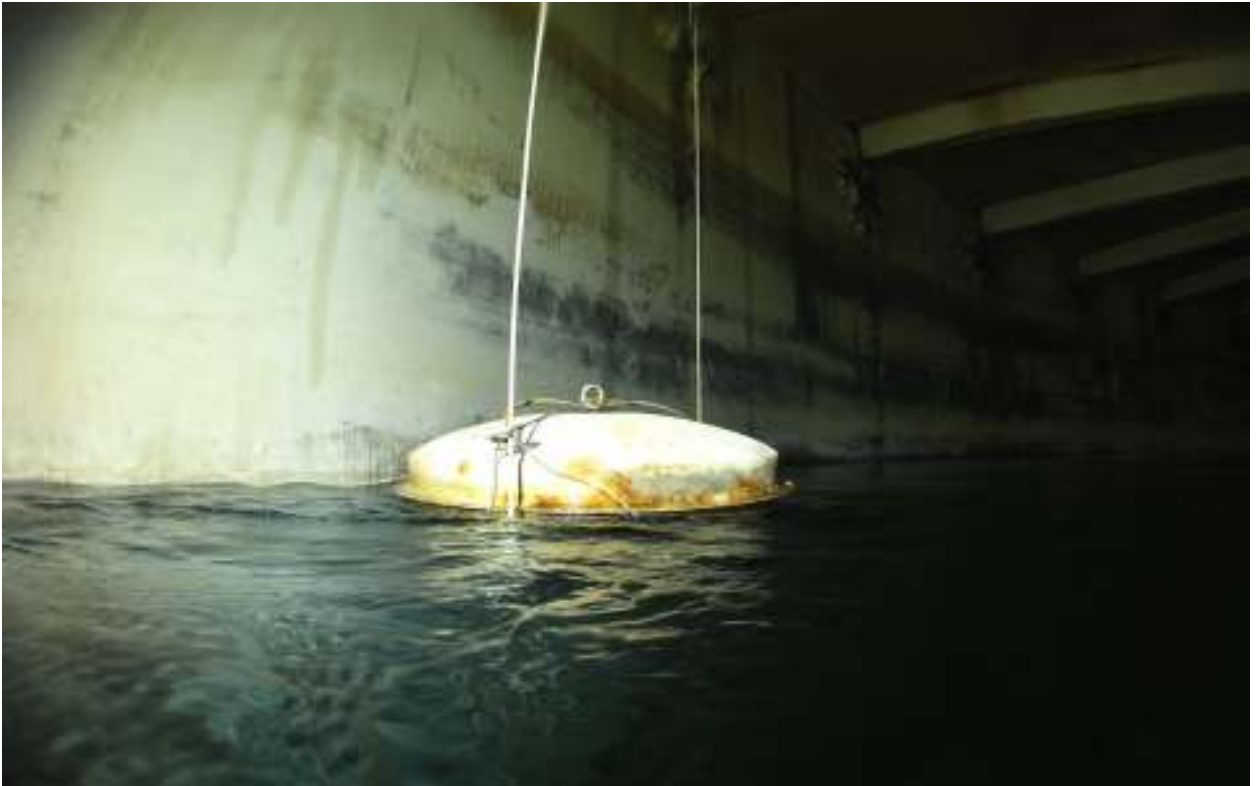
32. W.L.I. Float At Surface - Abandoned

- **Mechanical W.L.I. is no longer in service with float wire broken.**
- **W.L.L. Transducer at 12:00 position is in good condition and touching floor.**
- Observations:
 - Ensure electronic level measurement is functioning to remain in compliance with NAC 445A.6708.7
 - Install a new guide wire for float assembly at tank rehab.

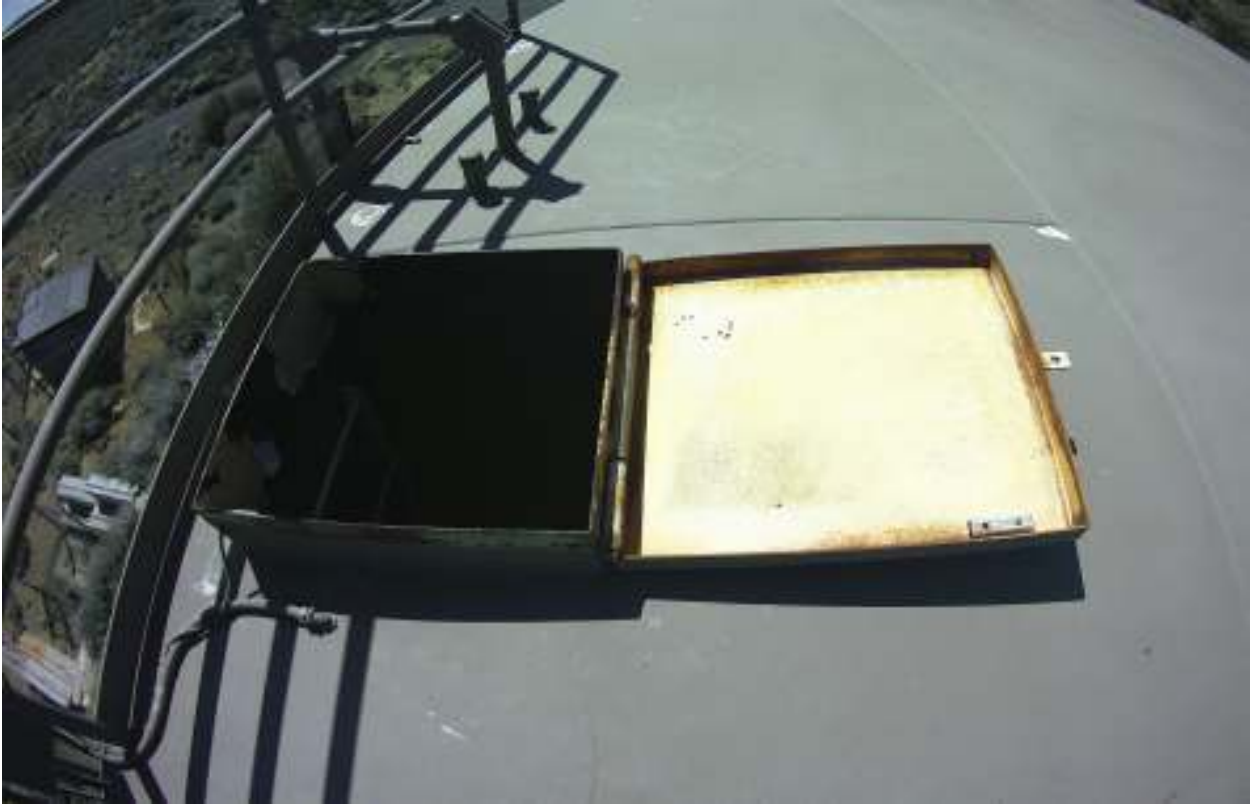
37. Access Hatch

- **24” x 24” Access hatch with cracking and peeling of coating around interior of opening exposing rusted steel.**
- Rust and rust staining on hatch cover. (No gasket)
- Observations:
 - Consider installing a gasket to ensure better seal around hatch cover.
 - See shell.

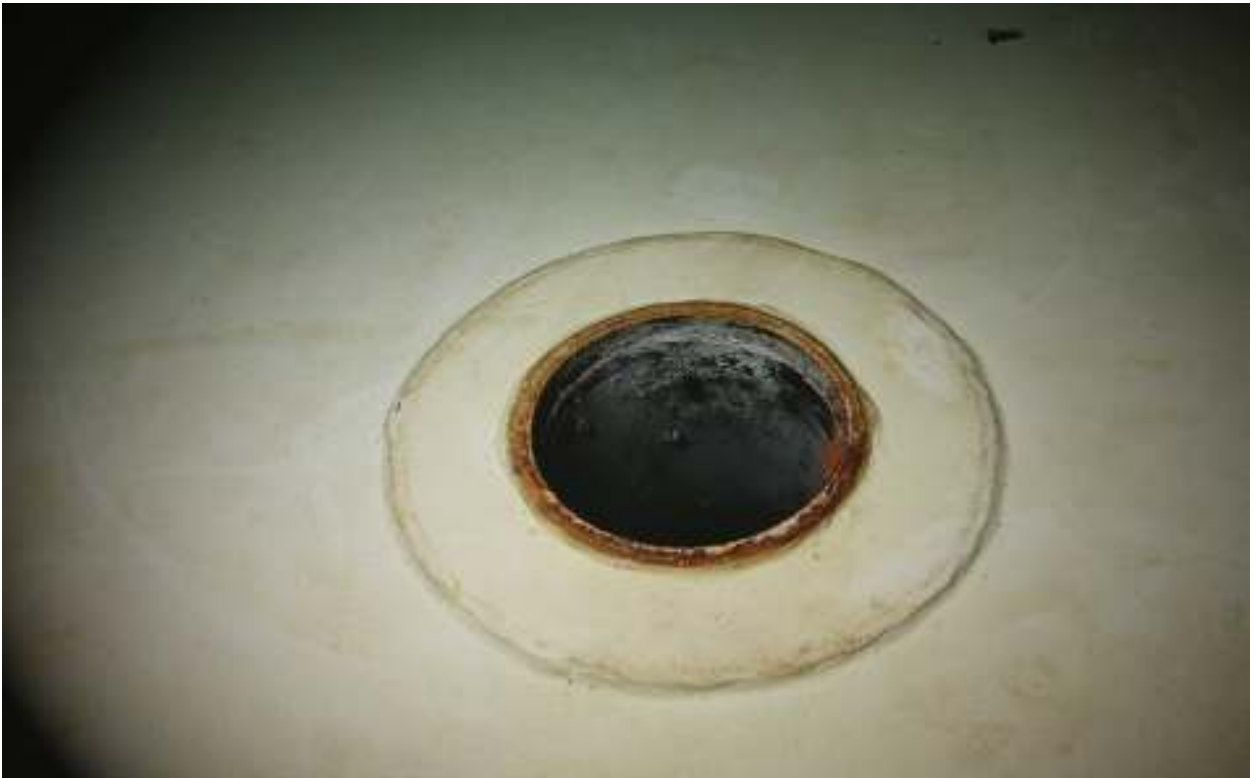
42. Drain

- **4” Diameter opening with no mud-guard - good condition and unobstructed.**
- Rust spots around opening edge and heavy sediment staining on interior.
- Observations:
 - NA.
