## 2019 APWA Project of the Year Nomination – Historical Restoration / Preservation

### *Fleish Flume, Overflow and Tailpiece Replacement*

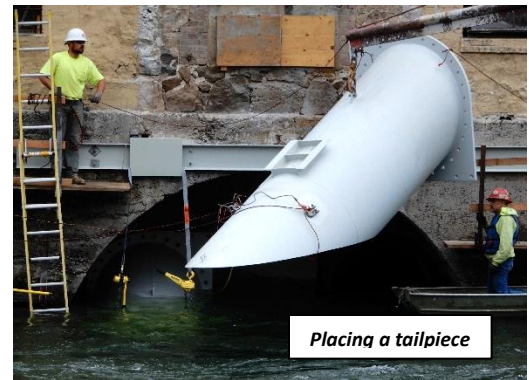
*Placing a tailpiece*

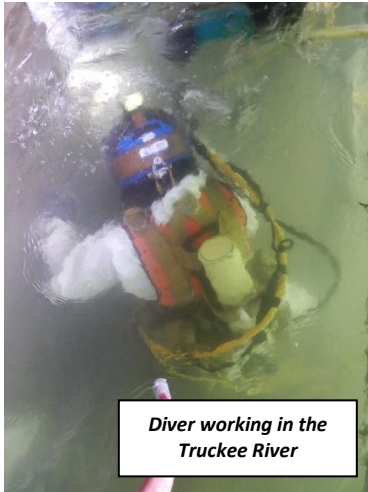
*Diver working in the Truckee River*

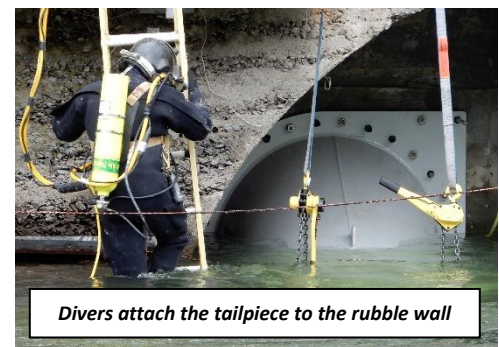
*Divers attach the tailpiece to the rubble wall*

Attaching 2,500 lb. pipes to a 114-year old rubble masonry wall underwater also presented a massive challenge. The divers drilled into the wall utilizing templates that matched the bolt pattern on the new flanges. Underwater epoxy was injected prior to insertion of the new anchor bolts. With no room for error, the bolts had to be straight, level and plumb to match the holes on the flanges.

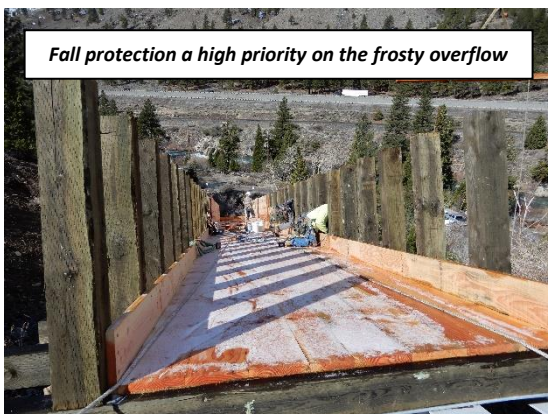
*Fall protection a high priority on the frosty overflow*
