Blue Locker

Community College Reservoir

05-19-2017

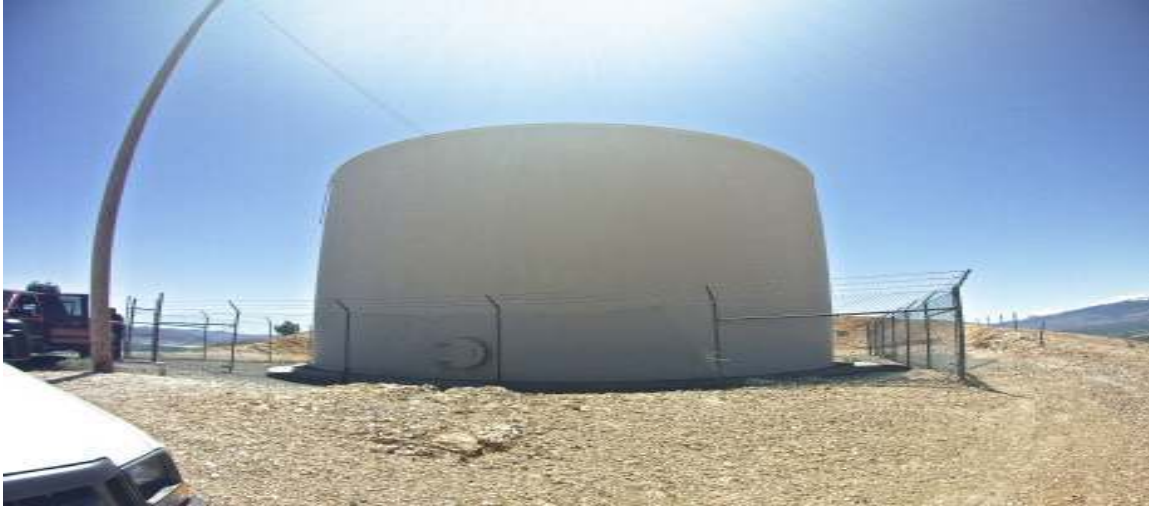
2. Exterior Shell

- **Coating - Poor condition.**
- Alligator cracking in top 2 rings with rust seeping thru all around tank.
- Rust spots in bottom ring due to holidays in the coating.
- No blisters observed.
- Coating is failing in isolated areas in all 4 rings.
- Recommendations:
 - This tank is a good candidate for a blast and recoat in the near future.

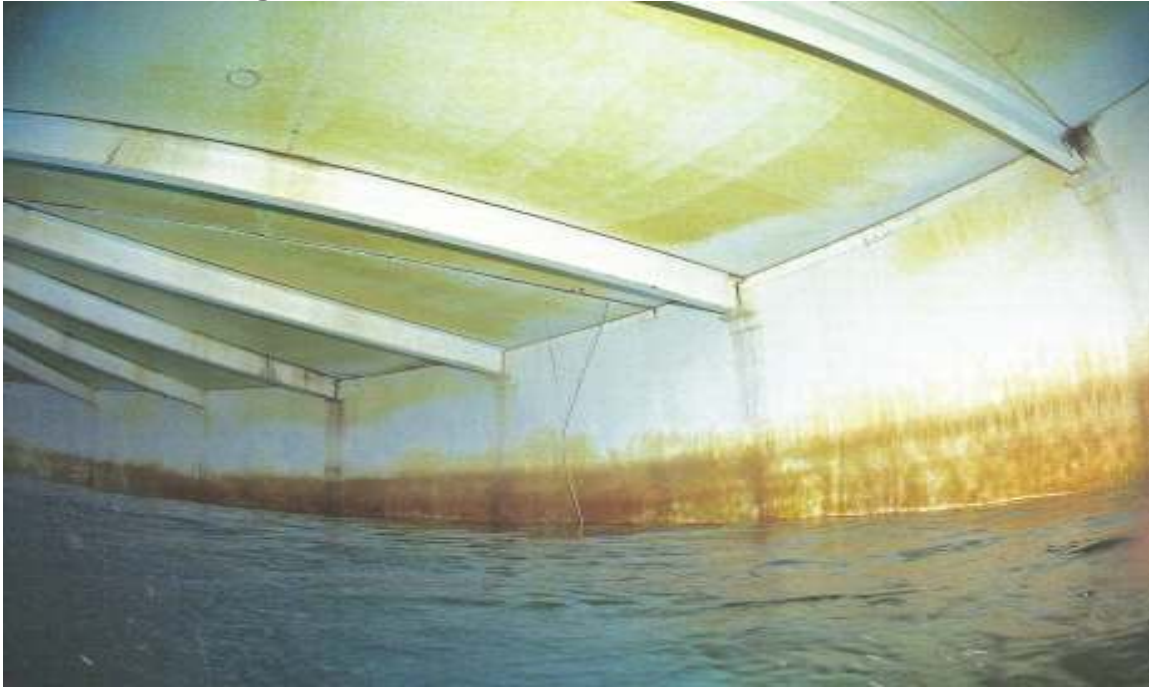
26. Ceiling - (Seismic)

- **Coating - Good condition.**
- No peeling or blisters observed.
- Surface rust on ceiling panels may indicate alligator cracking similar to upper half of shell.
- Rust and rust staining in crevices at beams.
- Recommendations:
 - See shell.

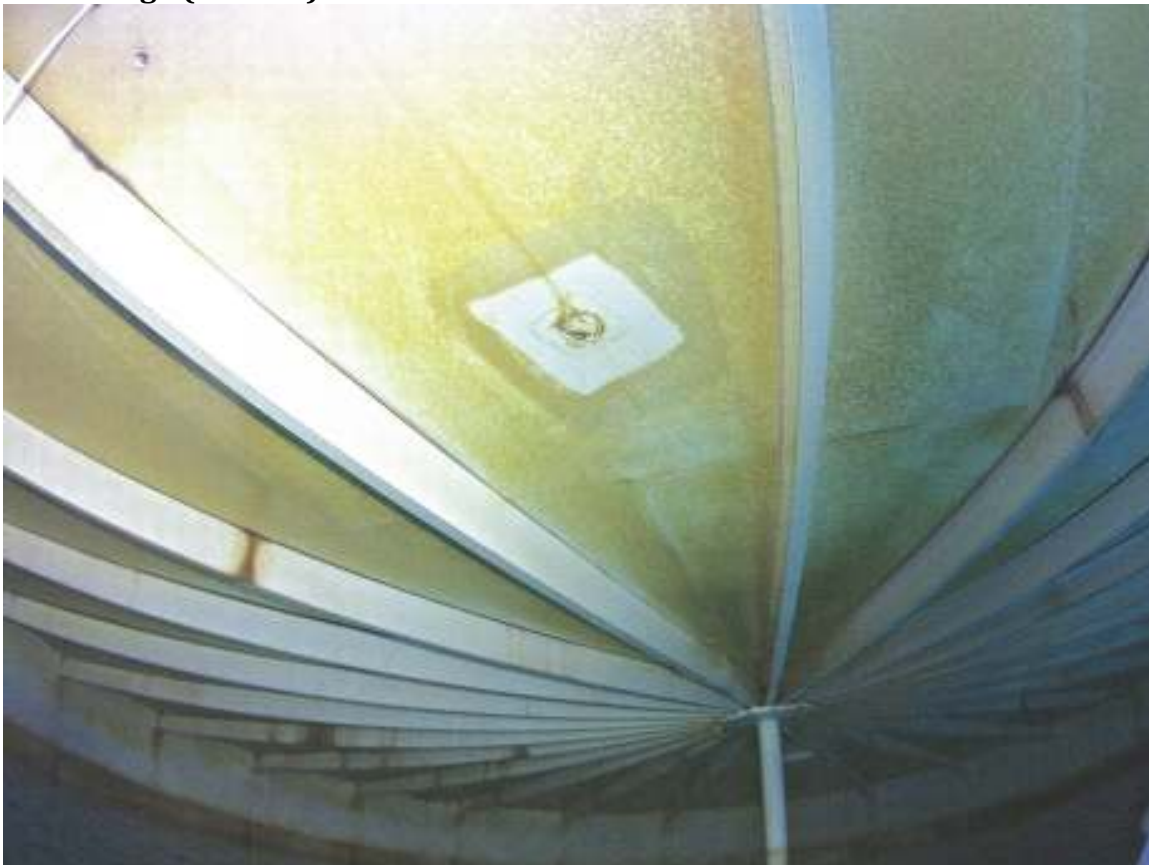
27. Ceiling with Roof Vent

- **24" diameter - Roof vent - Good condition with screen intact and secure.**
- Recommendations:
 - Ensure screen mesh is 22-24 mesh per NAC 445A.6708.5

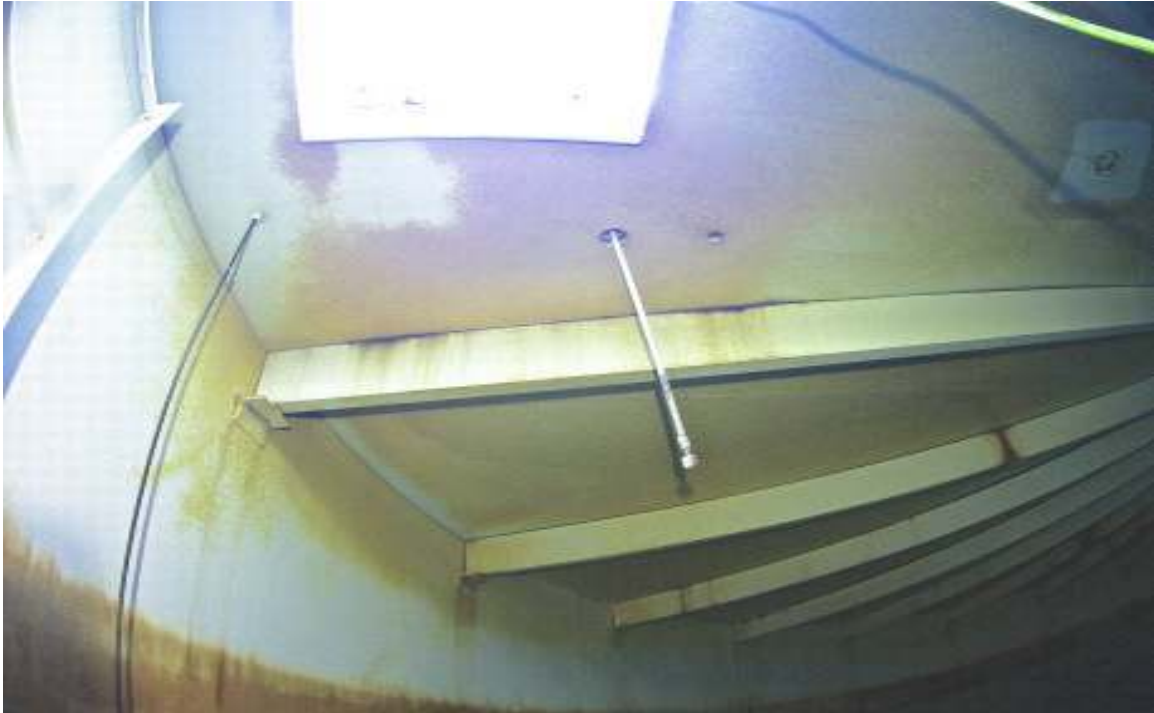
- **W.L.I. Transducer appears functional.**
- Transducer is touching floor.
- **Water level sensor at 12:00 position in ceiling appears functional.**
- **Mechanical W.L.I. has been abandoned with no float in reservoir & guide wires broken.**
- Recommendations:
 - None.

36. Mechanical W.L.I. - Abandoned

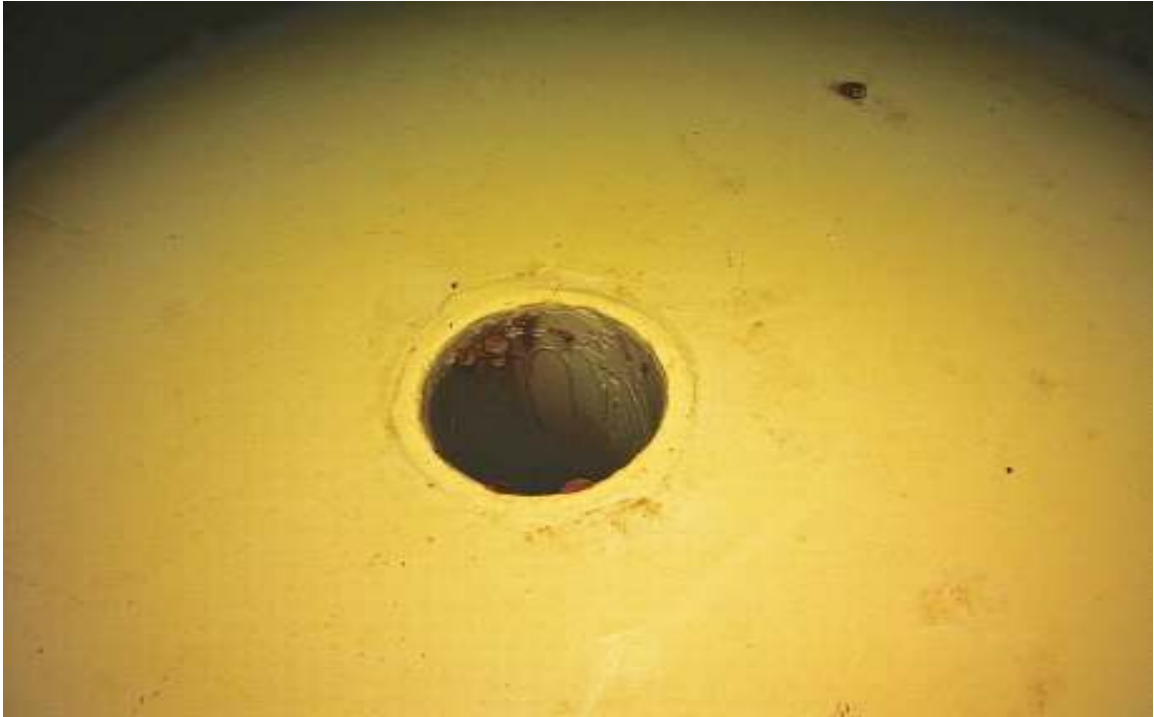
44. Overflow - Bottom

- **10” diameter Overflow - Good condition.**
- No flaws observed on interior overflow box or exterior pipe.
- Recommendations:
 - None.
