Desert Springs #3

04-11-2016

On April 11th, 2016, Blue Locker Commercial Diving Services, L.L.C. performed a cleaning and inspection of the Desert Springs #3 reservoir for Truckee Meadows Water Authority. This report, along with the provided video, documents the findings of the inspection. All observations are observed strictly for your own considerations.

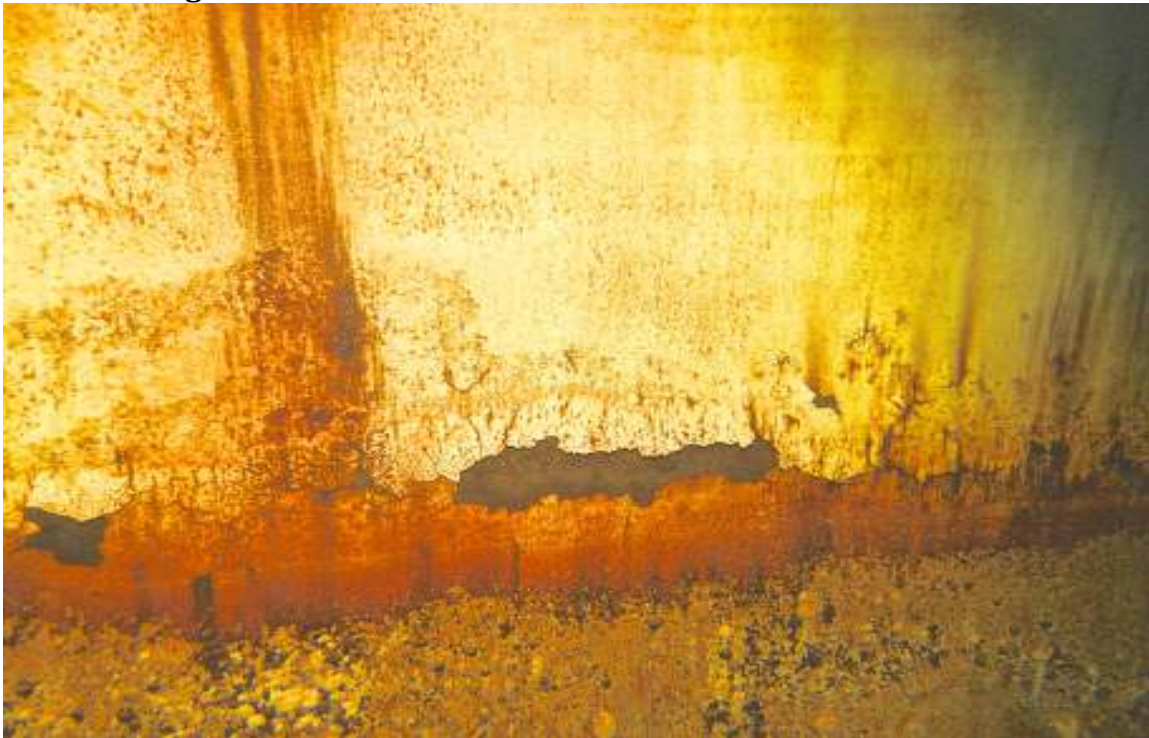
21. Shell Ring #3

- **Coating - poor condition.**
- Cracking and peeling in rings #1 & #3 of quadrant A, exposing rusted steel.
- Rust spots and rust nodules in all three rings throughout tank, worst in quadrants A & D.

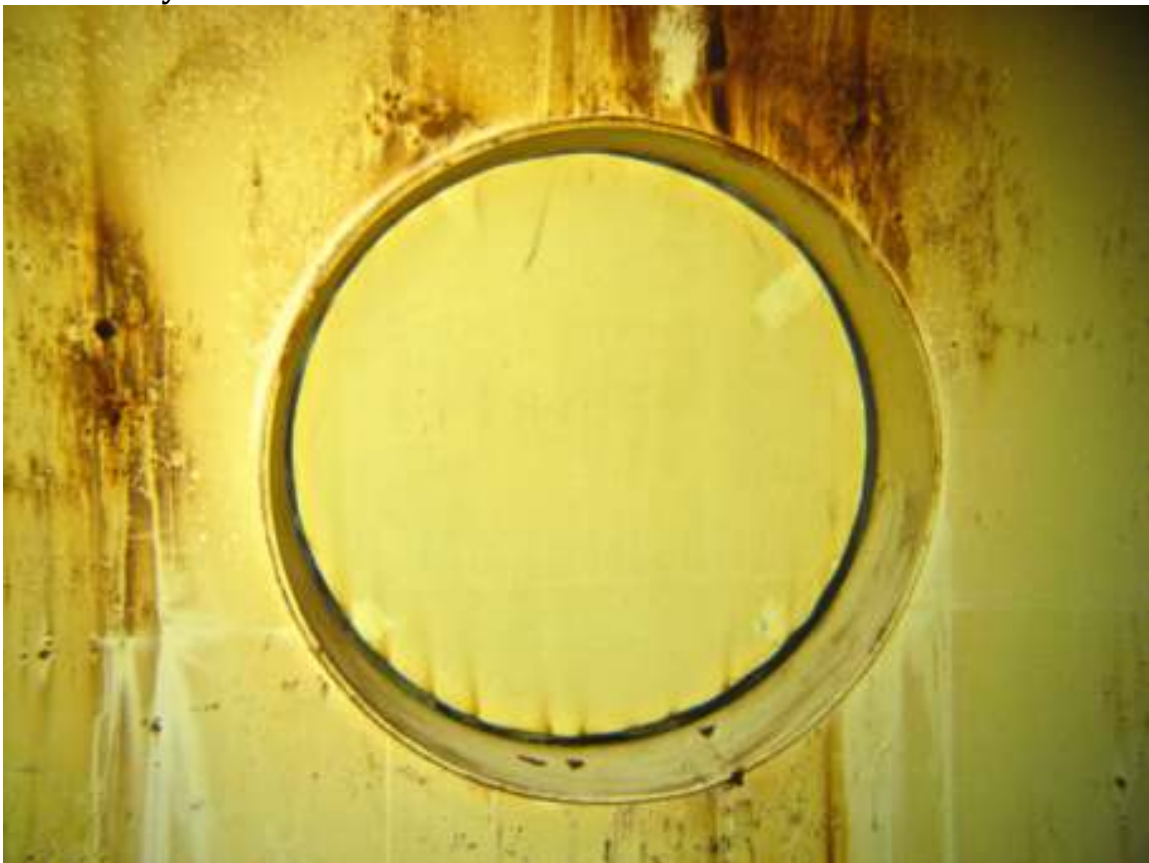
52. Manway #2

- **2 @ 30” diameter manways - good condition.**
- Seals appear to be intact.
- Rust observed on both manways around outside edges.
- No other flaws observed.
