T.M.W.A.

Mt. Rose #2

03-31-2016

On March 31st, 2016, Blue Locker Commercial Diving Services, L.L.C. performed a cleaning and inspection of the Mt. Rose #2 reservoir for Truckee Meadows Water Authority. This report, along with the provided video, documents the findings of the inspection. All observations are observed strictly for your own considerations.

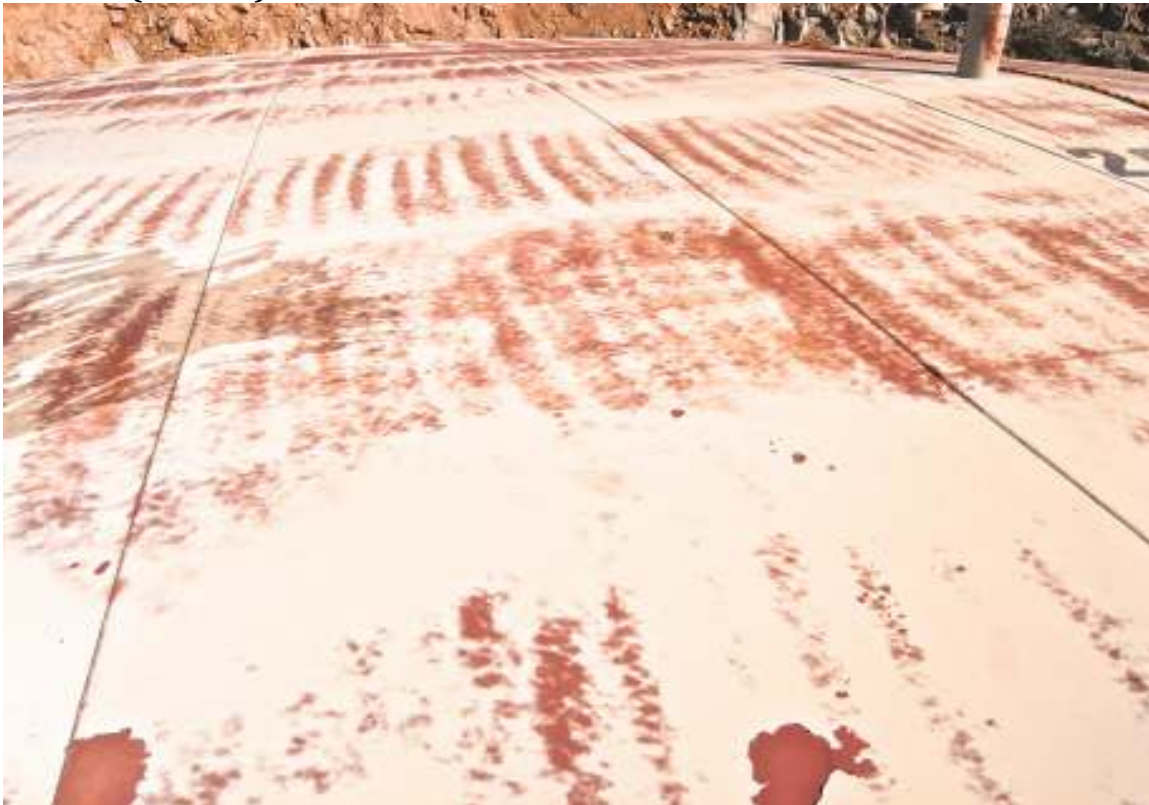
7. Floor

- **Floor coating – good condition.**
- No flaws observed through sediment.
- Less than 1/8th" of sediment was not removed by diver prior to inspection.
- No other flaws observed.

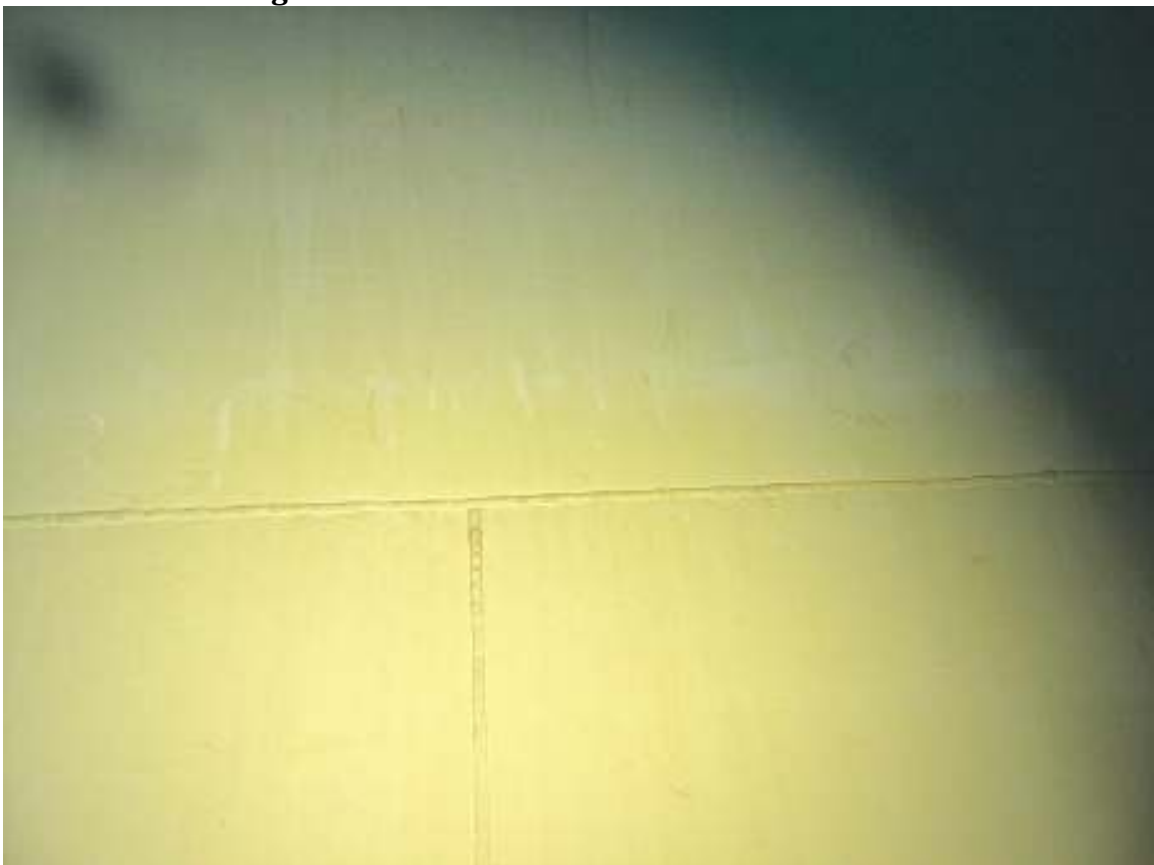
20. Shell Ring #2

- **Interior coating – good condition.**
- No blisters, cracking, peeling or rust observed.
- Rust staining and sediment staining observed in ring #2
- No other flaws observed.

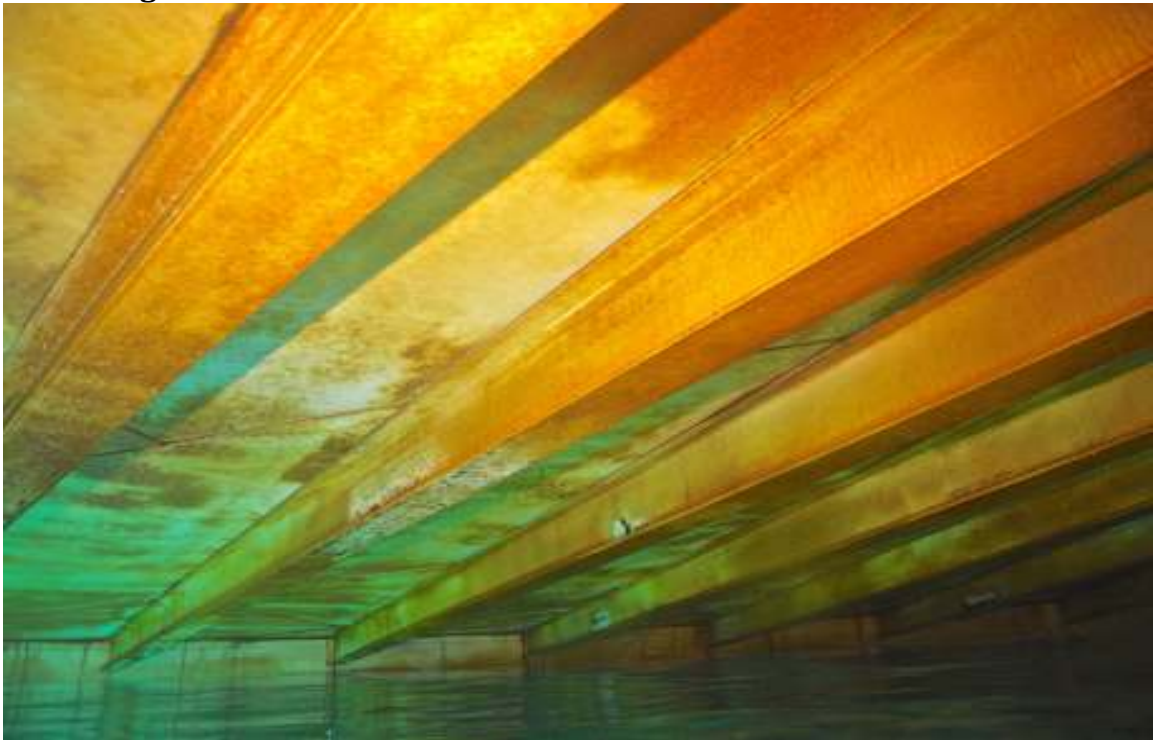
27. Ceiling

- **Ceiling coating – fair condition.**
- Surface rust and rust staining throughout tank.
- Cracking & peeling in coating on beams & panels, exposing rusted steel throughout ceiling.
- No other flaws observed.

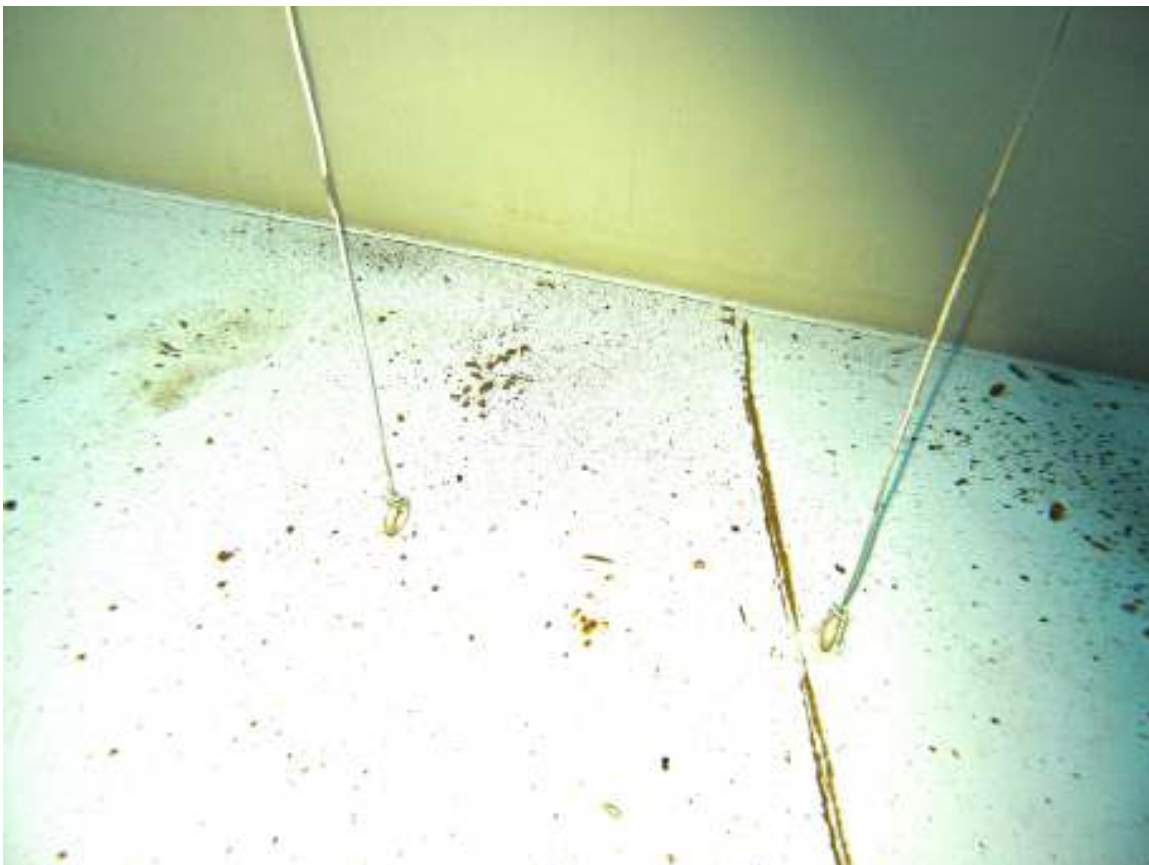
34. Transducer

- **Mechanical water level indicator - no longer in use, float removed by diver.**
- **Transducer is in good condition and appears functional and is sitting on floor.**
- Observations:
 - Ensure electronic level measurement is functioning to remain in compliance with NAC 445A.6708.7

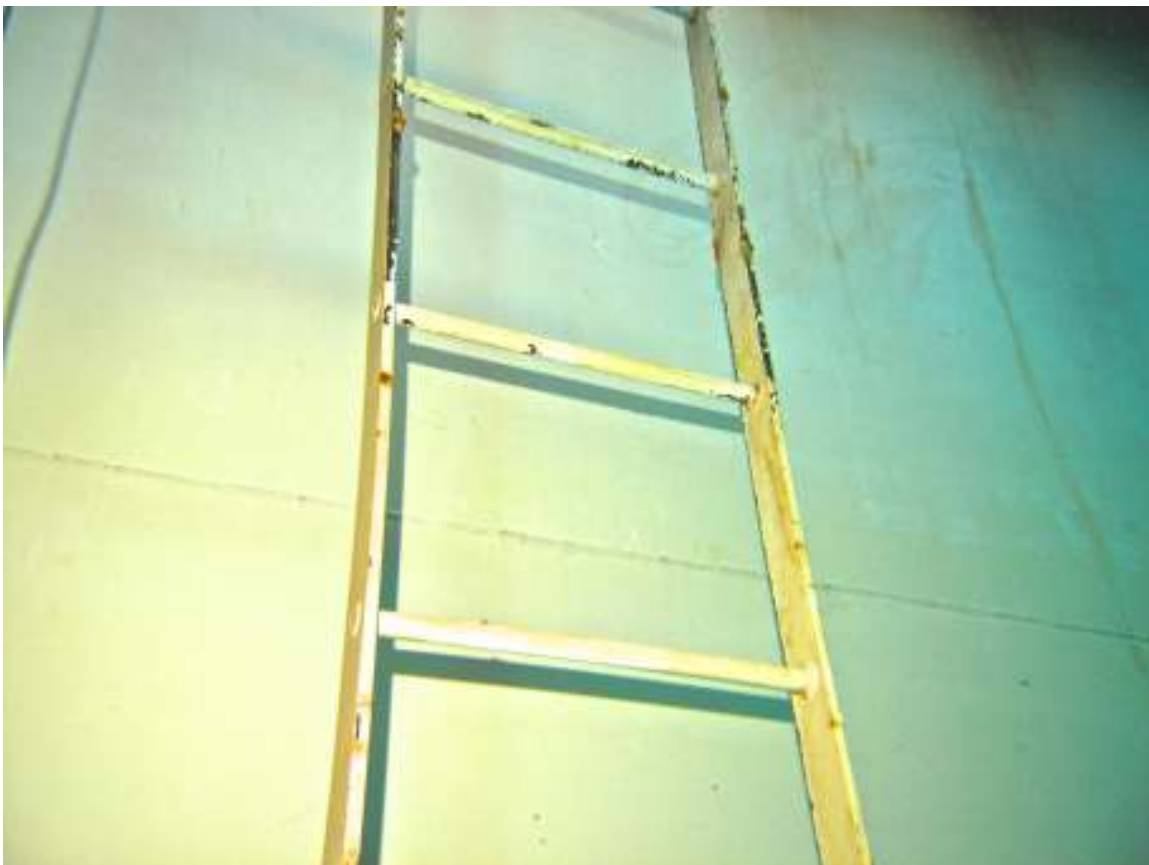
40. Interior Ladder - Bottom

- **Interior ladder appears to be in good condition.**
- Interior ladder is structurally sound and secure to shell.
- **Coating is in fair condition with peeling and rust observed on rungs and runners.**
- No other flaws observed.

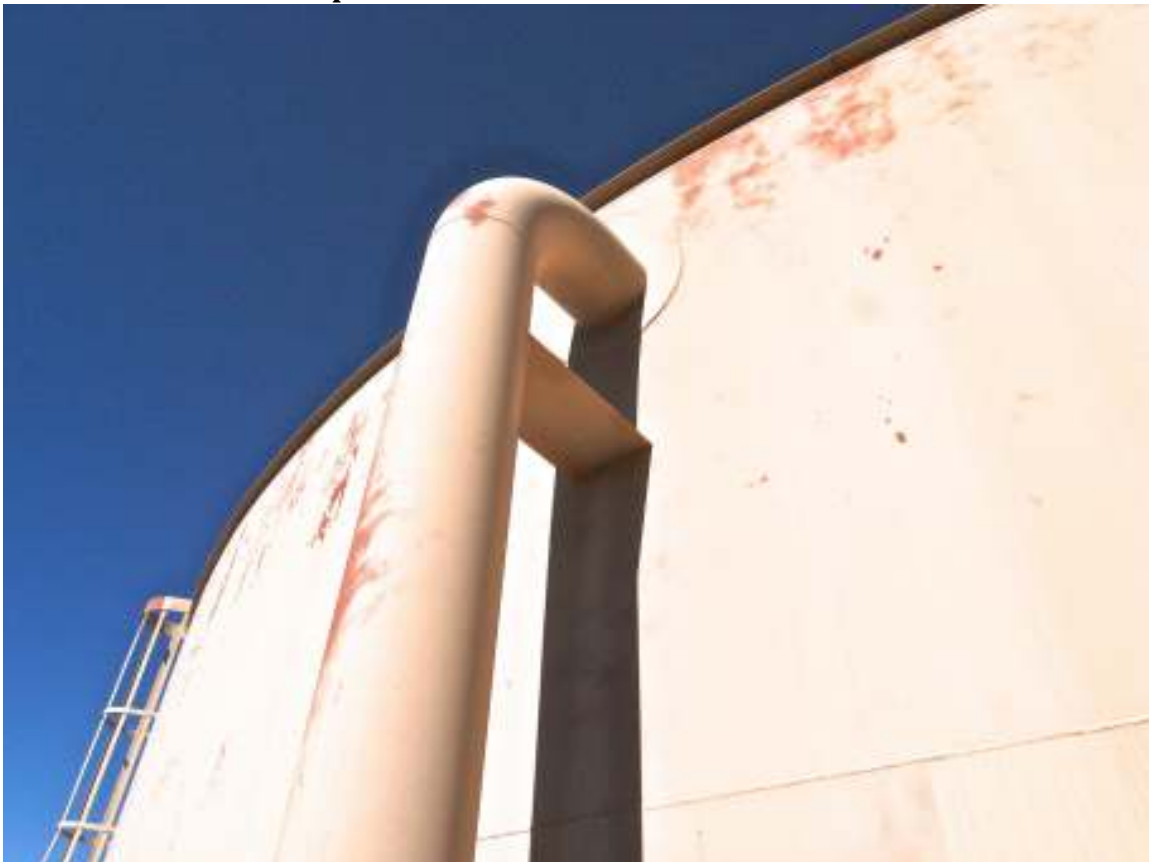
44. Overflow Box

- **12” diameter overflow pipe – sound and unobstructed - good condition.**
- Surface staining on lower half of overflow box.
- No other flaws observed.
