Northgate Reservoir #1

Northgate Reservoir #1
04-18-2018

Blue Locker Diving - Photo Documentation

Horizon Hills #1

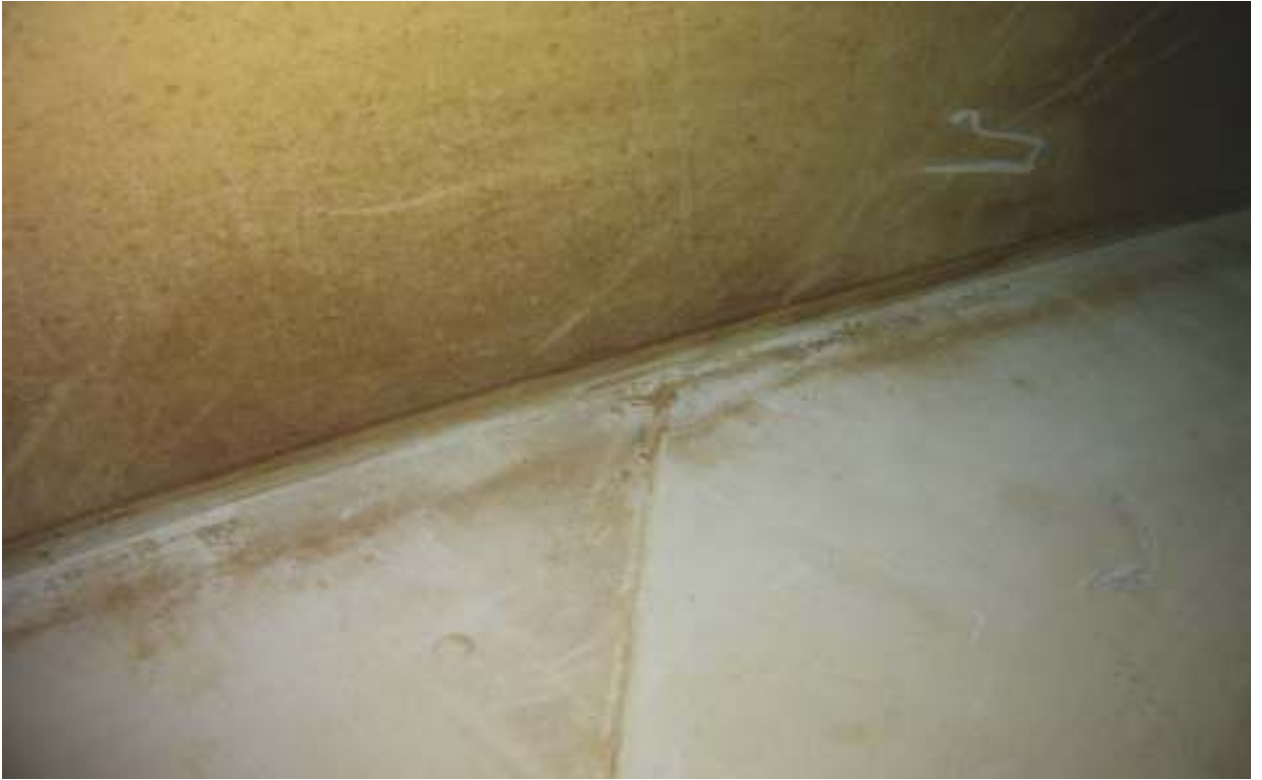
16. Shell Ring #1

- **Shell – Coating is in good condition.**
- No cracking, peeling, or blisters observed.
- Rust spots mostly near floor.
- Heavy sediment staining in bottom 2 rings.
- Ceiling coating is beginning to deteriorate in several areas.
- No other flaws observed.
- Observations:
 - Consider incorporating an epoxy program to touch up the coating on floor and shell with an NSF approved epoxy at regular scheduled inspections.
 - Prepare funding for a blast and recoat.

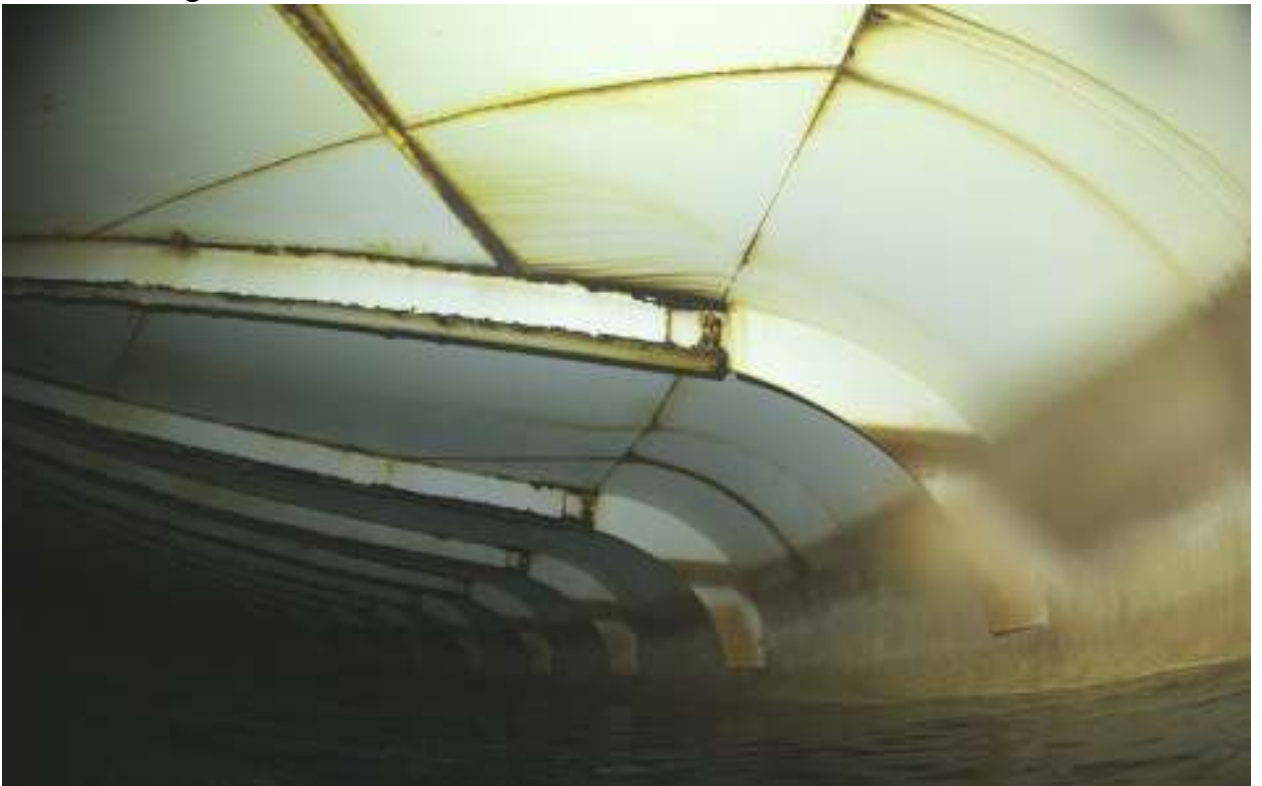
23. Ceiling At Shell

- **Ceiling – Coating is in poor condition.**
- **Cracking and peeling on beams exposing rusted steel.**
- Steel on beams is beginning to delaminate.
- Rust and rust staining on ceiling panels and on beams near center.
- Observations:
 - Blast and recoat is recommended due to the condition of coating on ceiling.
 - Prepare funding for a blast and recoat and check the condition of the beams prior to performing work. (Delamination of the steel is occurring)
 - Use caution when walking on top of reservoir.

- **Keep up with regularly scheduled maintenance & cleanings on a 3-5 year rotation.**
- **Blast and recoat recommended.**
- **This tank has coating and structural issues.**
- **Delamination of a few beams is occurring and the steel is beginning to divide itself into multiple layers. These issues need to be addressed before a blast and recoat is performed.**
- **Although delamination was only spotted on a few beams this may be an indication of more to come as time goes on.**

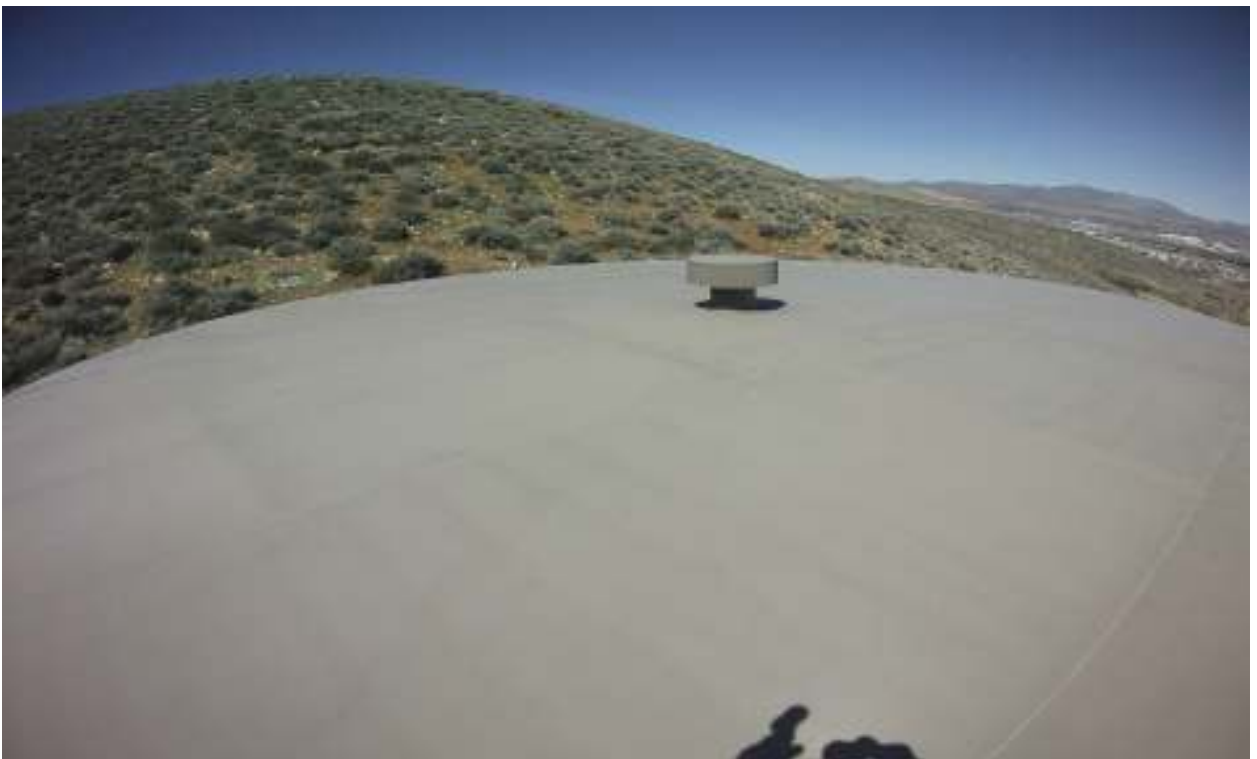
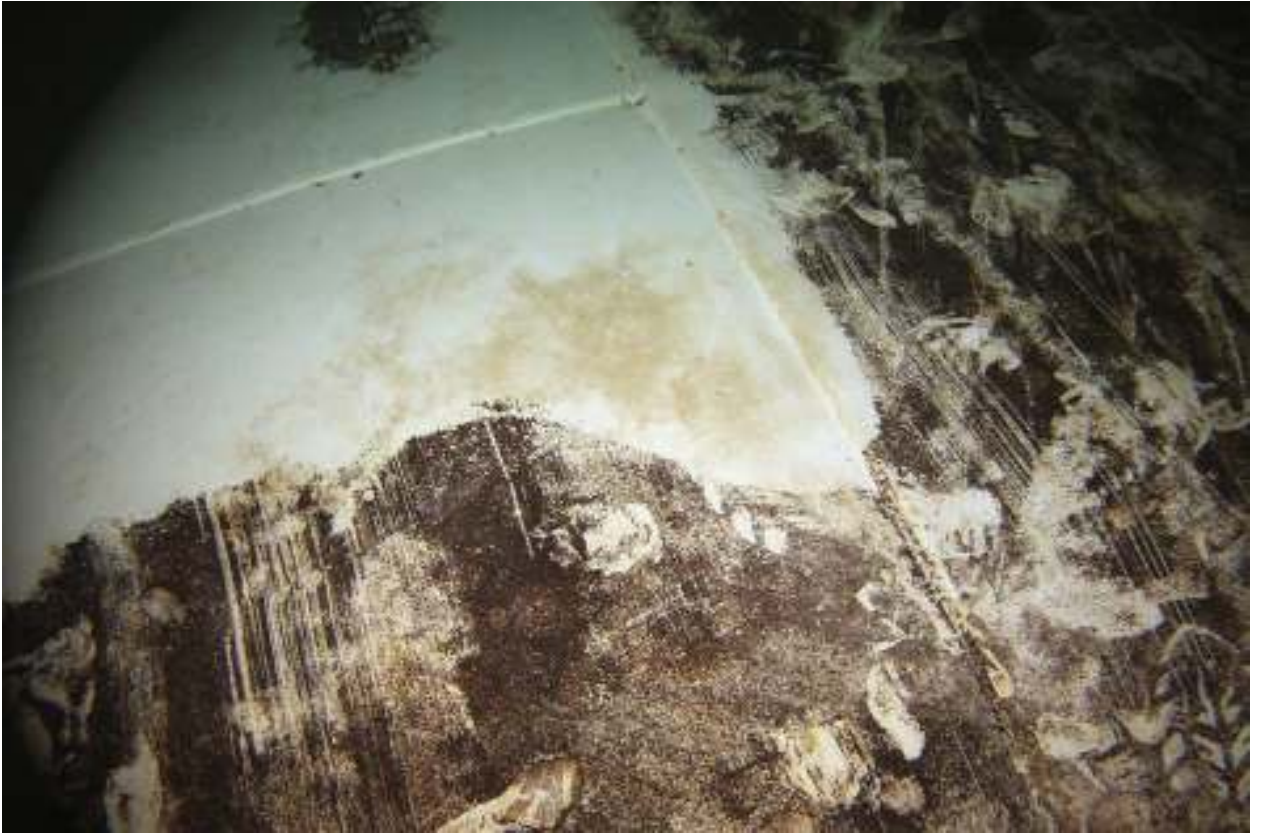
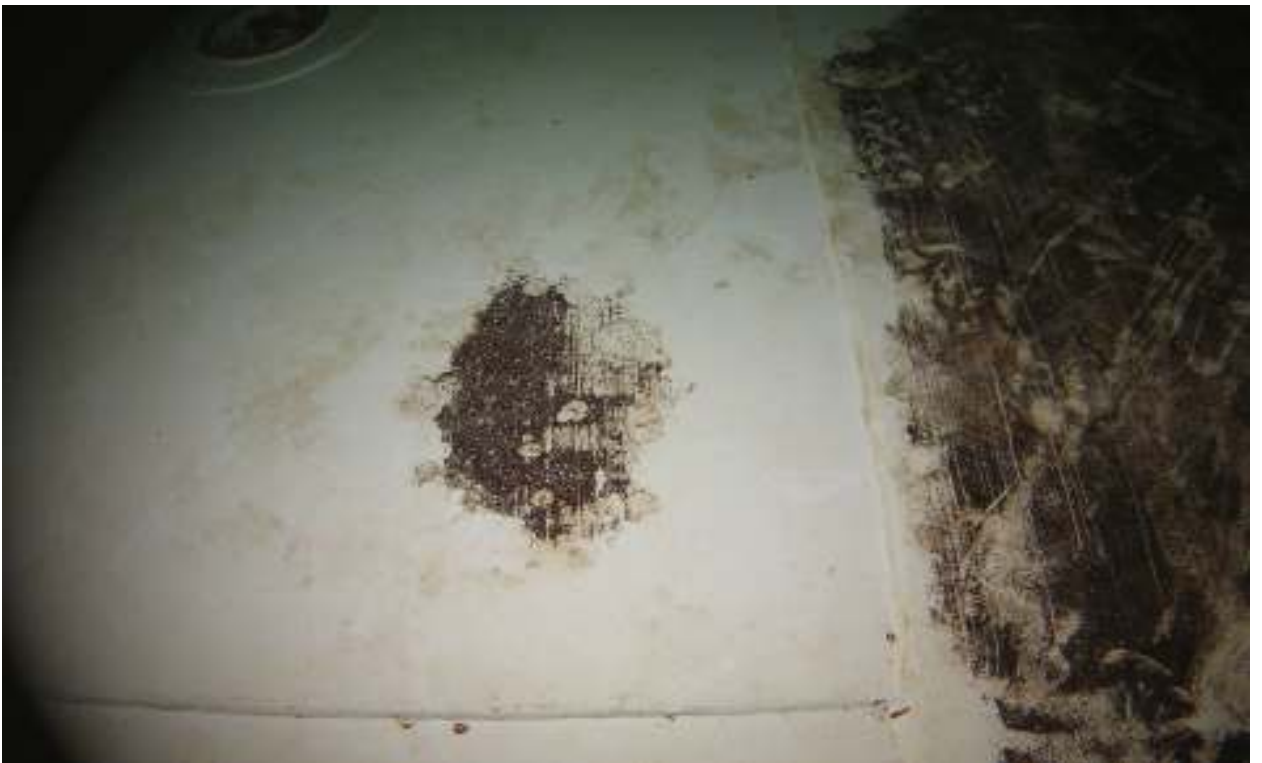
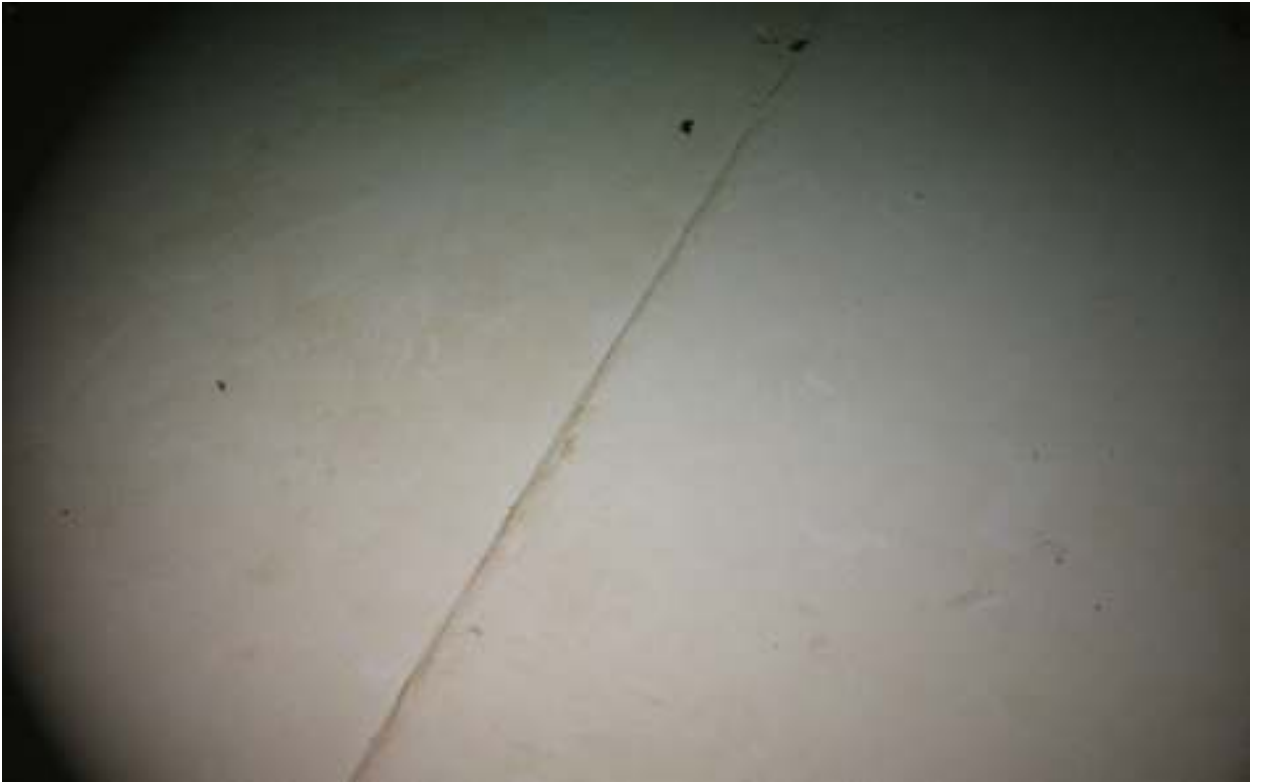
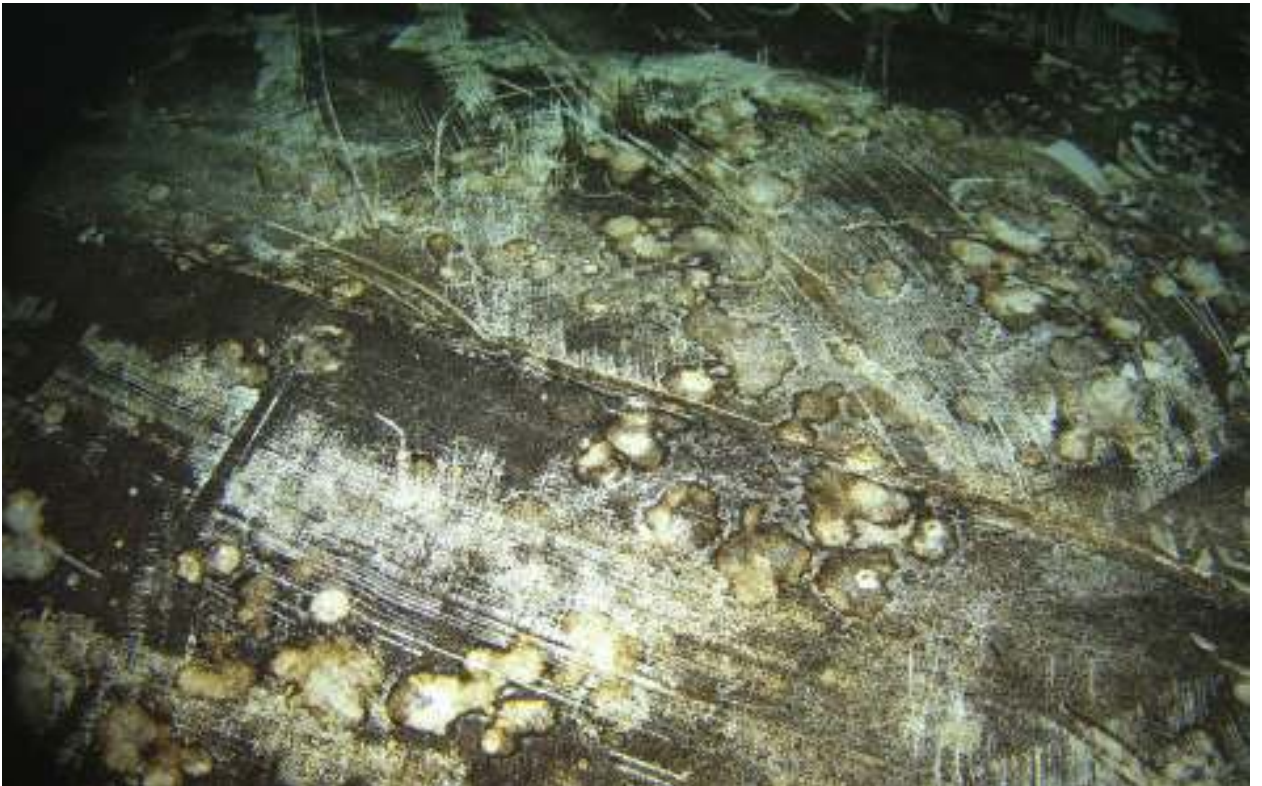
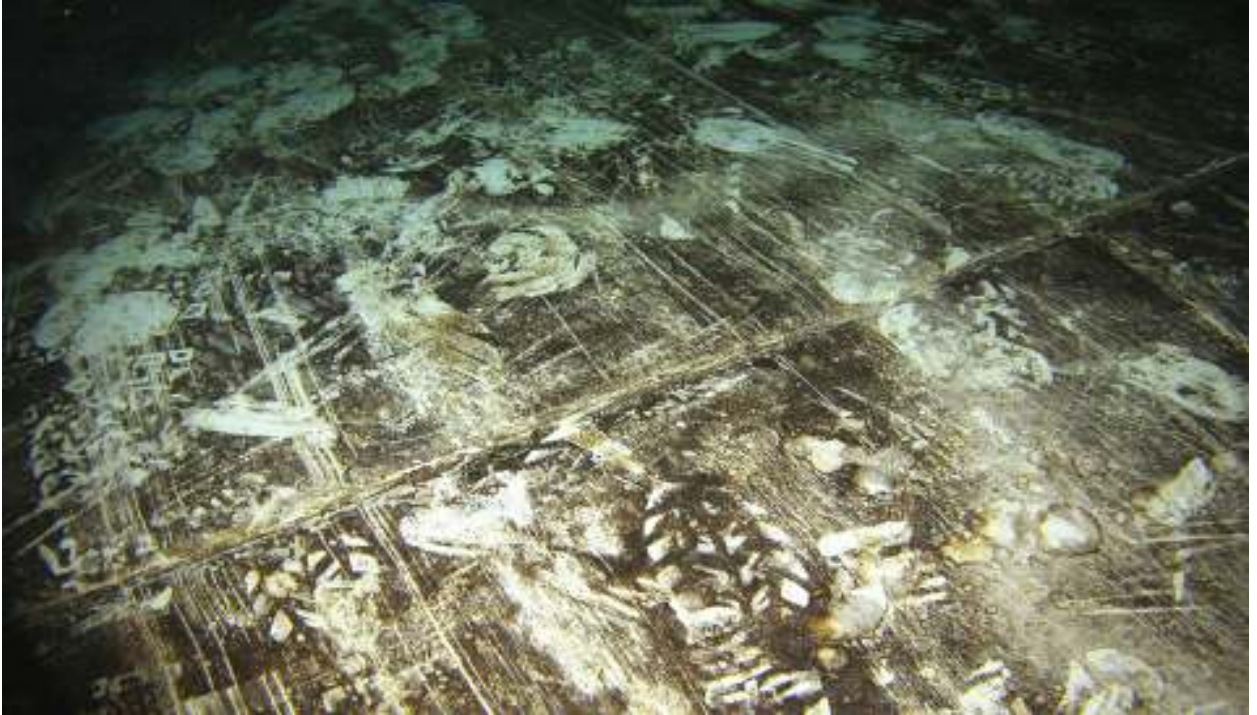
- **Floor coating – good condition.**
- No cracking, peeling or blisters observed.
- Isolated rust spots on floor, some may be staining from debris.
- Heavy Sediment staining on 80% of floor and mostly in the middle.
- 1/8” sediment and debris (coating chips and rust from shell and ceiling) on floor removed prior to inspection.
- Observations:
 - See shell.

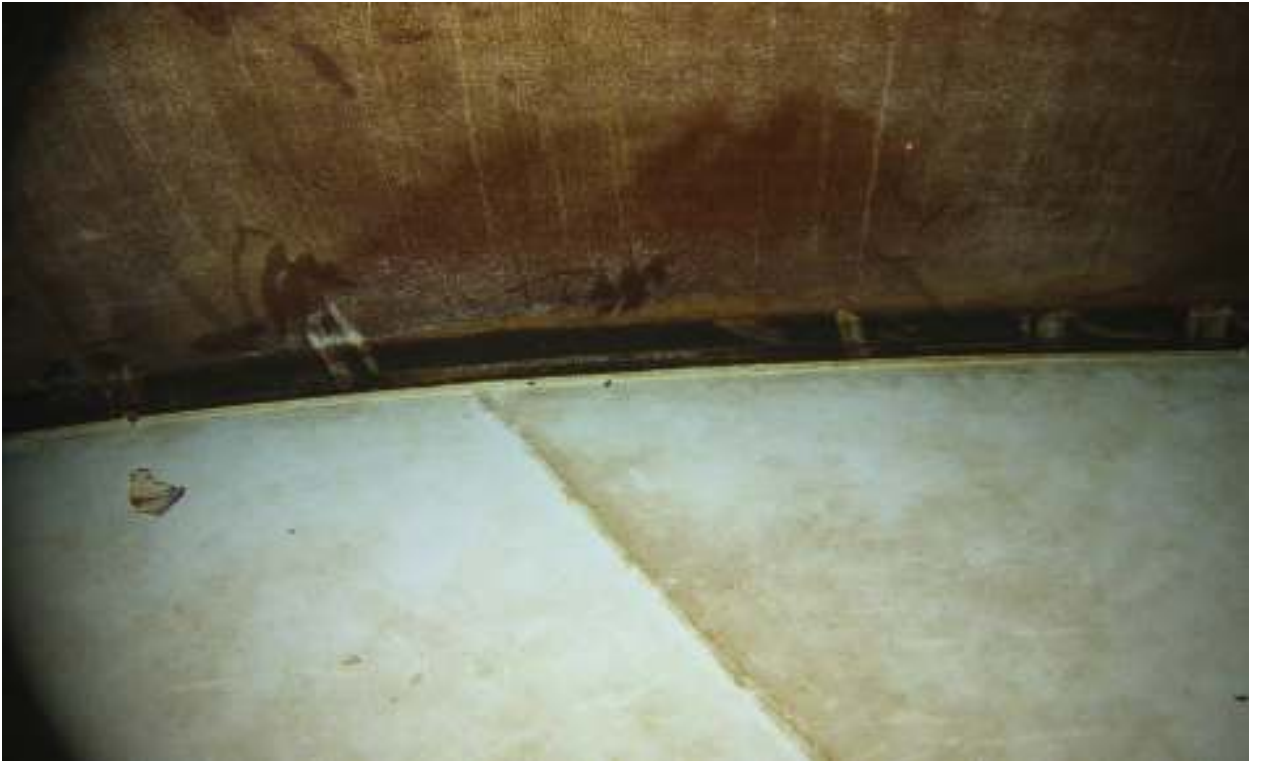
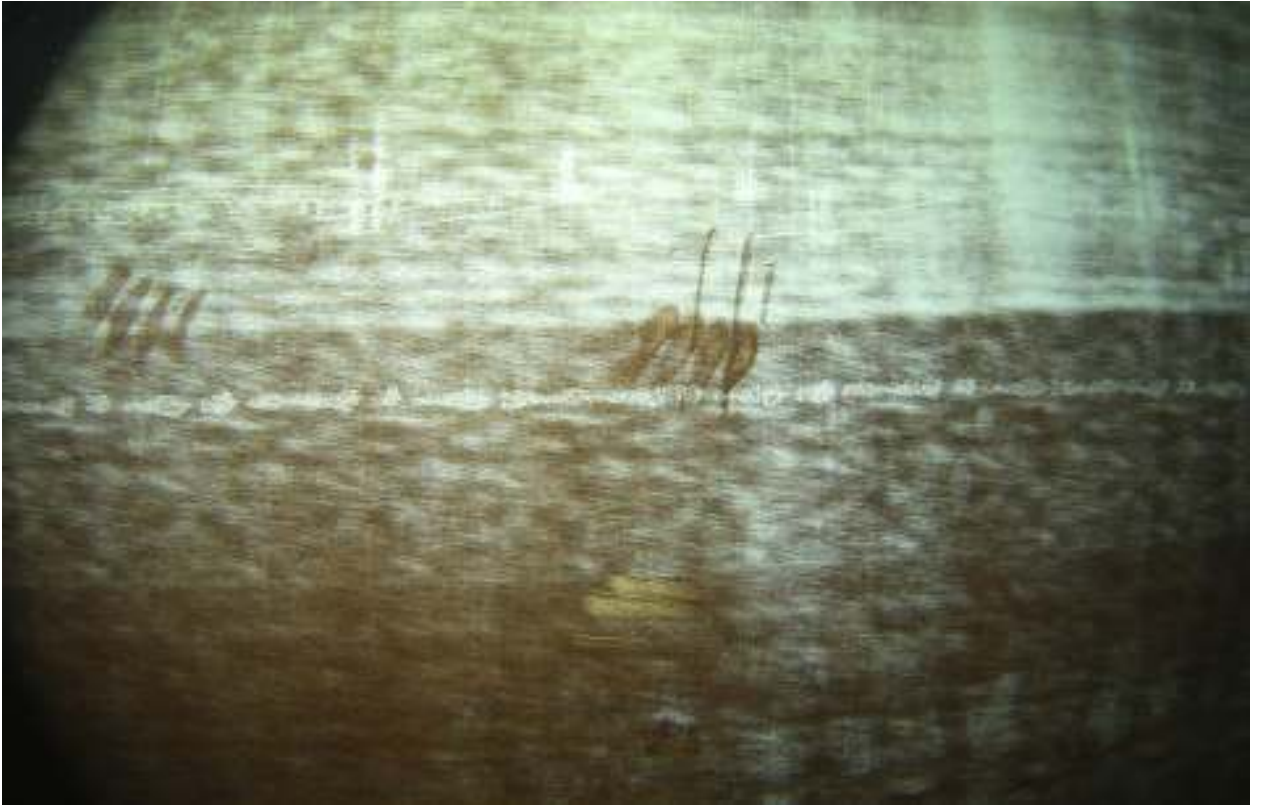
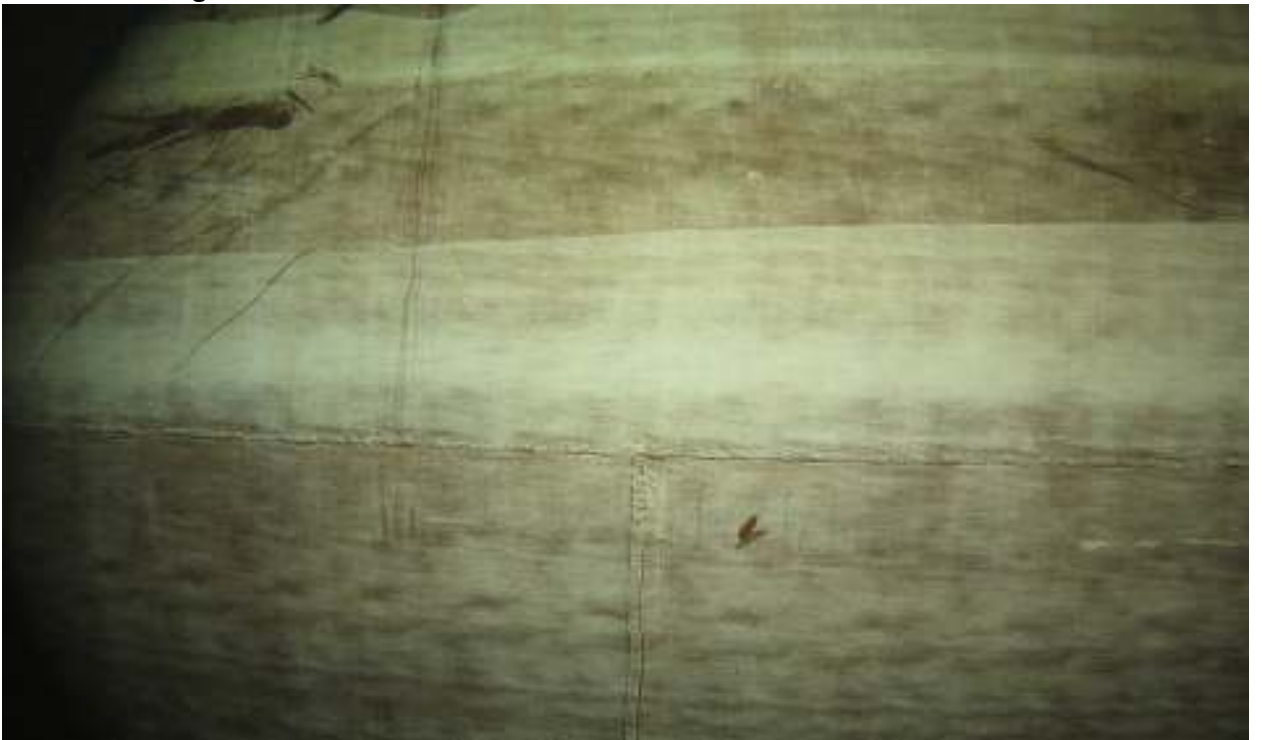
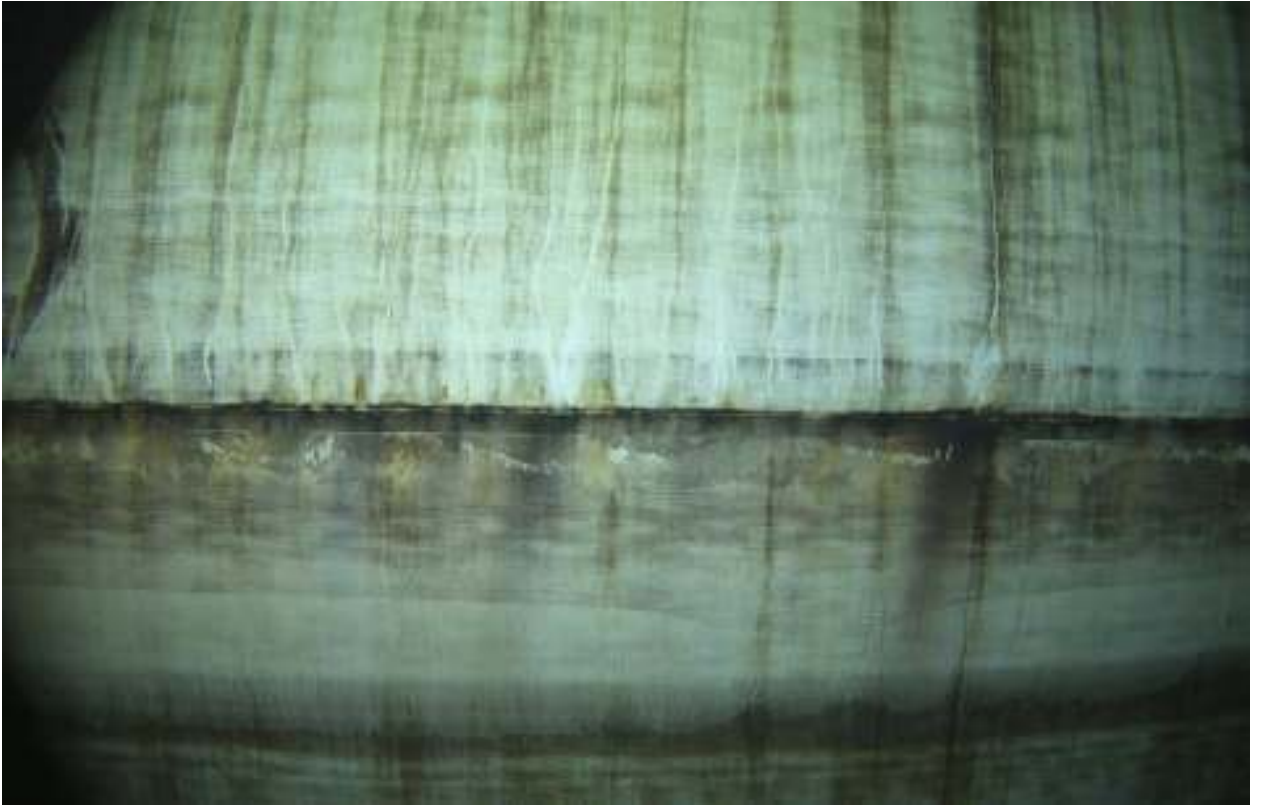
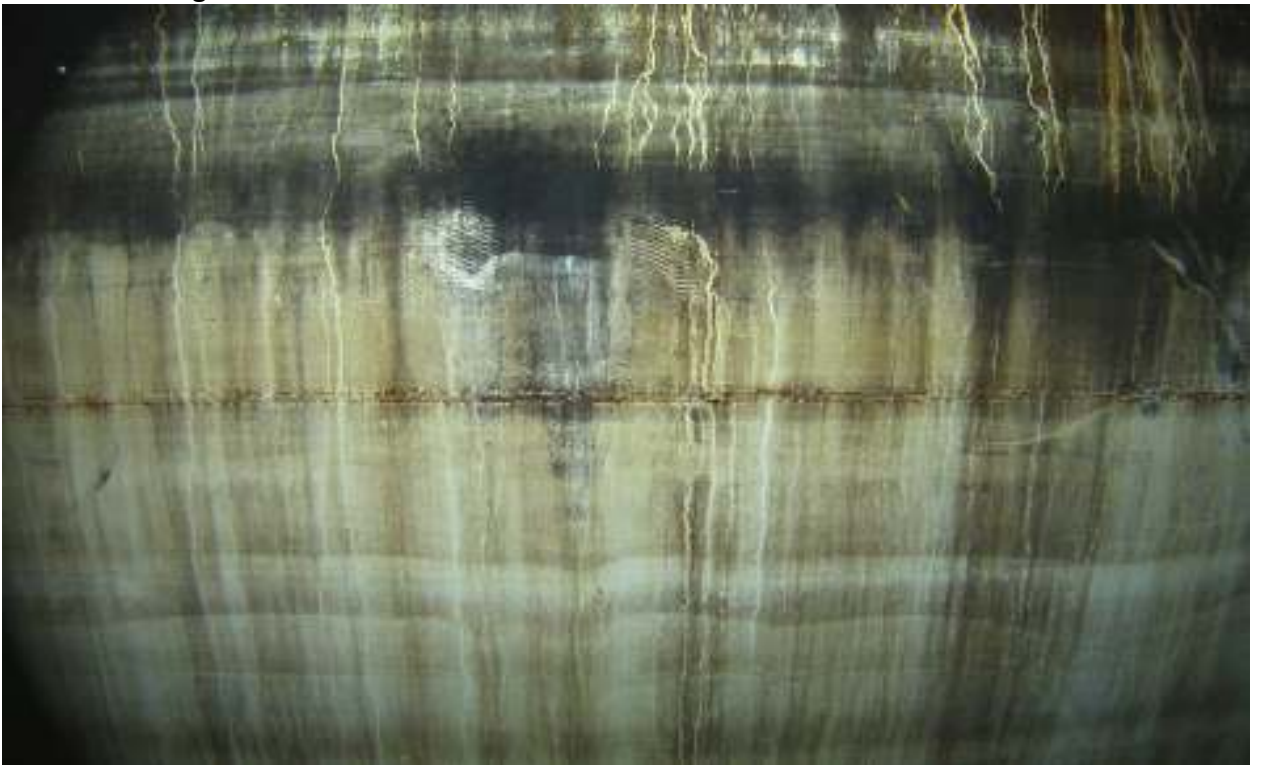
- **Interior coating – poor condition.**
- Alligator cracking and peeling of coating in Ring #3 and mostly on south ½” of reservoir, exposing rusted steel.
- Isolated rust spots and patches of blisters on bottom 2 rings along with heavy sediment staining.
- Observations:
 - This reservoir is overdue for a blast and recoat.
 - Put this one at the top of the list for interior coating rehabilitation.

- **Keep up with regularly scheduled maintenance & cleanings on a 3-5 year rotation.**
- **Blast and recoat recommended.**
- **See all observations at the bottom of each section.**

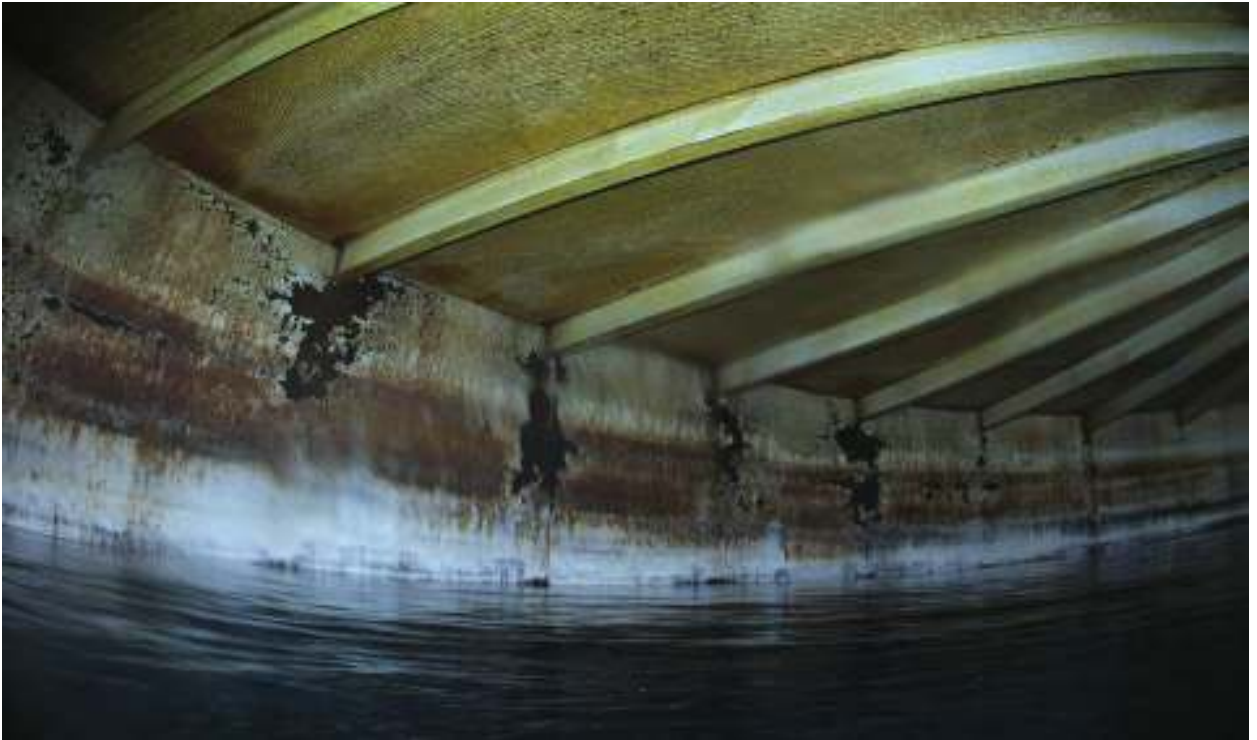
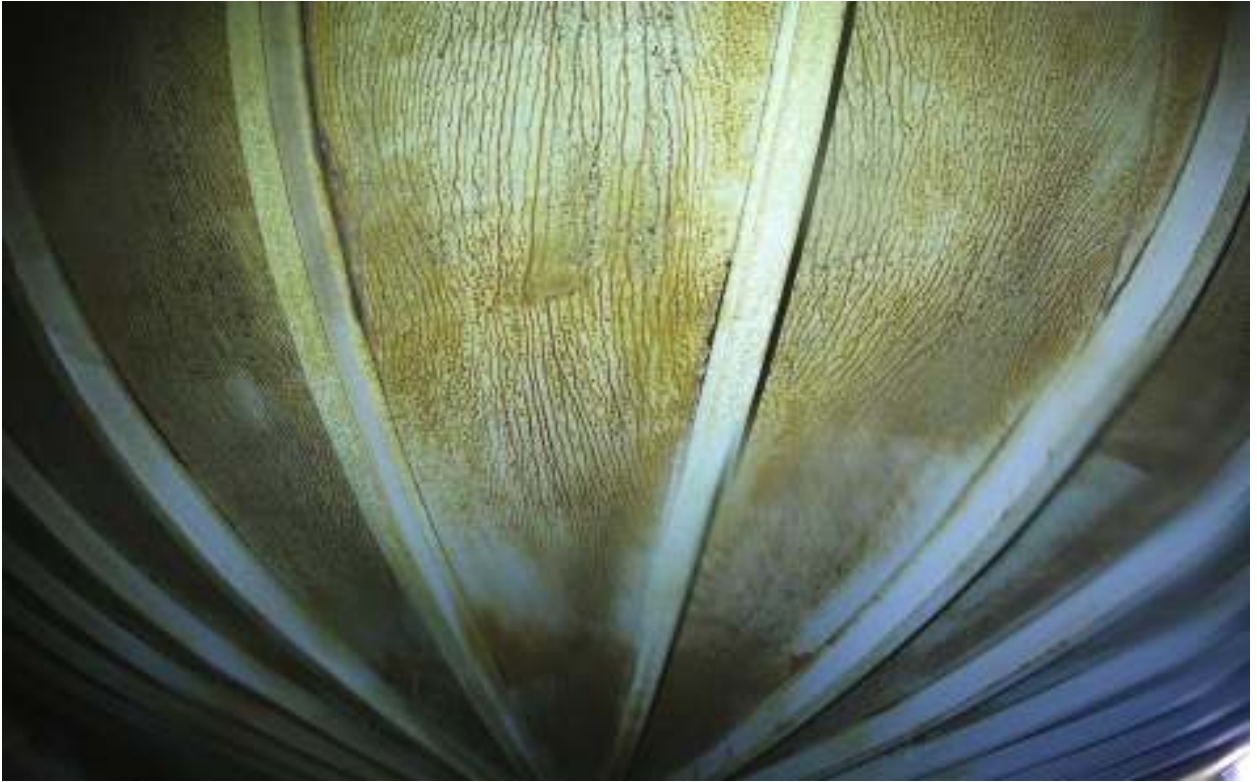
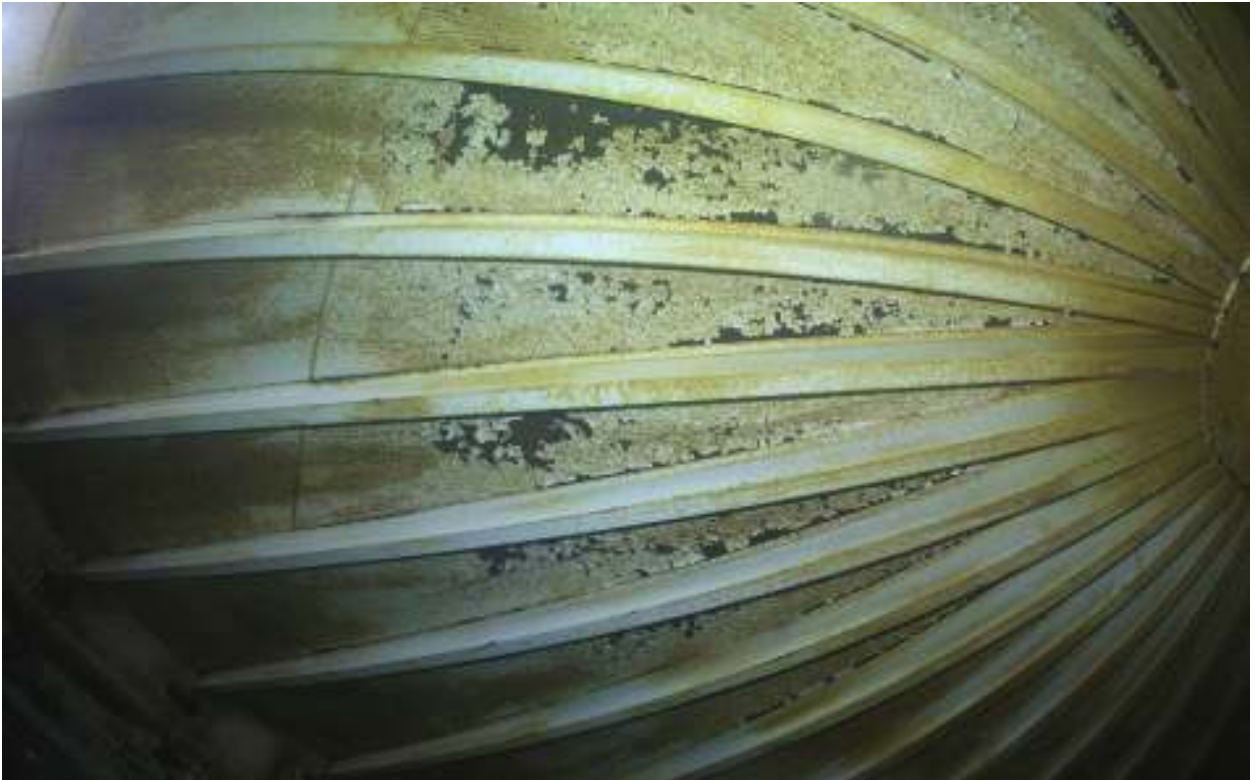
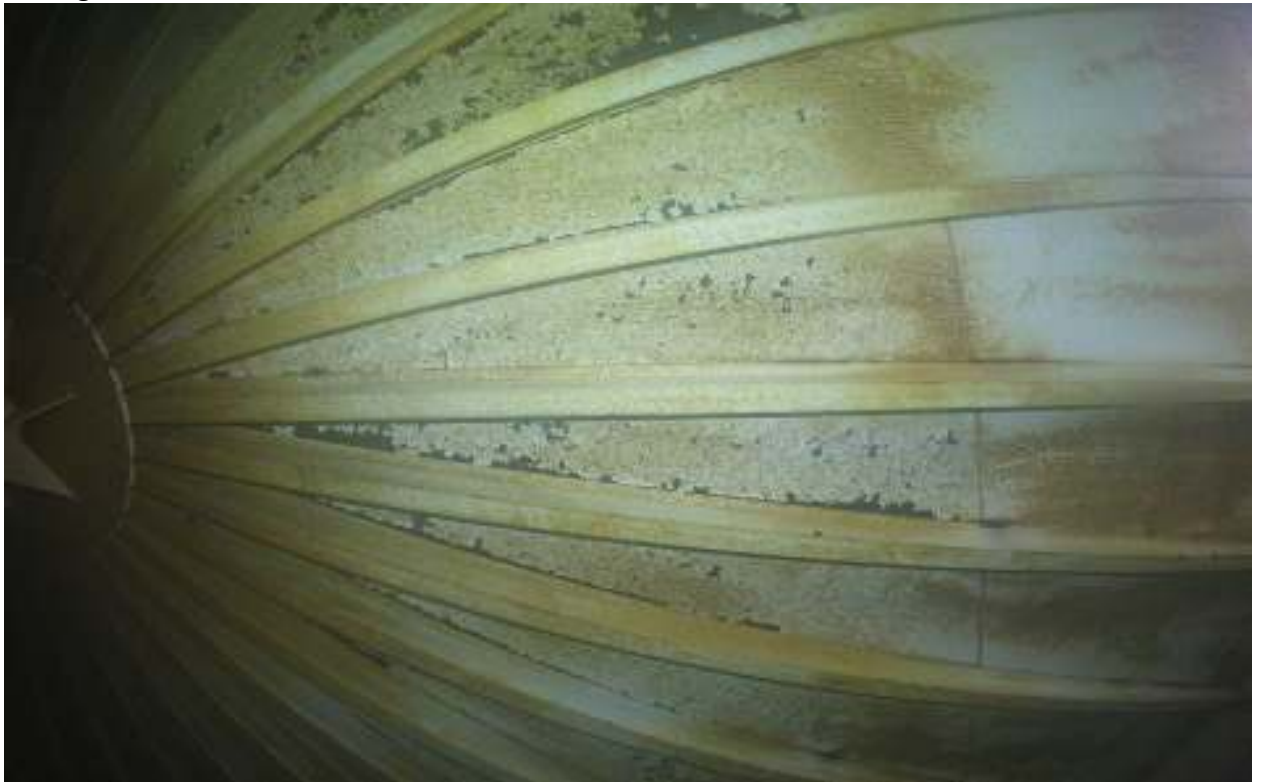
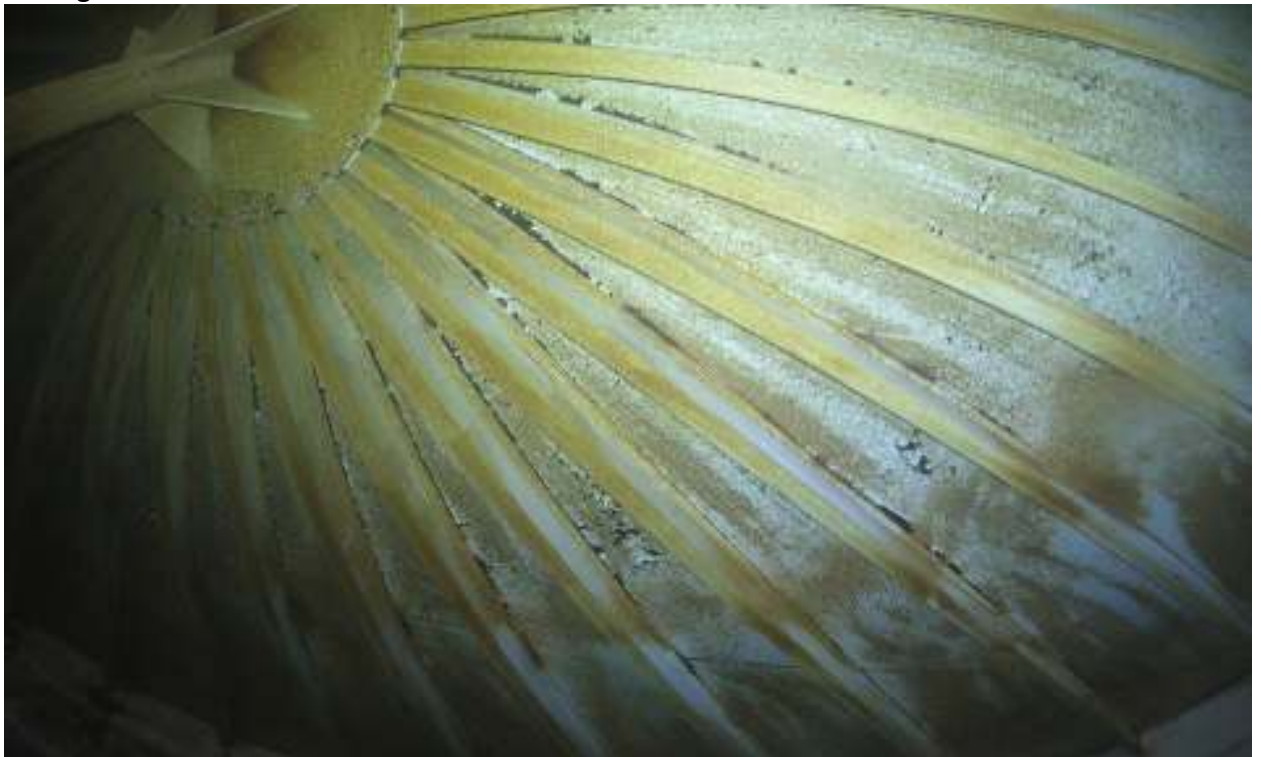
- **Ceiling coating – poor condition.**
- Alligator cracking and peeling on ceiling panels and beams exposing rusted steel.
- Observations:
 - See shell.

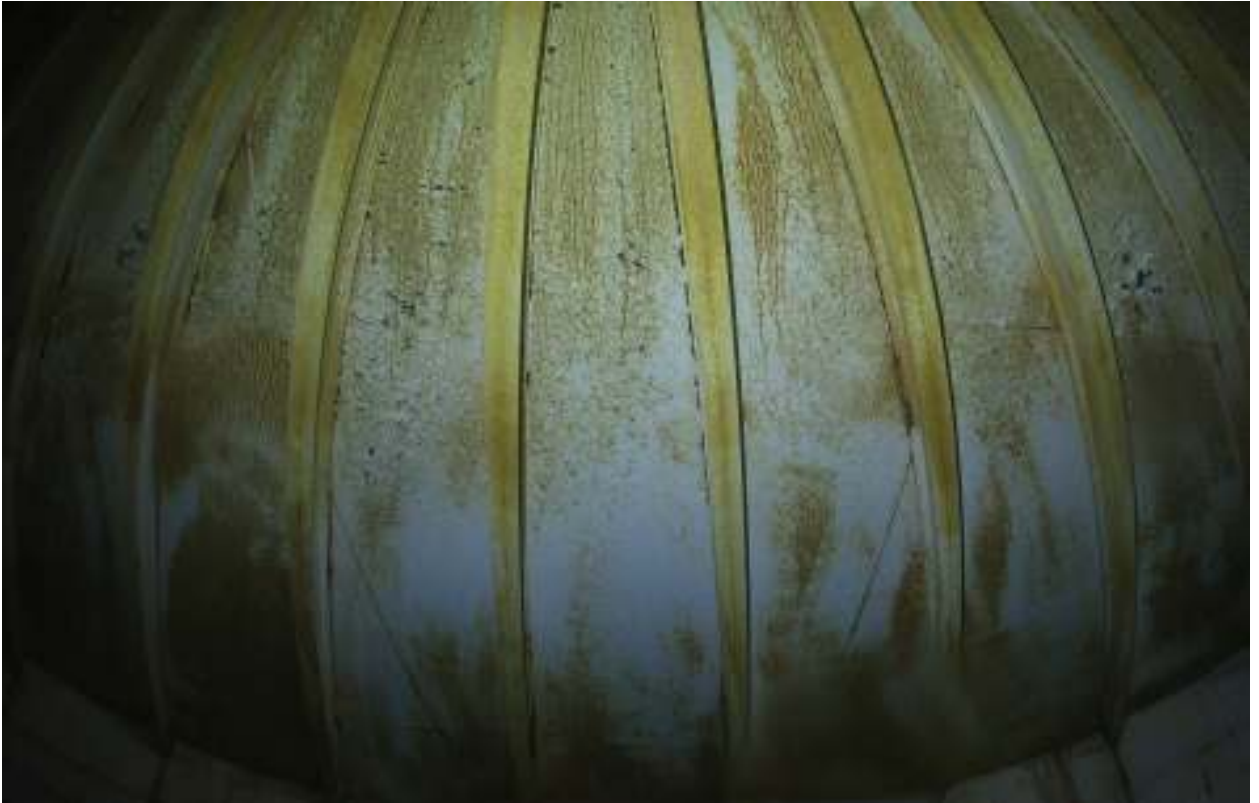
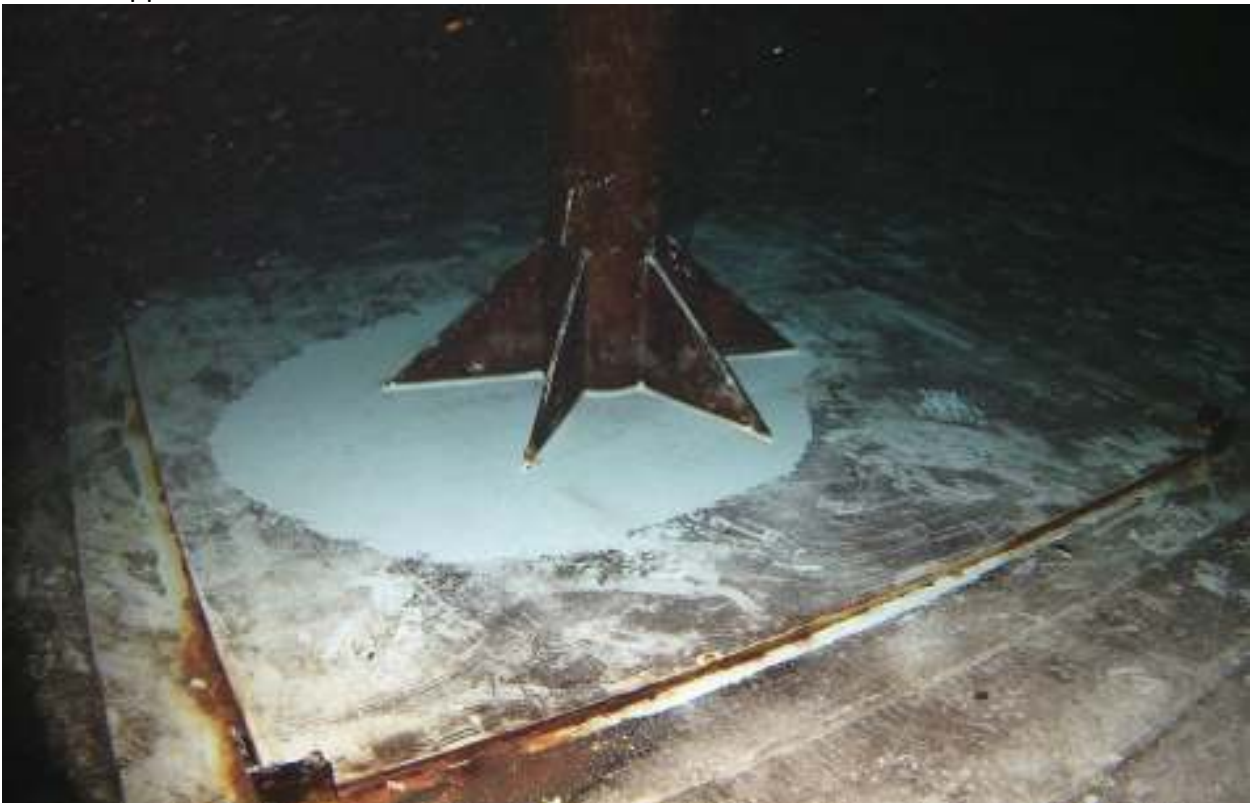
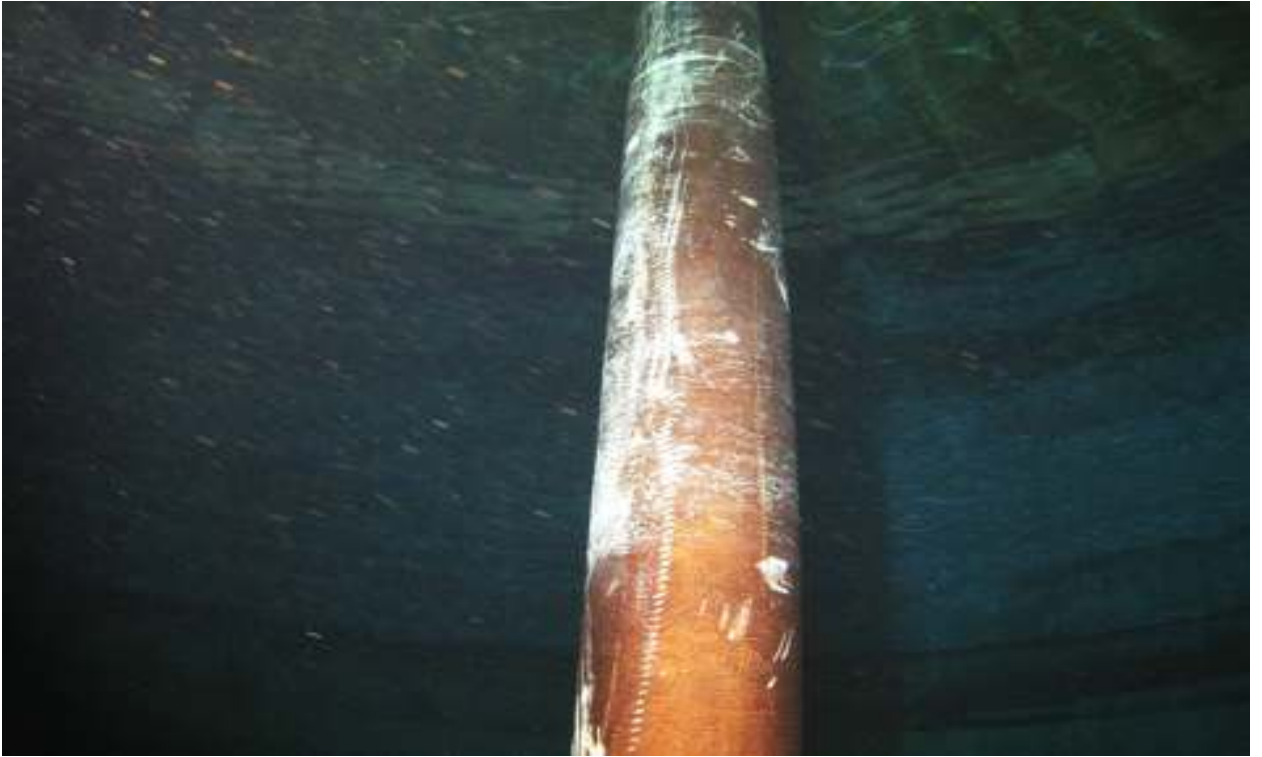
- **(1) Center support pole is structurally sound and coating is in fair condition.**
- Sediment staining on lower 2/3 of pole and base.
- Crevice corrosion and peeling on top hat exposing rusted steel.
- Observations:
 - See shell.

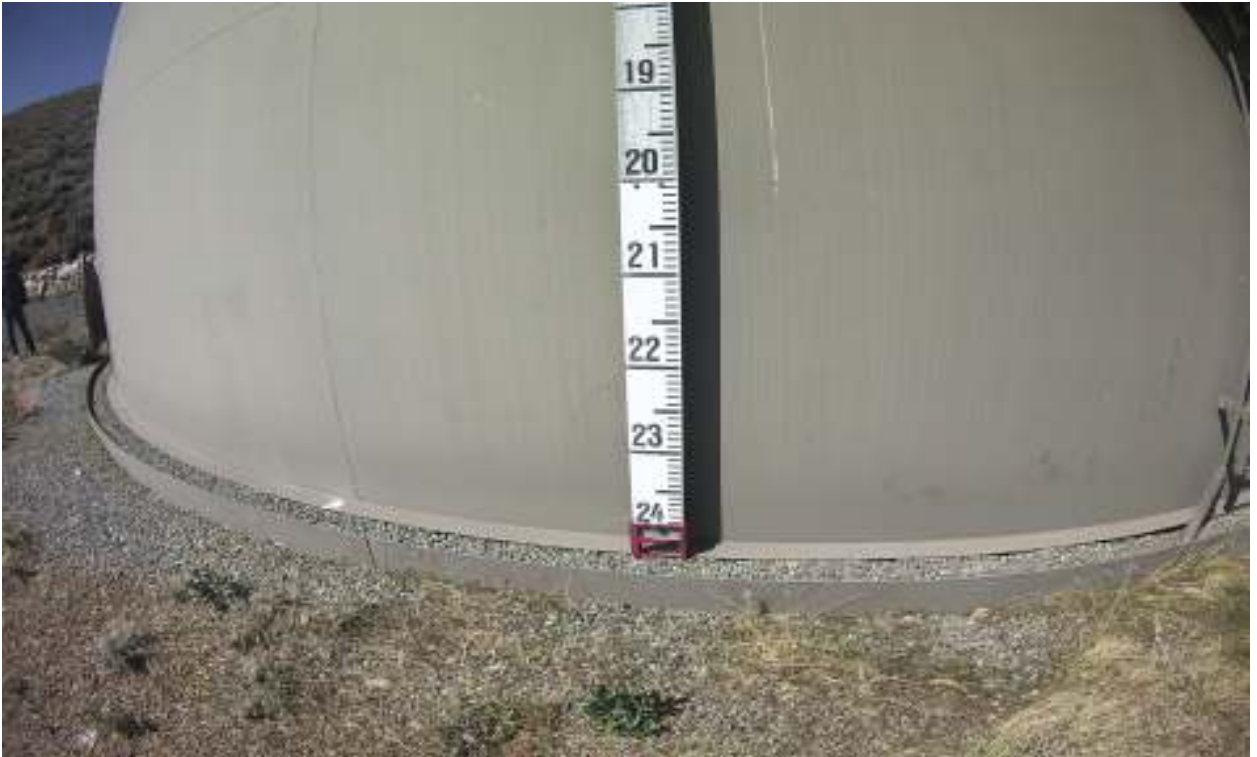
31. W.L.I. Abandoned

- **Mechanical W.L.I. is no longer in service with float wire broken.**
- **W.L.L. Transducer at 12:00 position is in good condition and touching floor.**
- Observations:
 - Ensure electronic level measurement is functioning to remain in compliance with NAC 445A.6708.7
 - Install a new guide wire for float assembly at tank rehab.
