Northgate Reservoir #1

Northgate Reservoir #1
04-18-2018

Blue Locker Diving - Photo Documentation

Horizon Hills #1

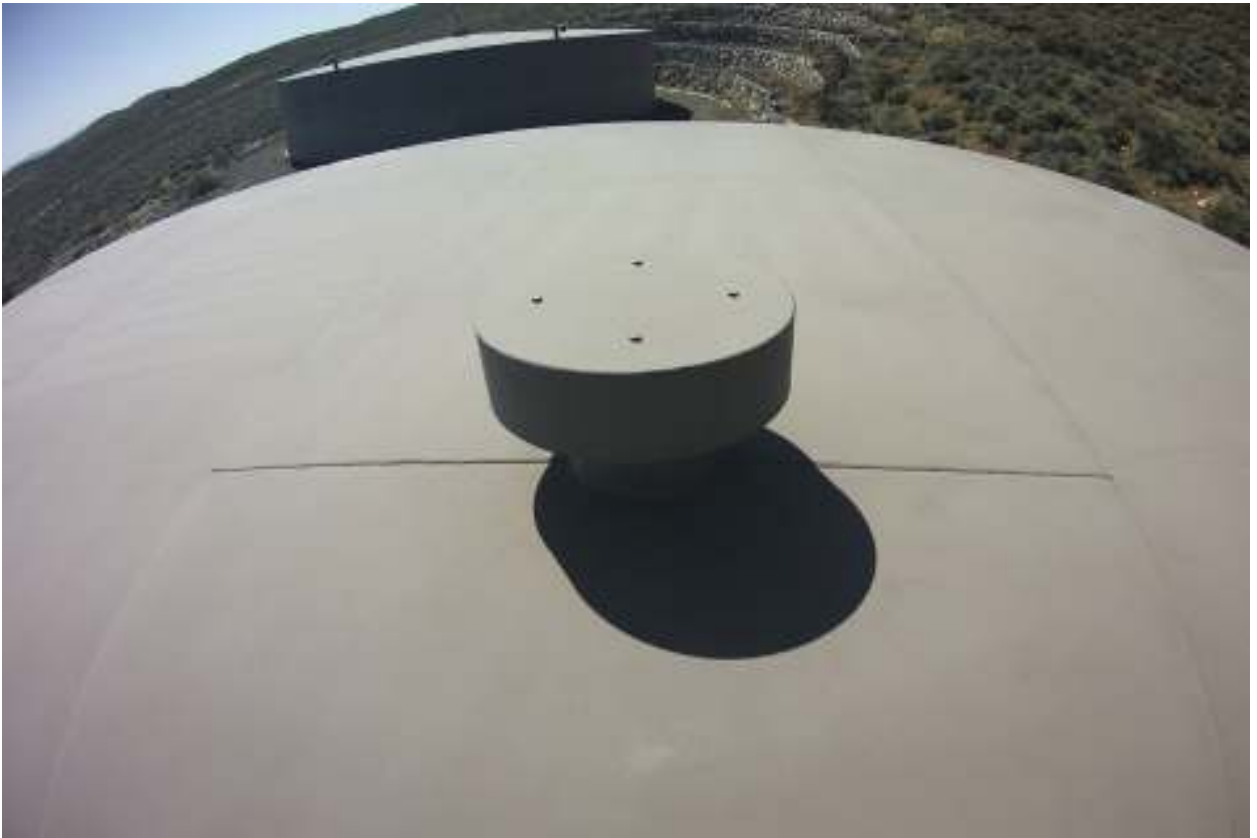
35. Center Roof Vent

- **10” diameter center roof vent - good condition with screen intact.**
- Observations:
 - Ensure screen mesh is 22-24 mesh per NAC 445A.6708.5

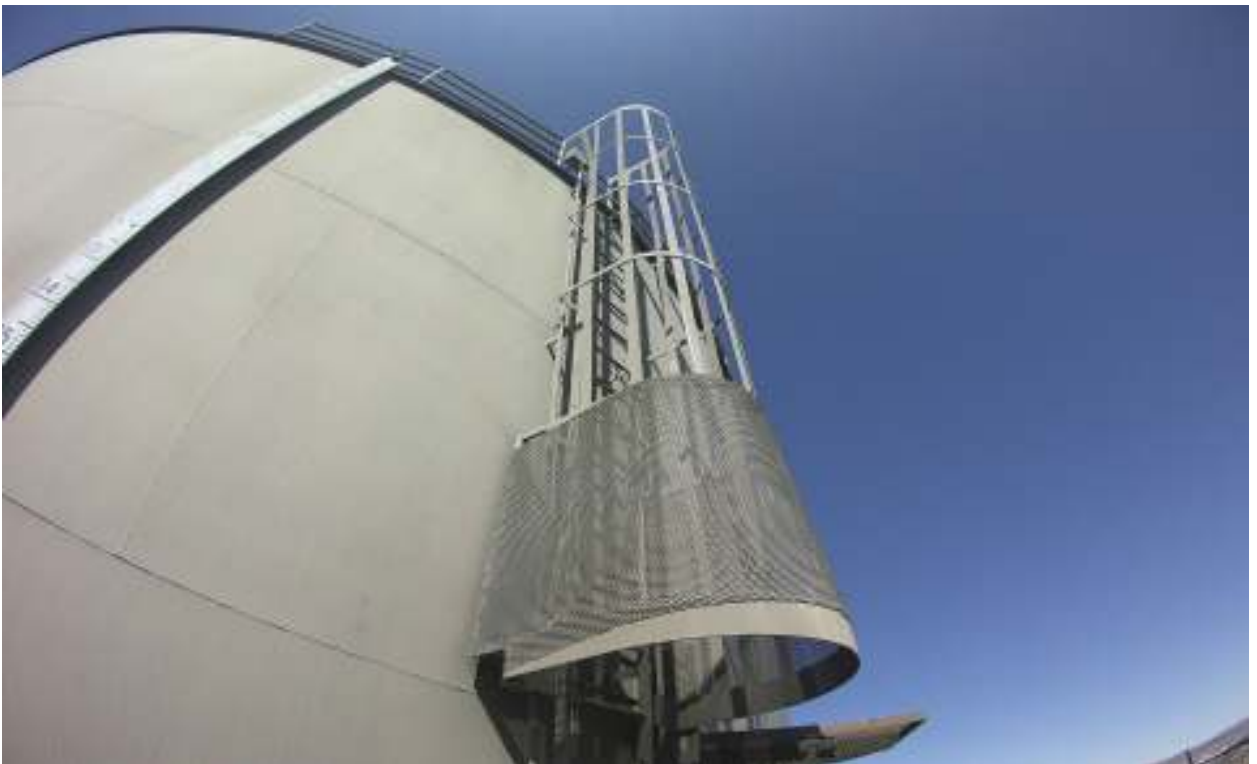
36. Exterior Ladder

- **Exterior Ladder is structurally sound and secure to shell with no flaws observed on runners on cage.**
- Worn spots on rungs exposing undercoating and metal.
- Safety climbing device, none present.
- Observations:
 - Touch up with lead free high visibility paint.

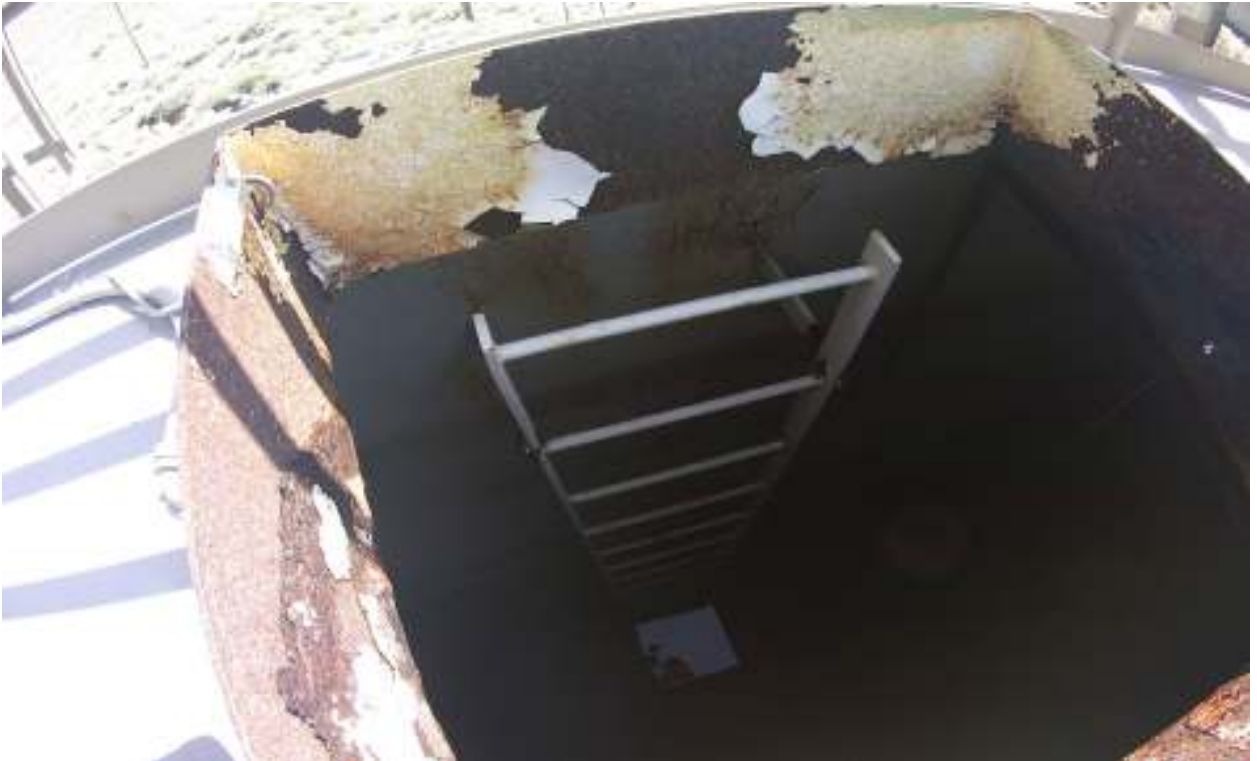
38. Interior Ladder - Top

- **Interior ladder – Good condition and secure to shell.**
- Coating is in good condition, 2 or 3 spots have peeled away exposing stainless steel underneath.
- Observations:
 - Recoat with an epoxy coating at tank rehab.

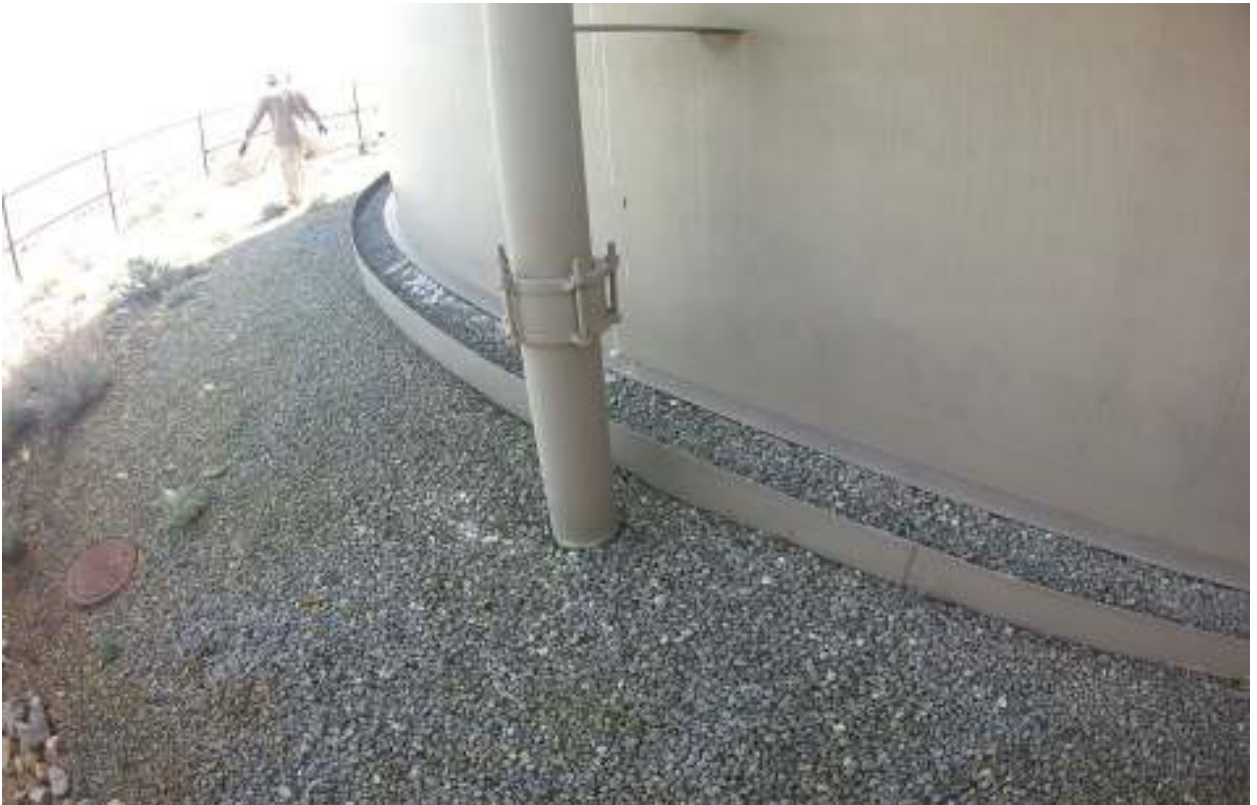
43. Overflow - Bottom

- **6” Diameter exterior overflow pipe and interior overflow box are in good condition with no flaws observed.**
- Observations:
 - NA.

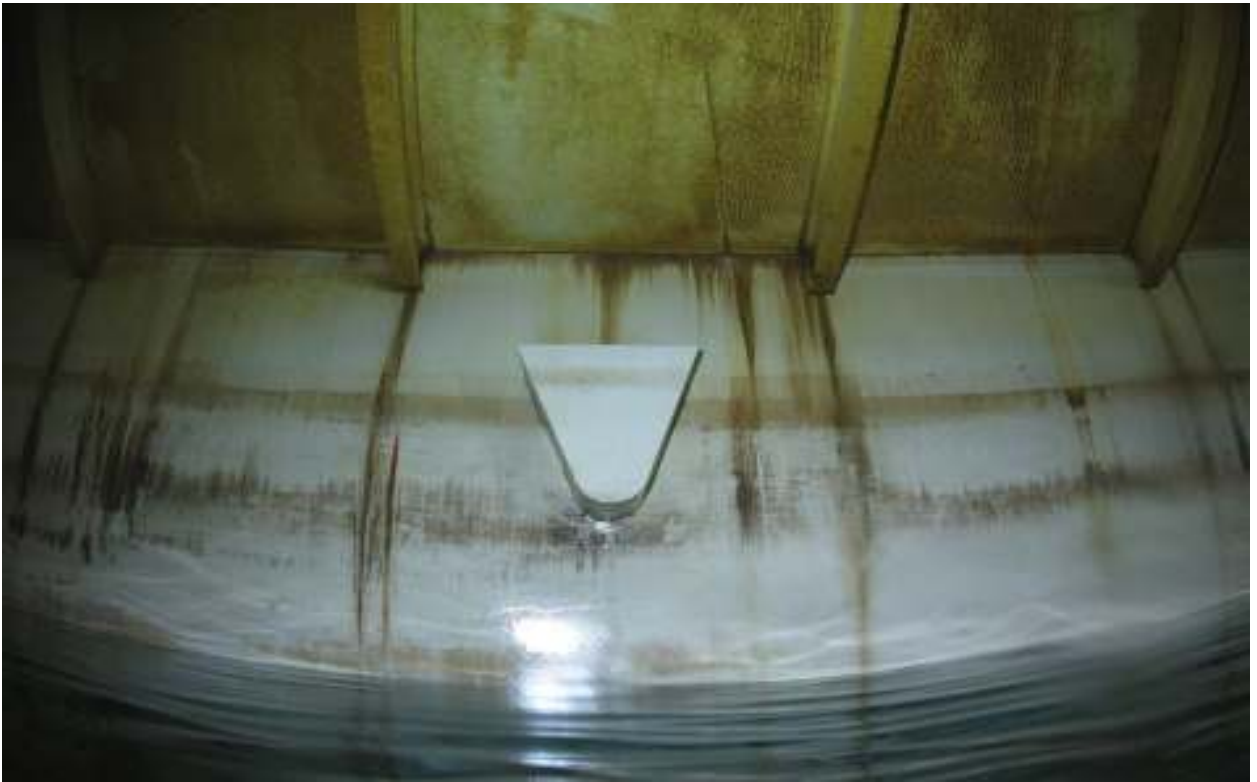
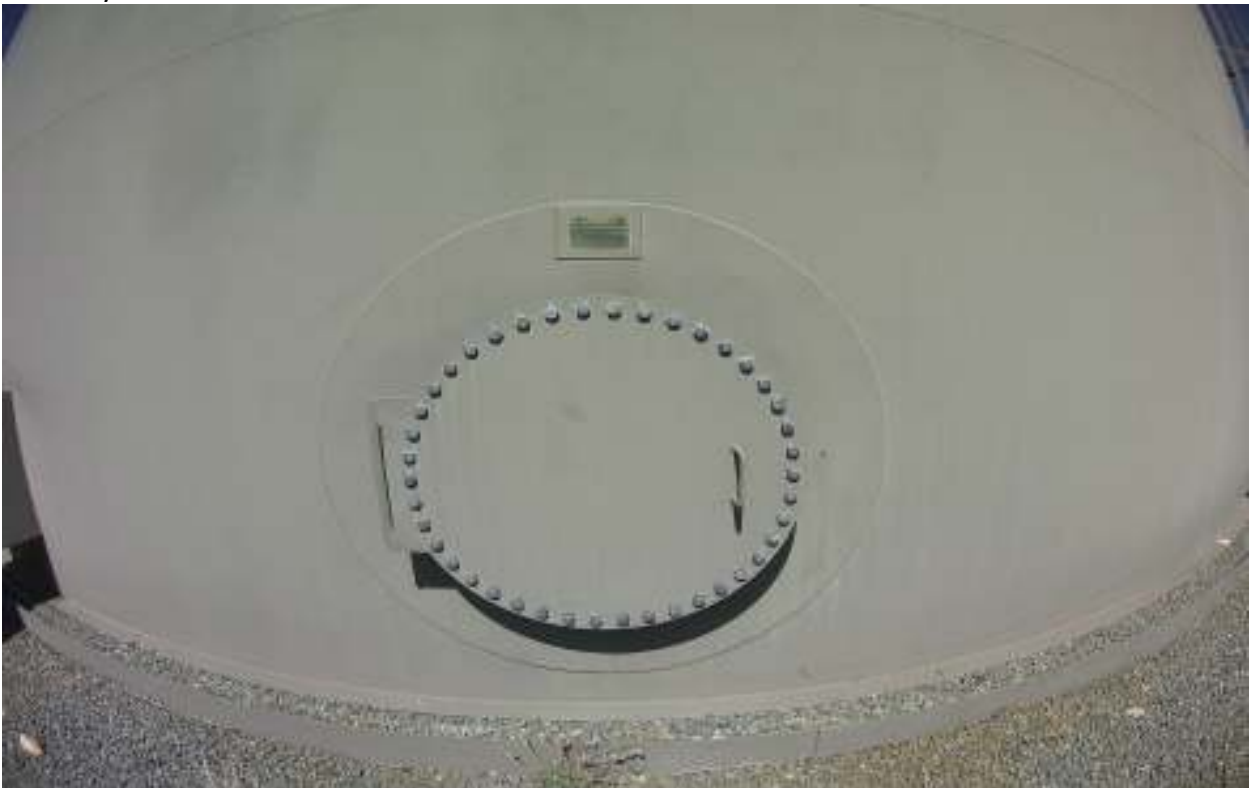
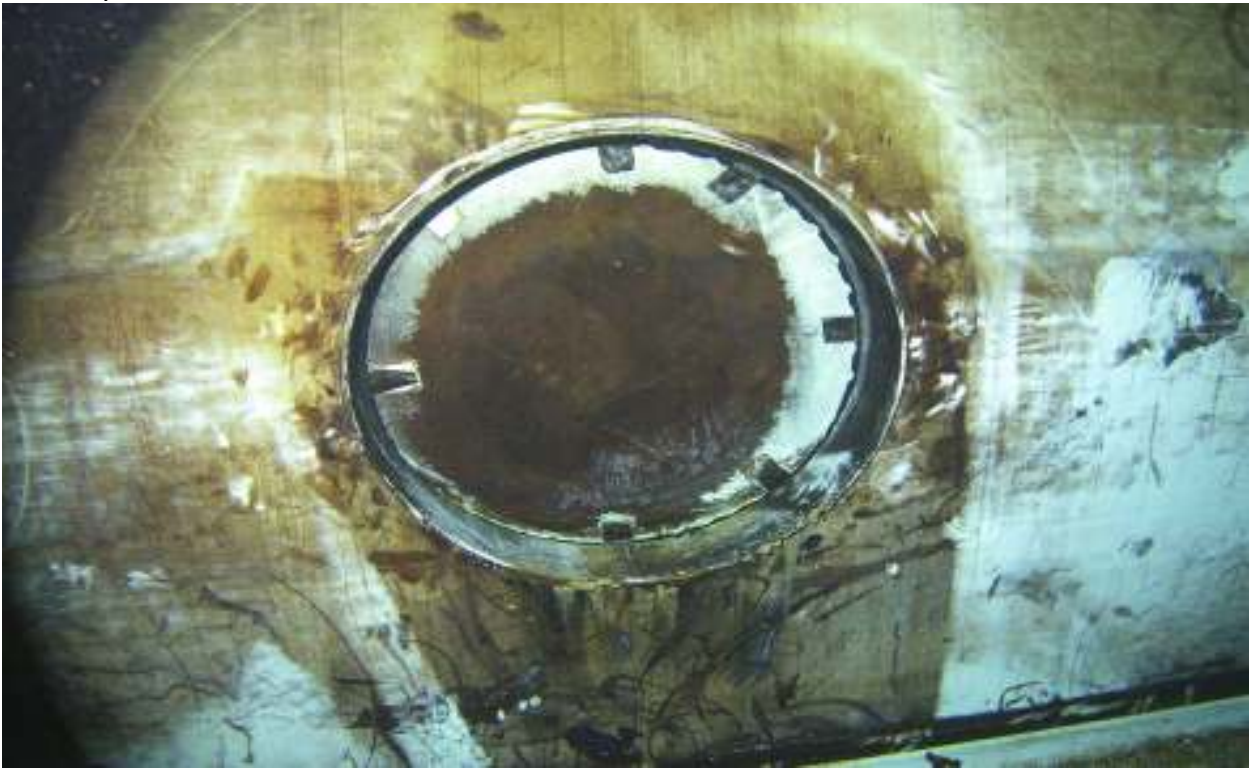
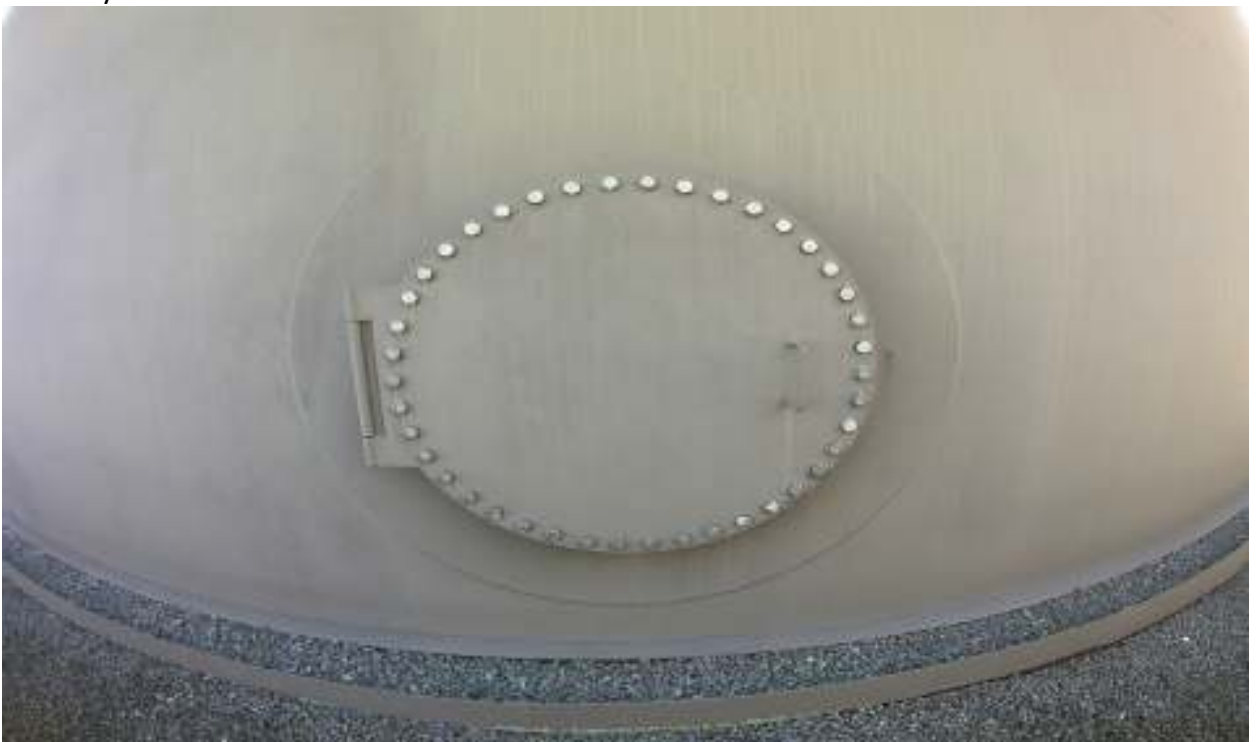
- **2 @ 30" diameter manways - good condition with seals intact.**
- Heavy sediment staining on both manways similar to surrounding shell.
- Rust spots on penetration edge of both manways.
- Observations:
 - **NA.**

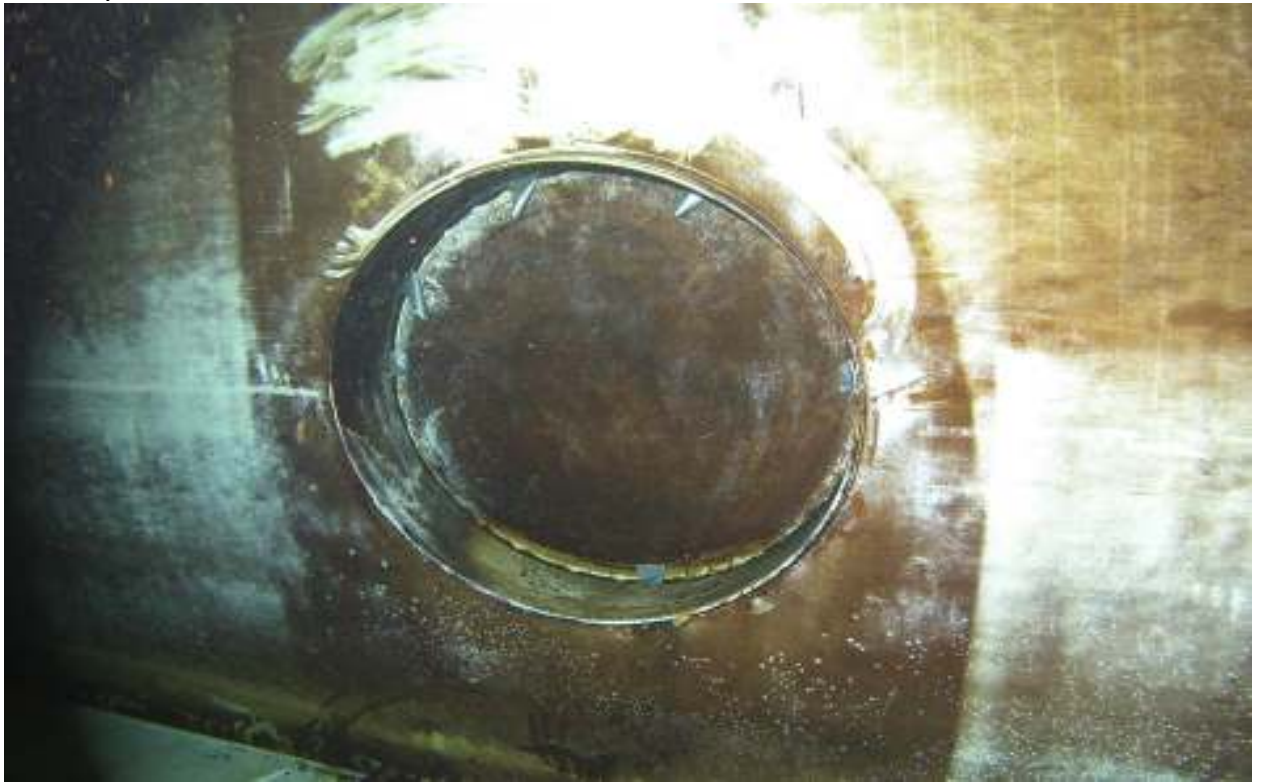
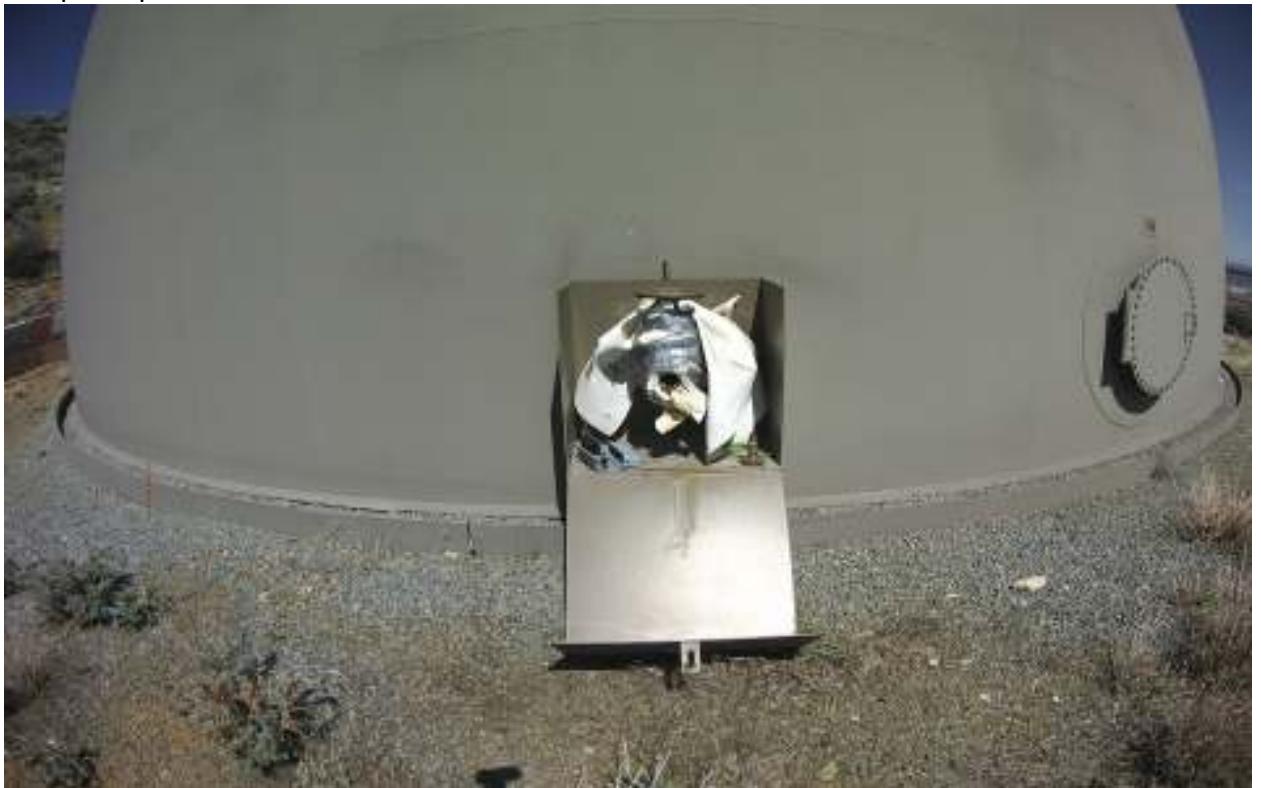
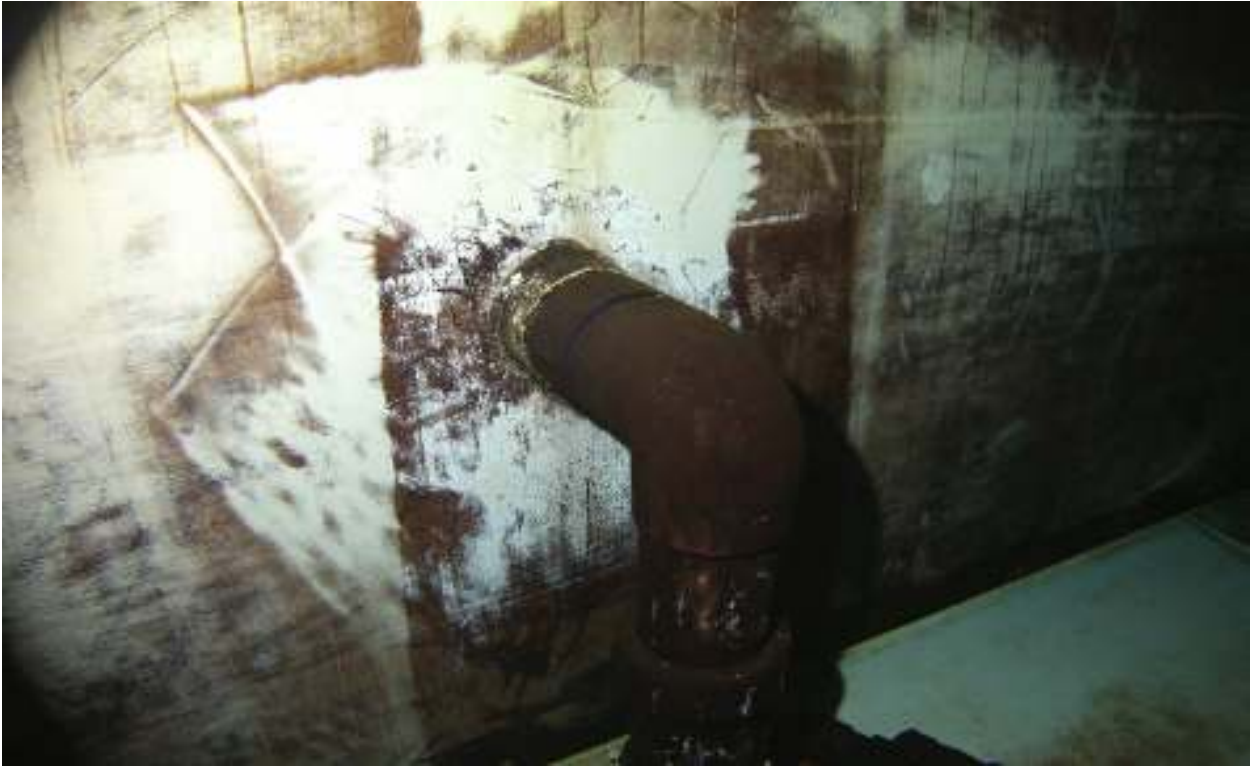
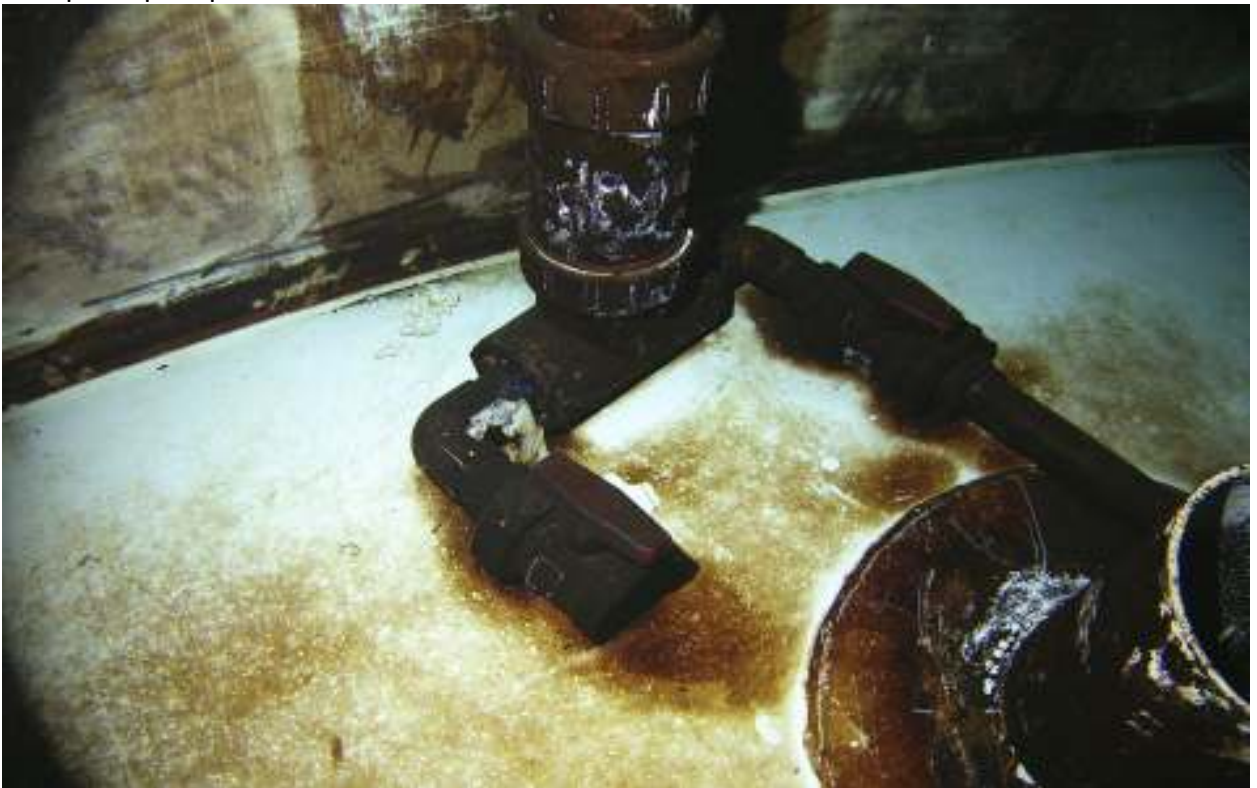
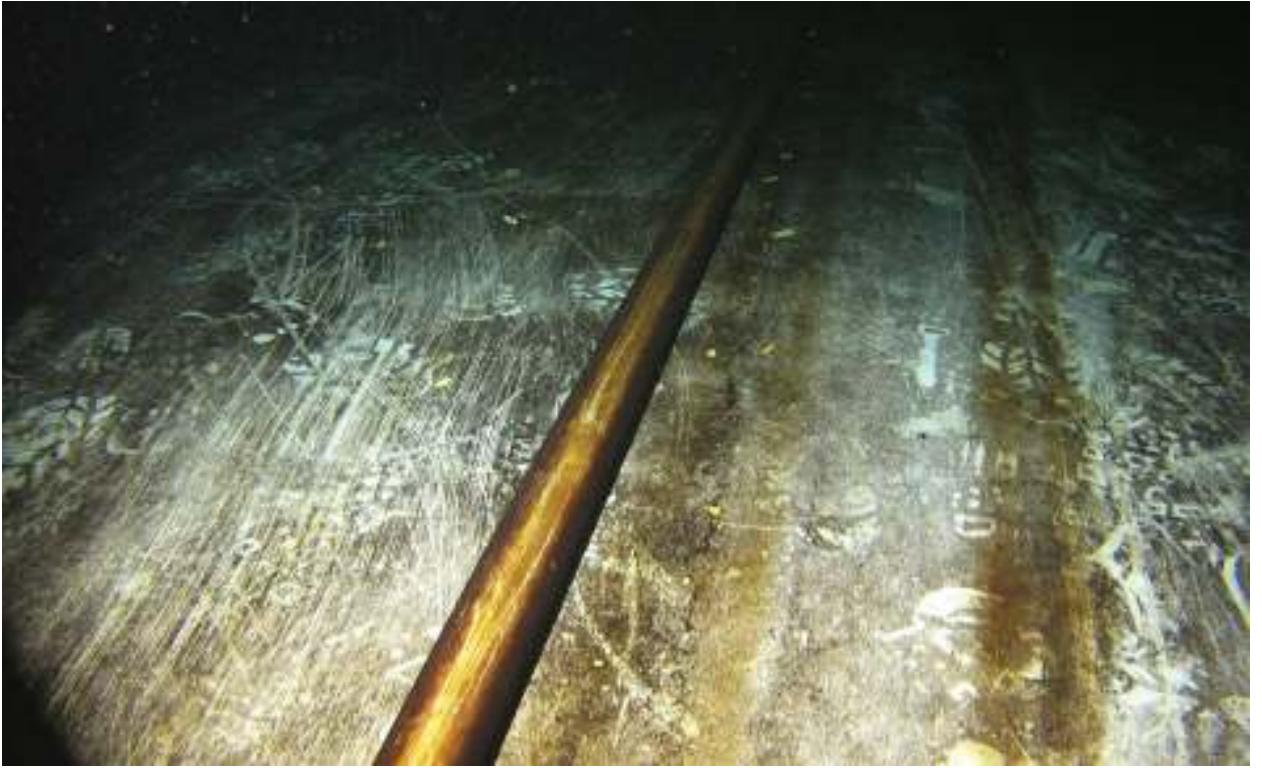
- **2.5" Diameter pipe used for sample tap - good condition.**
- Interior pipe is PVC with one short and open and a longer pipe that goes across tank, which is capped.
- Heavy sediment staining otherwise no flaws observed.
- **2" Diameter capped floor penetration – good condition.**
- **3" Diameter floor penetration in good condition and unobstructed with rust forming on edge of opening.**
