Utilities plan and budget for pipeline rehabilitation projects in advance. But when Mother Nature unleashed a magnitude 4.7 earthquake on one of its canals, the Truckee Meadows Water Authority shifted into high gear to maintain its water supply and repair an aged flume. **BY JENNIFER SANZI**

# MOTHER NATURE HASTENS PIPELINE REPAIR

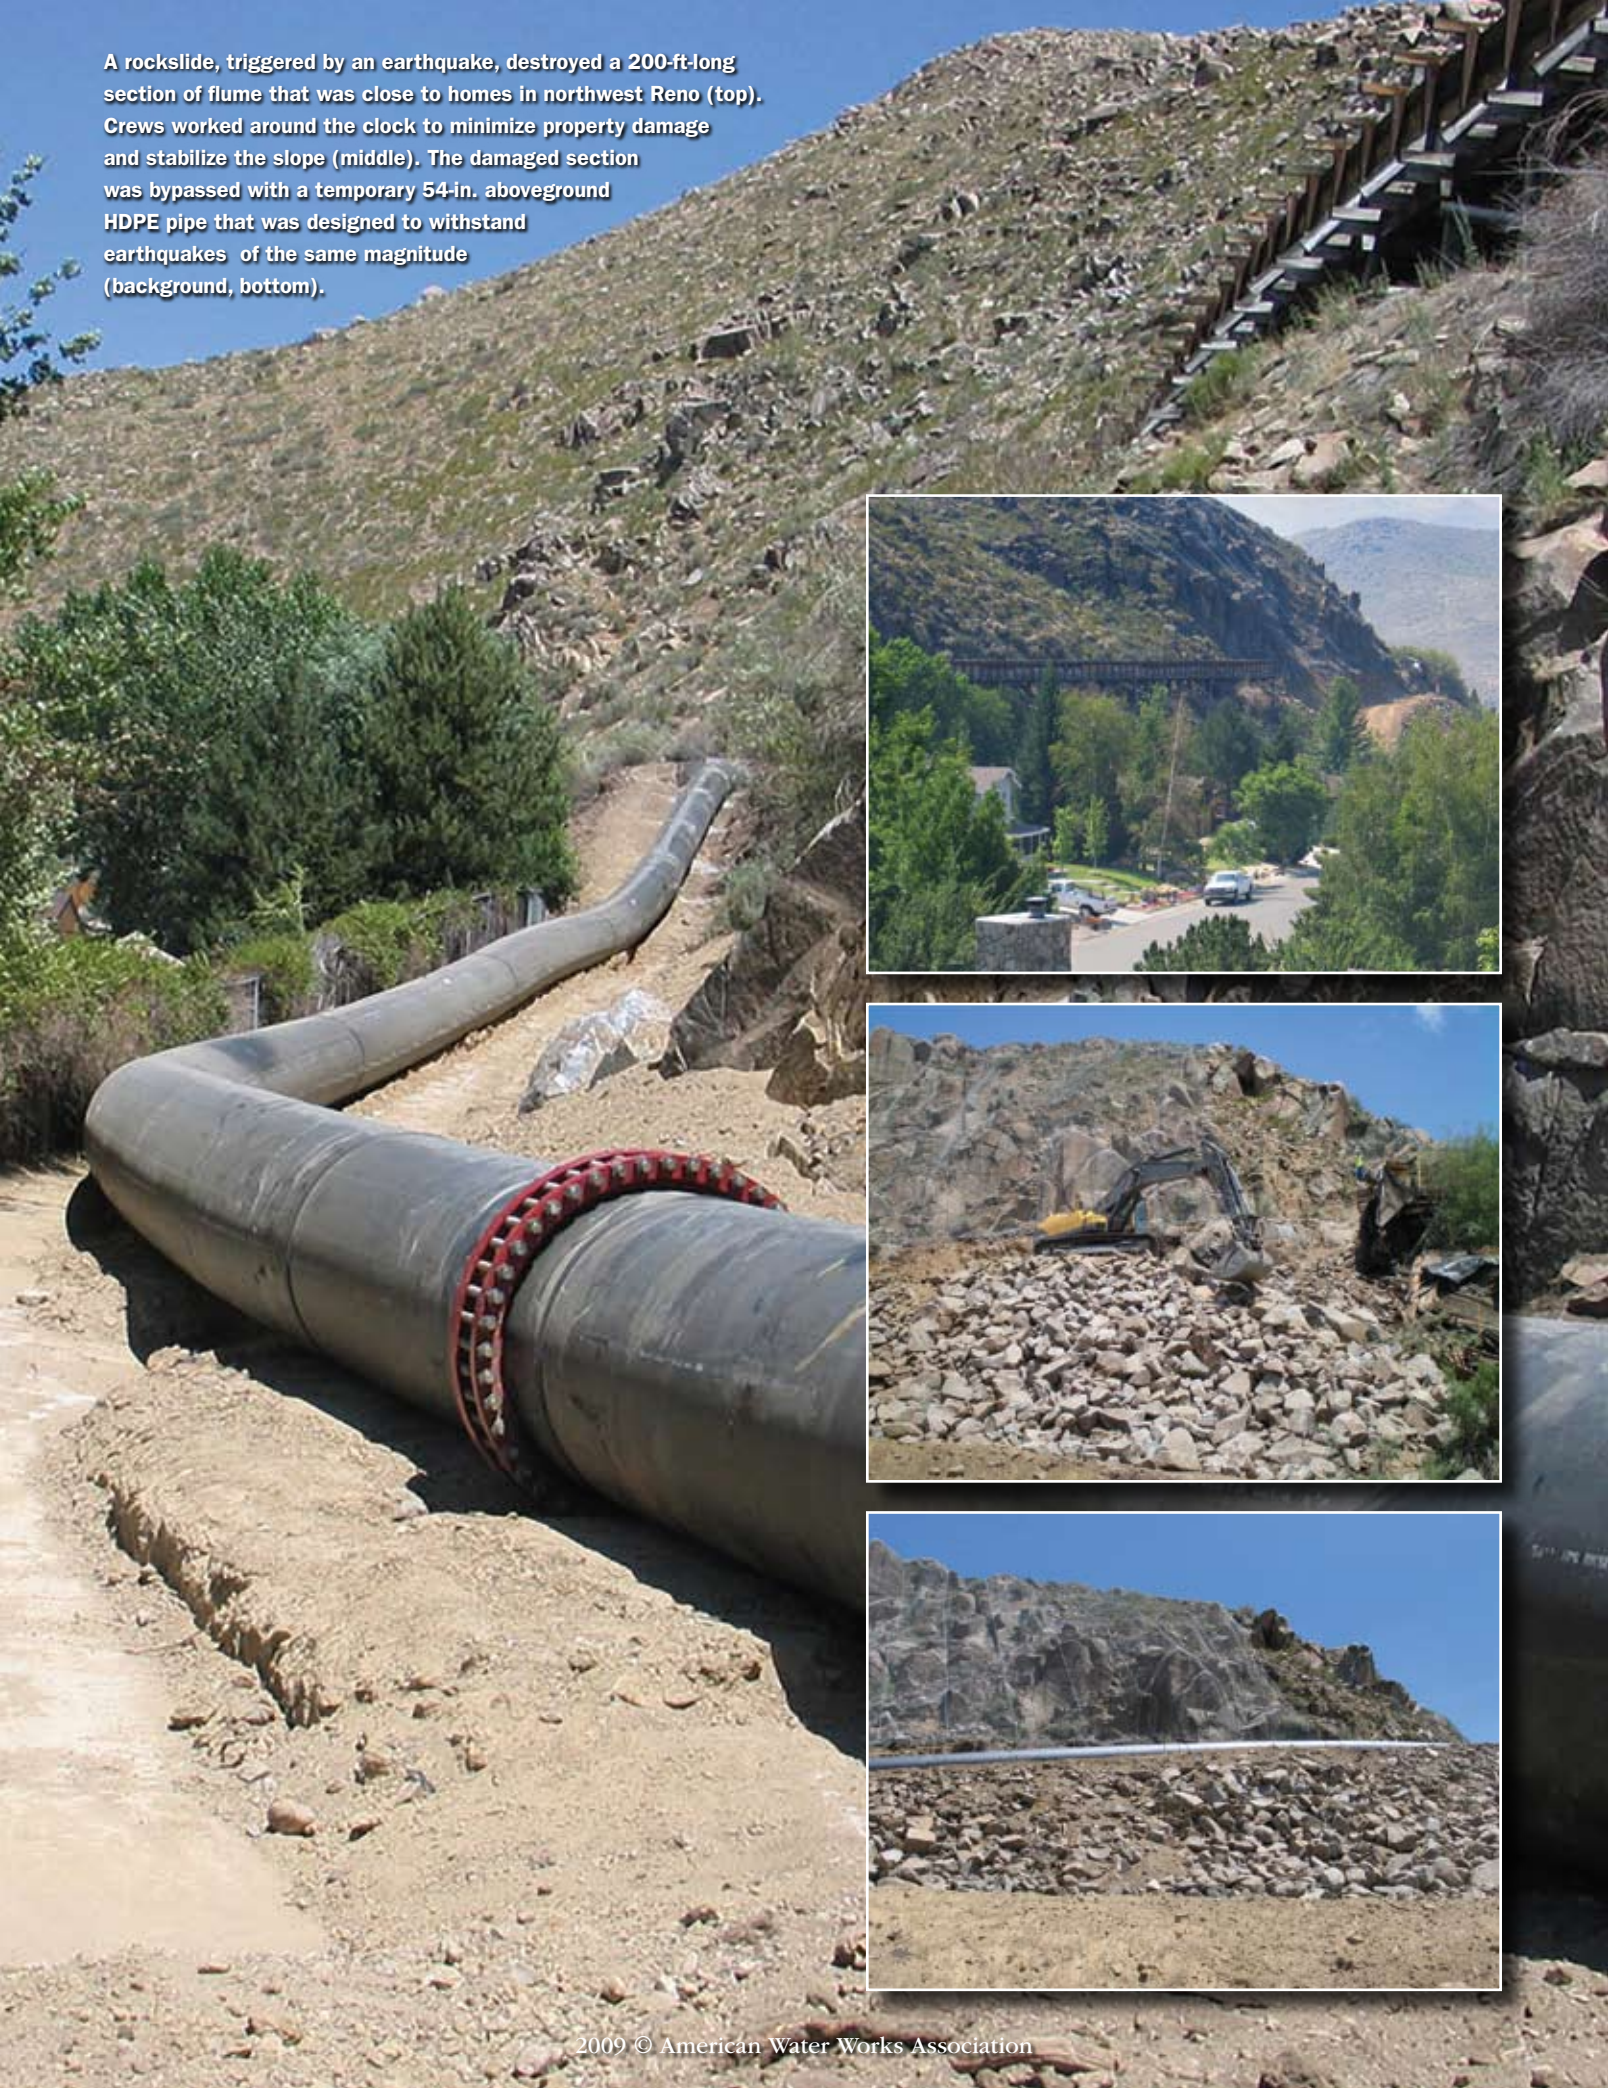
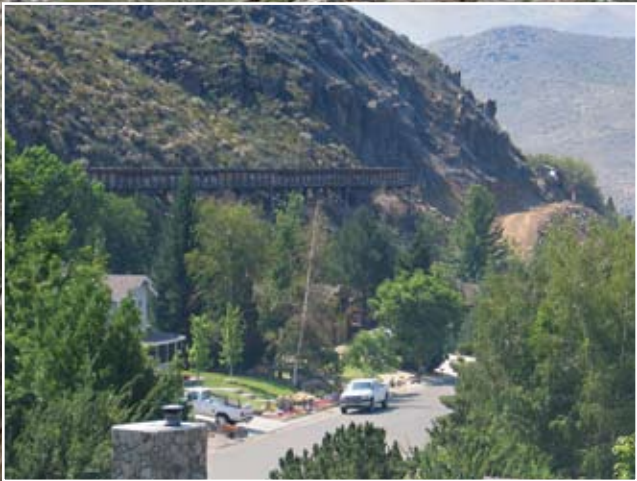
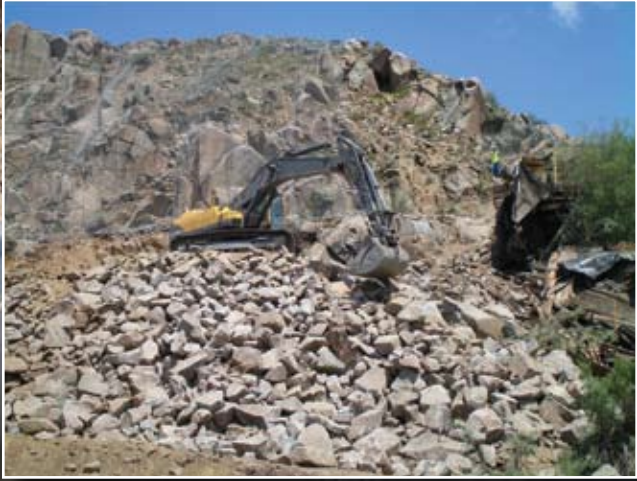
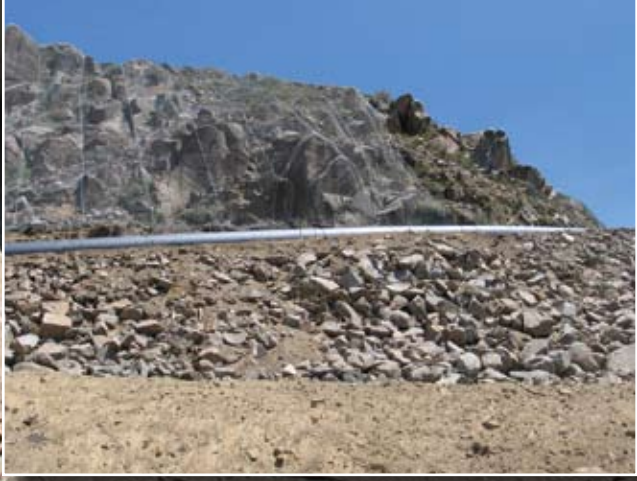
In northwest Reno, the earthquake triggered a rock slide that destroyed a 200-ft section of flume at the Highland Canal, TMWA’s primary raw water conveyance system, which supplies 50 mgd of raw water through gravity flow to the Chalk Bluff Water Treatment Plant. Built by Chinese laborers in the 1800s, the wooden flumes and some canal sections have been restored throughout the years. The Chalk Bluff Treatment Plant, owned and operated by TMWA, is the largest treatment facility in the distribution system.

A rockslide, triggered by an earthquake, destroyed a 200-ft-long section of flume that was close to homes in northwest Reno (top). Crews worked around the clock to minimize property damage and stabilize the slope (middle). The damaged section was bypassed with a temporary 54-in. aboveground HDPE pipe that was designed to withstand earthquakes of the same magnitude (background, bottom).

Ultimately, a Nevada-based construction company bypassed the damaged section with a 54-in. aboveground high-density polyethylene (HDPE) pipe that was designed to withstand earthquakes of the same magnitude. Construction began in June, and by August the extensive work had restored gravity flow and eliminated the need for diesel pumps. The total project cost was \$780,235, which was offset by the energy and operational savings associated with the temporary diesel pump station.

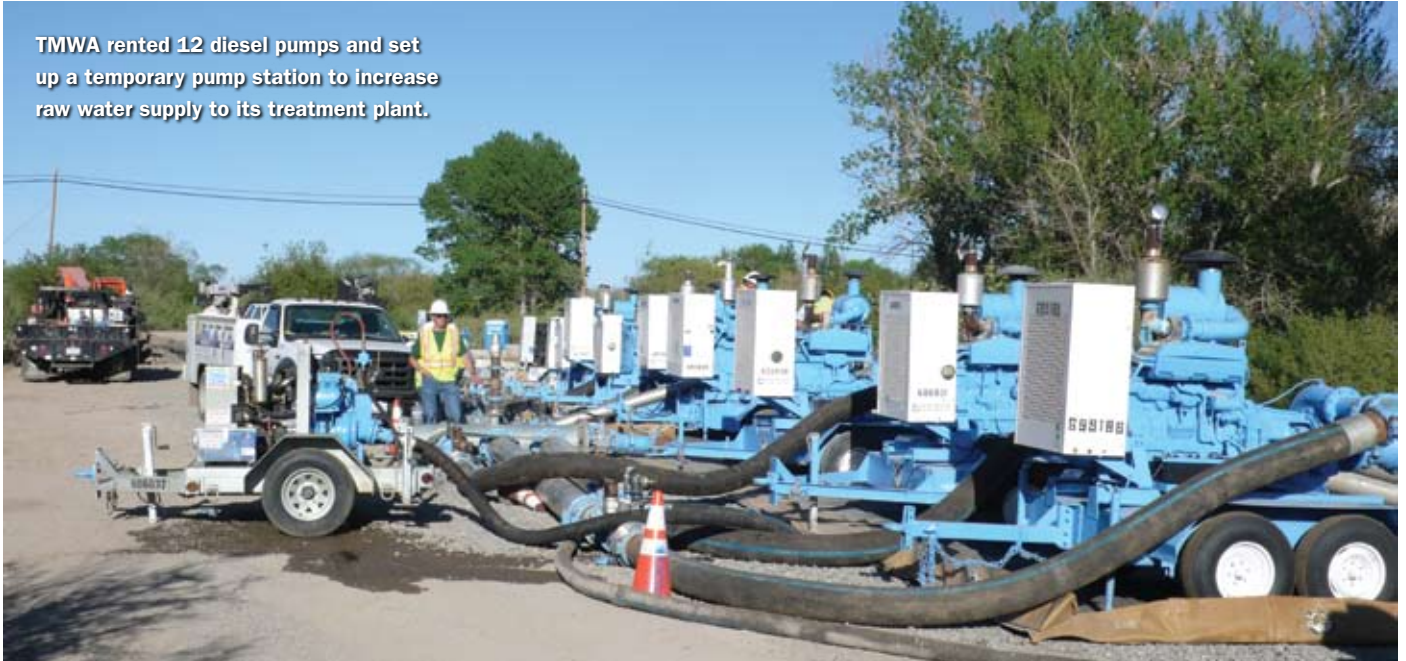
TMWA rented 12 diesel pumps and set up a temporary pump station to increase raw water supply to its treatment plant.

**River Water.** TMWA managers and operators began researching options to offset the loss in system capacity, including renting pumps and pipes from a company that helped drain water in New Orleans after Hurricane Katrina. A temporary station was set up to pump water directly from the Truckee River, Reno's main drinking water source, to the Chalk Bluff plant at a 160-ft elevation gain. The pumps supplied 35 mgd of river water to the Chalk Bluff plant, providing enough raw water capacity to operate the Chalk Bluff plant at its 83-mgd capacity.

However, the 12 gas-guzzling diesel pumps—each using nine gal of diesel fuel per hr—cost TMWA \$390,000 per mo to move raw water to the plant. Additional costs included sound mitigation to protect neighboring homes from noise pollution and around-the-clock security monitoring. Although expensive, the solution was successful and gave TMWA time to find a more cost-effective solution for meeting summer demand.
